Our ref. ANSV 1147/19

Subject: serious incident occurred on the 10th of August 2019, at Rome Fiumicino airport (Italy), to B787-8 registration marks LN-LND. ANSV safety recommendations.

1. Foreword.

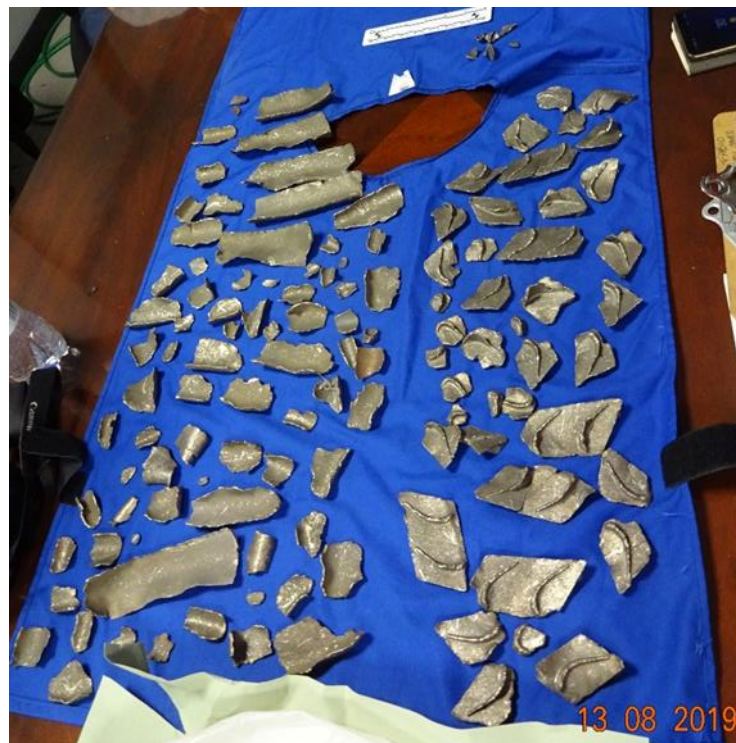
About 4 kg of debris (mainly fragments of turbine blades, picture 2) coming from the left engine were recovered from the streets of Fiumicino (the city nearby the airport, detail in the red rectangle in figure 3), along the direction of the runway, where several damages to buildings and cars were reported by the population. No debris were found within the airport area.

Picture 2: debris collected in the streets of the city nearby the airport, Fiumicino.

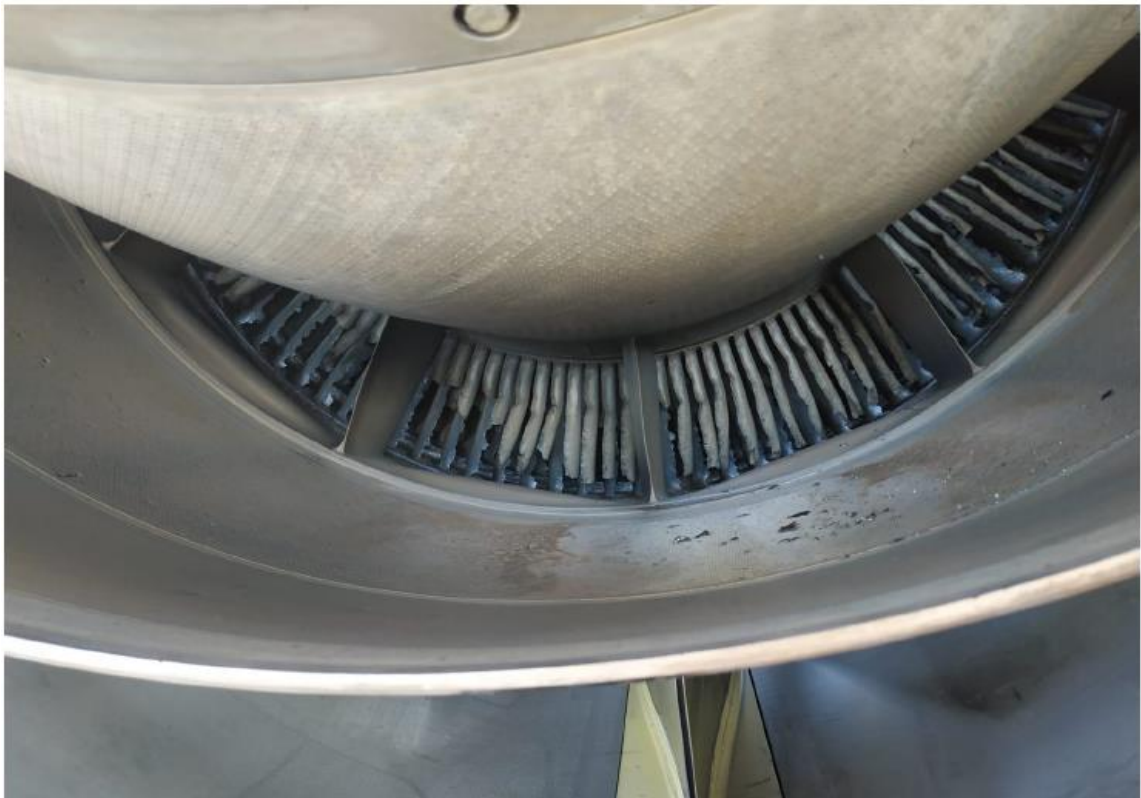
The B787-8 LN-LND was equipped with two Rolls Royce Trent 1000 G/01A. After the event, the left engine (the one that failed) did not show externally any particular sign of damage, except for the last turbine stage that was heavily damaged and blade fragments were found in the tailpipe (picture 3). The aircraft showed multiple holes and impact marks underneath the n° 2 flaps, flap fairing and on the horizontal stabilizer (pictures 4/8). Some minor dents were also found on the fuselage (picture 9). The left main landing gear tires deflated due to the hot-braking as a consequence of the overweight landing (picture 10). Complete assessment of the damage level of the aircraft is still on-going at the date this ANSV document is issued.

Picture 3: external evidence of left engine damage.

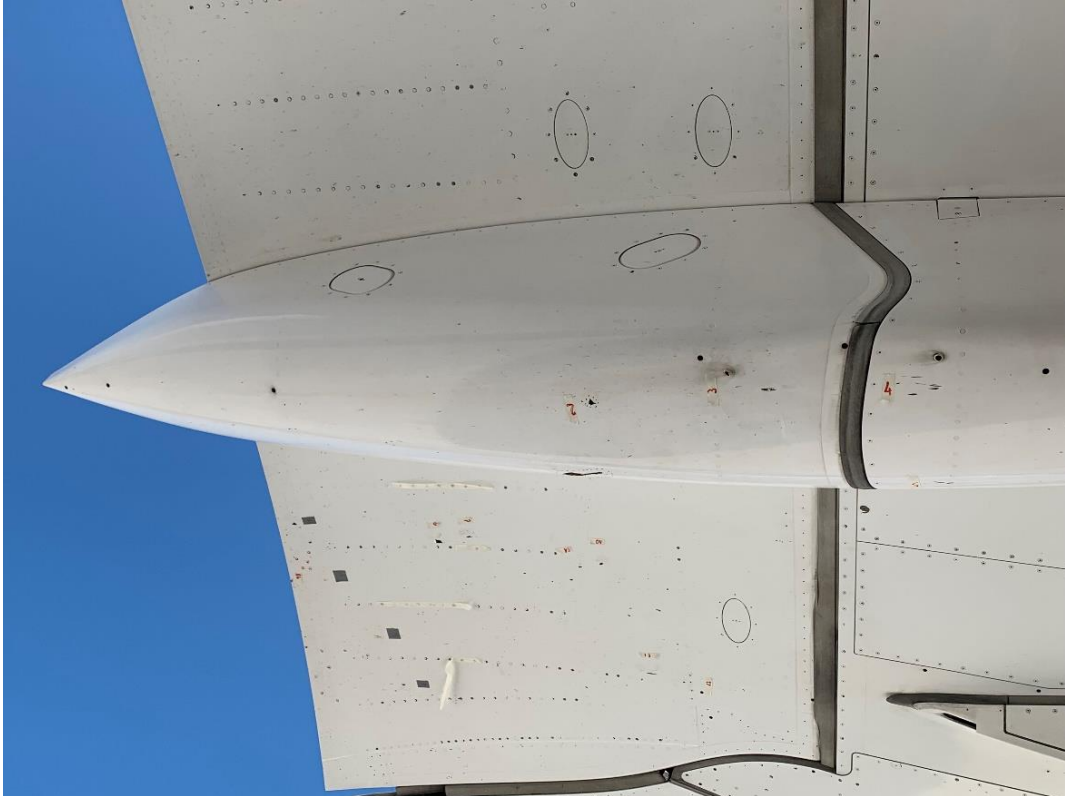
Picture 4: aircraft damage.

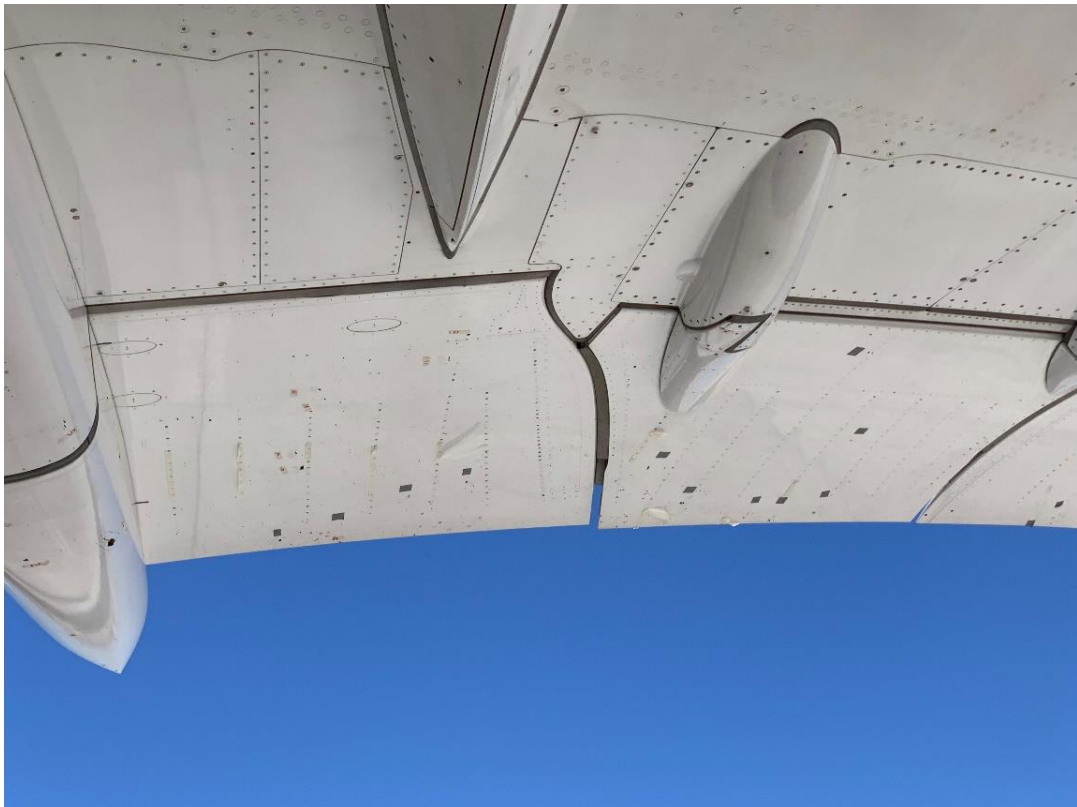
Picture 5: aircraft damage.

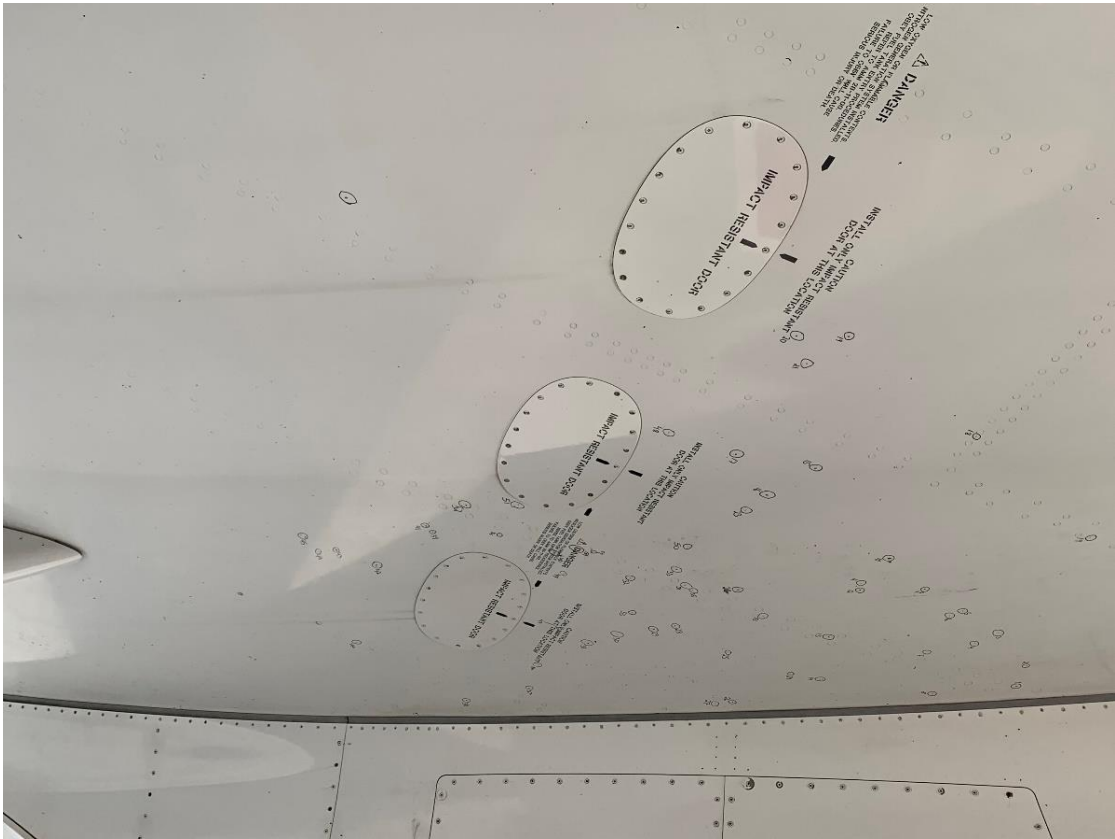
Picture 6: aircraft damage.

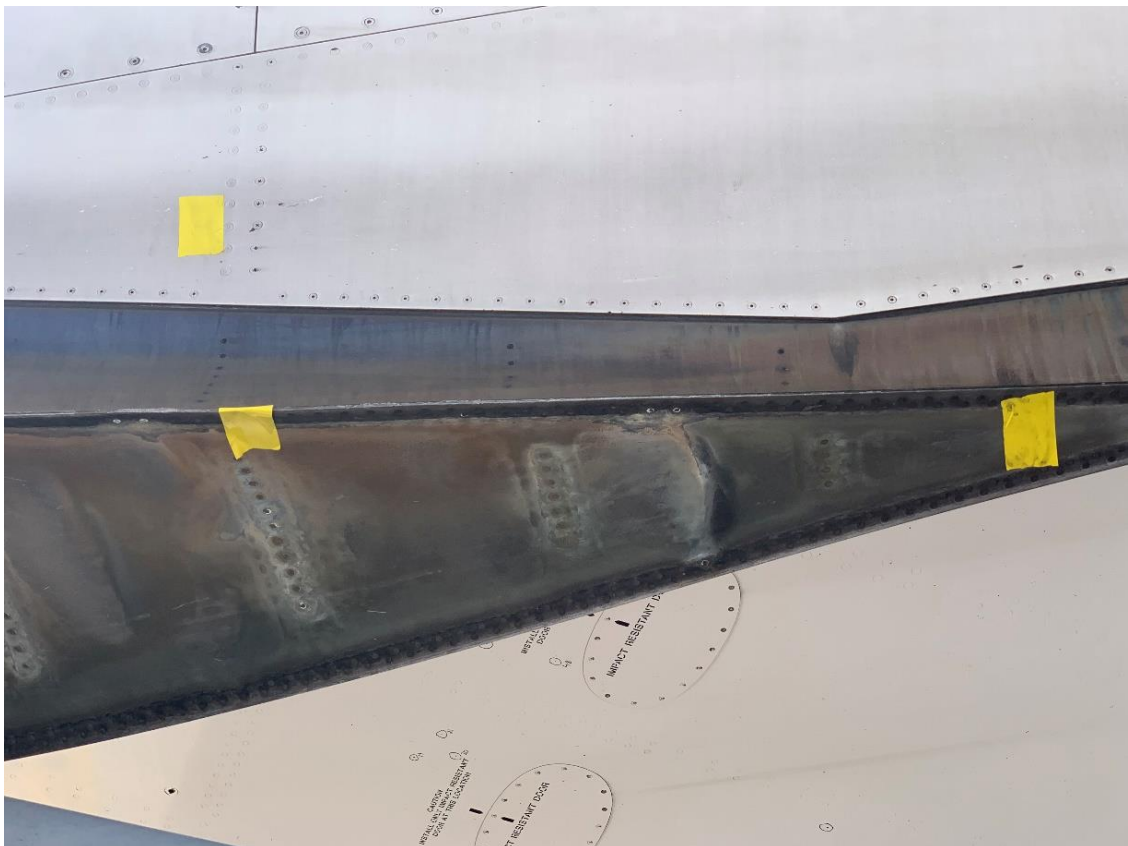
Picture 7: aircraft damage.

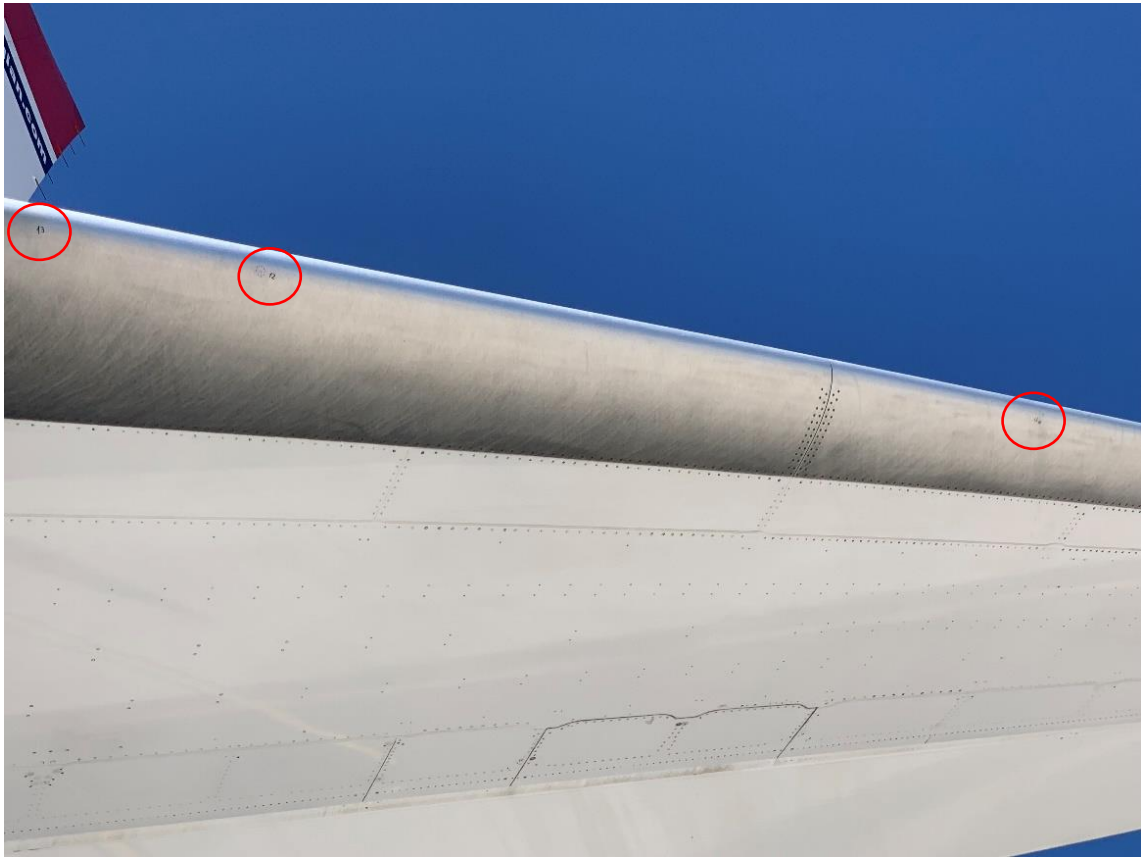
Picture 8: aircraft damage, horizontal stabilizer.

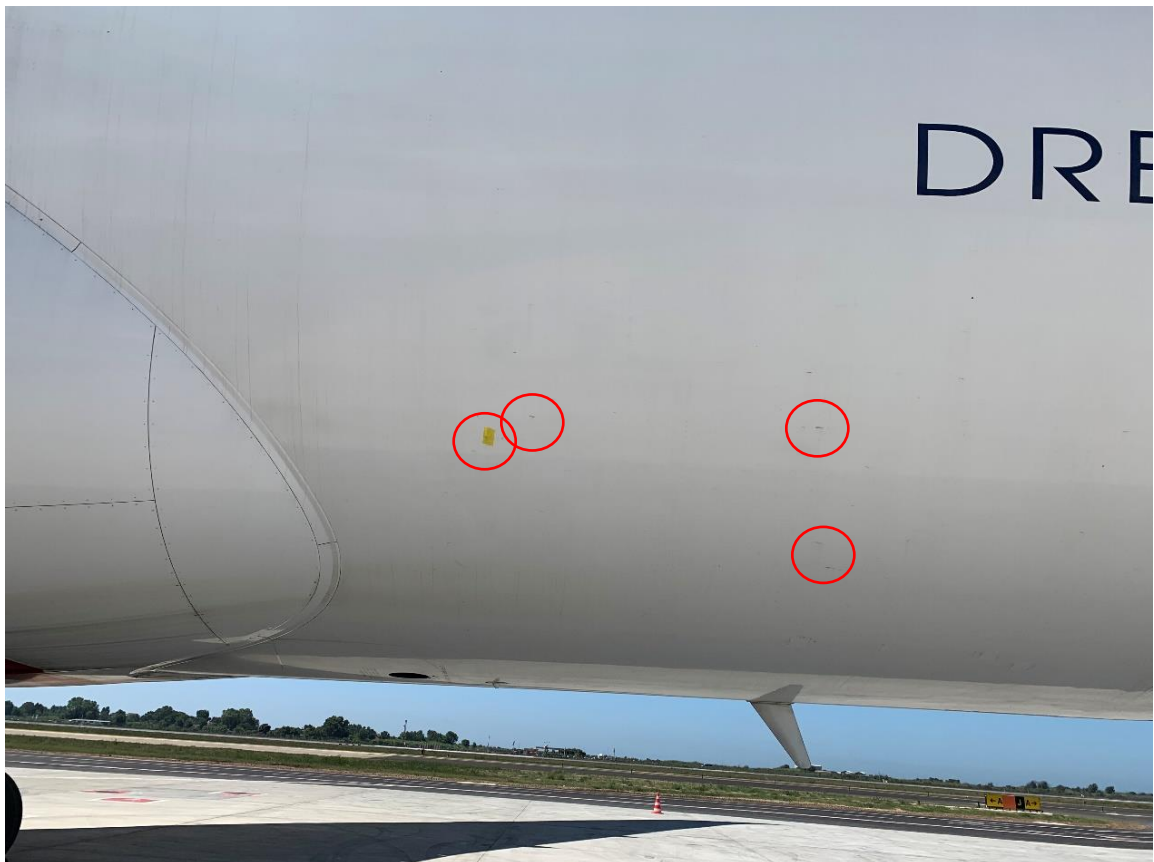
Picture 9: aircraft damage, fuselage.

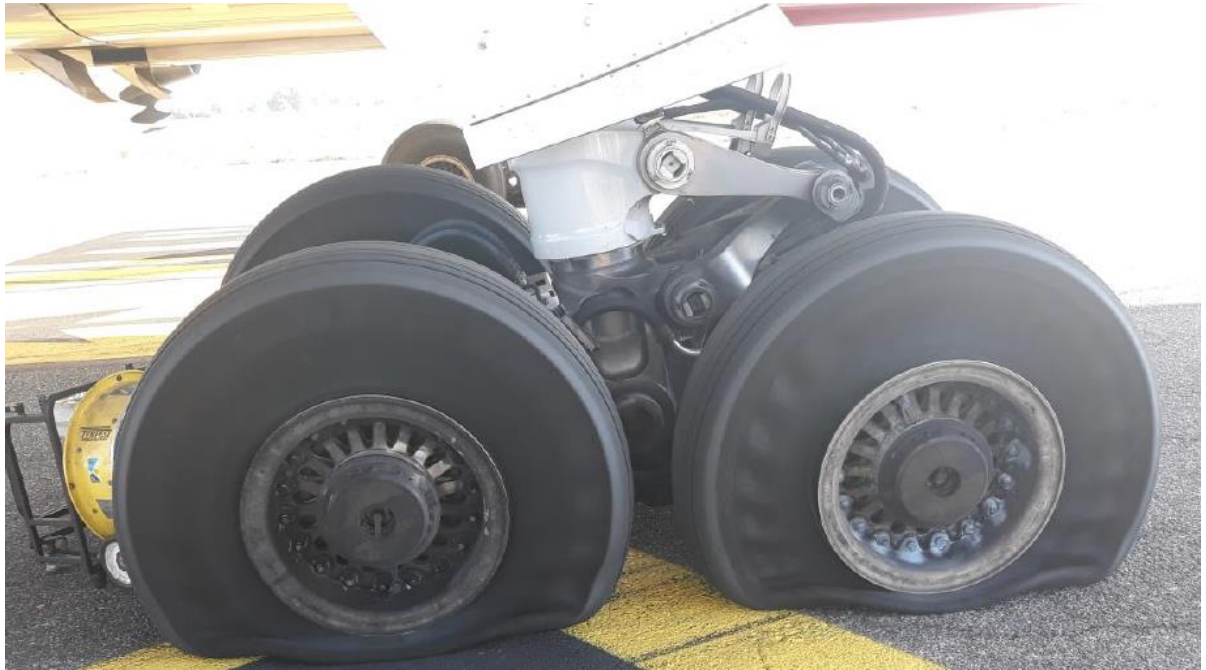
Picture 10: deflated left landing gear tires.

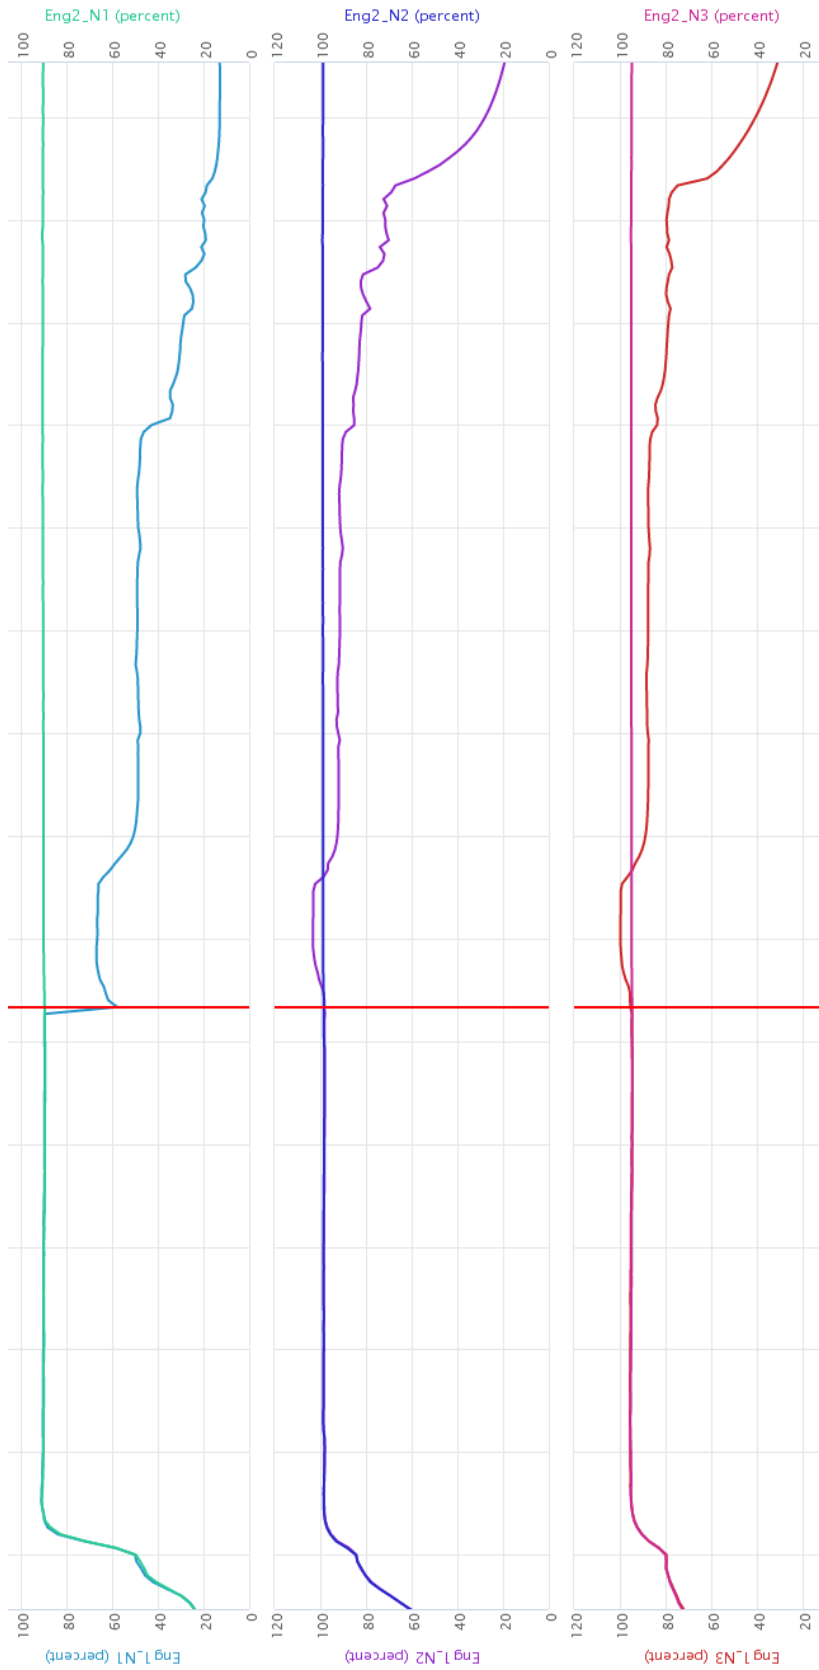
The preliminary analysis of the EAFR data shows that at 14.46.05 UTC (about 6 s before the “Eng1_Vib_Warn” discrete parameter activation) an abrupt decrease of left engine N1 (from 90% to less than 60%, figure 4). At the same time, left engine N2 and N3, oil temperature and pressure slightly increased (figure 5). From the point onward the overall vibration level of the left engine increased (figure 6/7). The left engine IFSD was commanded by the crew at 14.48.06 UTC. The engine manufacturer reviewed the EMU (5 Hz sampling rate) data, confirming the above evidence as well as highlighting, in addition, that the behavior of the engine was compatible with an Intermediate Pressure Turbine (IPT) blade damage. In more detail, the EMU data shows that the drop in N1 happened after IP tracked order vibration increased (as a result of the IPT blade release). Therefore, the most likely sequence of events is (figure 8):

Figure 4: selection of EAFR data, red line 14.46.05 UTC, comparison of ENG1 (left) and ENG2 (right).

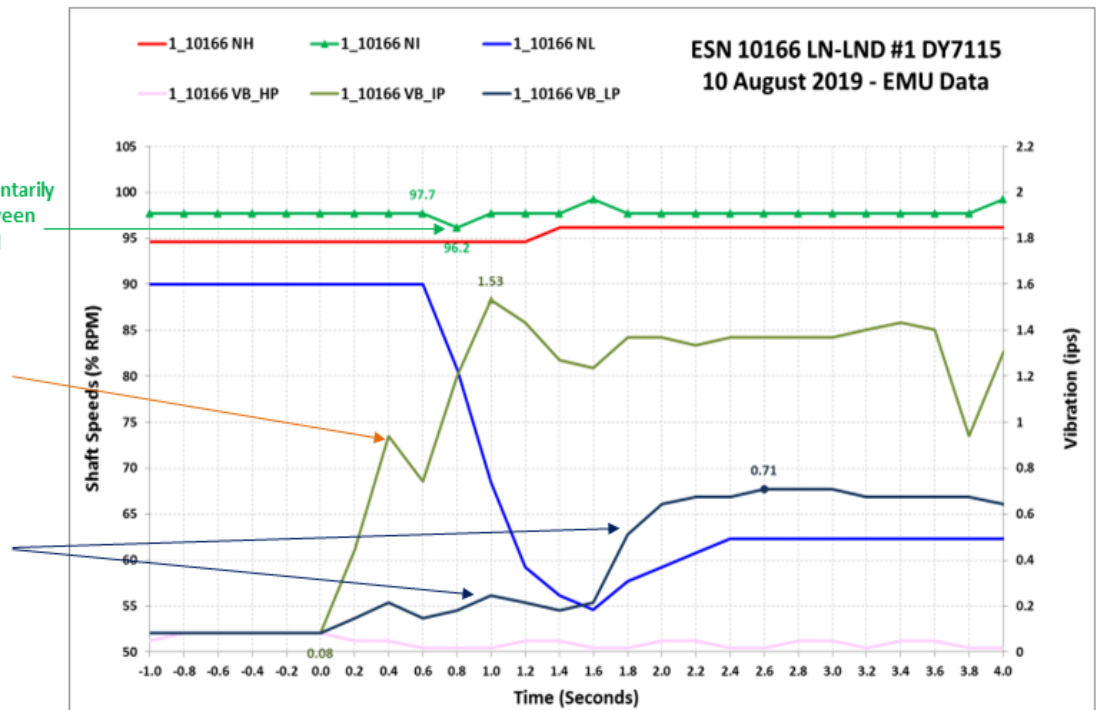
- IPT blade release resulting in IP tracked order vibration increase;
- IPT blade release causes downstream damage to the LP turbine and a reduction in LP shaft speed and increase in LP tracked order vibration;
- the engine control system then attempts to restore power before the pilot shuts down the engine.

IP speed decreased momentarily from 97.7% to 96.2% between 0.6 and 0.8 sec after initial parameter changes

IP vibration increase from 0.08 ips to 1.53 ips in 1 second

LP vibration slight increase at the same time as IP vibration increase, and larger increase 1.6 sec later, peaked at 0.71 ips at 2.6 sec.

Figure 8: EMU data analysis (source Rolls-Royce).

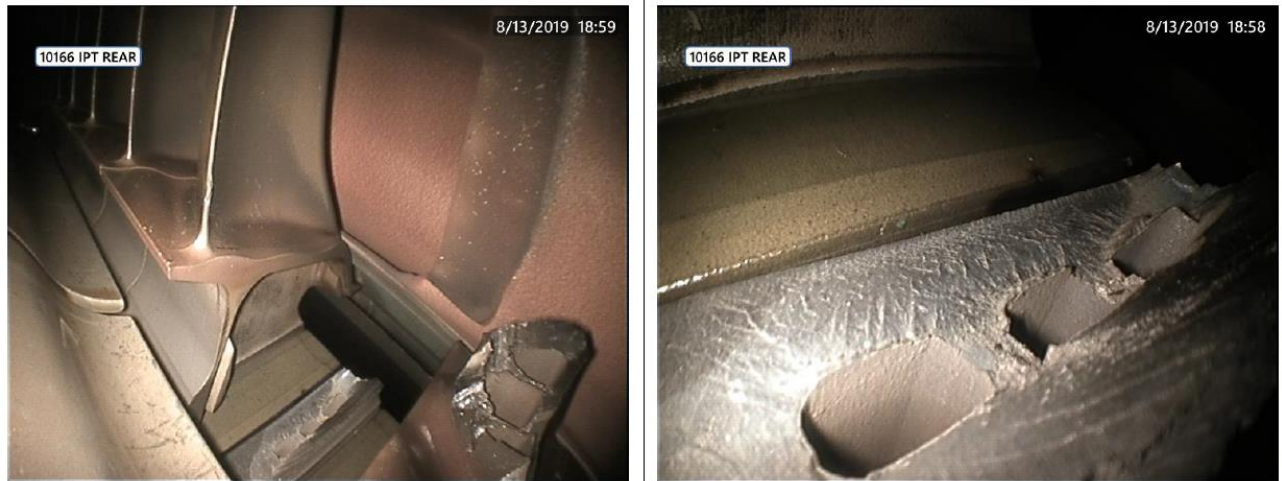
Borescope inspection of the left engine revealed as main evidence the failure of two adjacent blades (picture 12 left) in the IPT stage (figure 9) and consequent damages in the following stages, confirming the preliminary data analysis. The fracture surface of one of the two IPT blades fractured appears to be a progressive failure (picture 12 right). The trailing blade, also fractured, appears to be an overload failure.

Picture 12: fracture surfaces of the IPT blades found broken.

Since 2015 there have been 10 previous cases of IPT blade (IPTB) progressive fractures. The failure mechanism has been recognized as corrosion-fatigue due to sulphidation (picture 12 right). The appearance of the fracture surface from the IPT blade of the Trent 1000 G/01A SN 10166, left engine of the B787-8 registration marks LN-LND in the flight of the event, appears to be consistent with this kind of fracture mechanism. Following a table reporting the 11 cases in total.

To take immediate actions to achieve an higher level of safety, also taking in consideration, but not limiting EASA initiatives to, defining different and more stringent time limits for the Trent 1000 pre-mod 72-H818 IPT blades.

To re-evaluate the whole validity of the service management adopted by the manufacturer for the Trent 1000 pre-mod 72-H818 IPT blades, endorsed by the AD 2019-0135.

To evaluate provisions relevant to the de-pairing of pre-mod 72-H818 engines, avoiding two engines of the same pre-mod status being installed on the same aircraft, thus further lessening the possibility of a DIFSD.
