DICHIARAZIONE INTERMEDIA

INCIDENTE
occorso all'aeromobile
Fokker F27 MK050 marche SE-LEZ,
aeroporto di Catania Fontanarossa,
30 aprile 2016

Technical Event Investigation Report

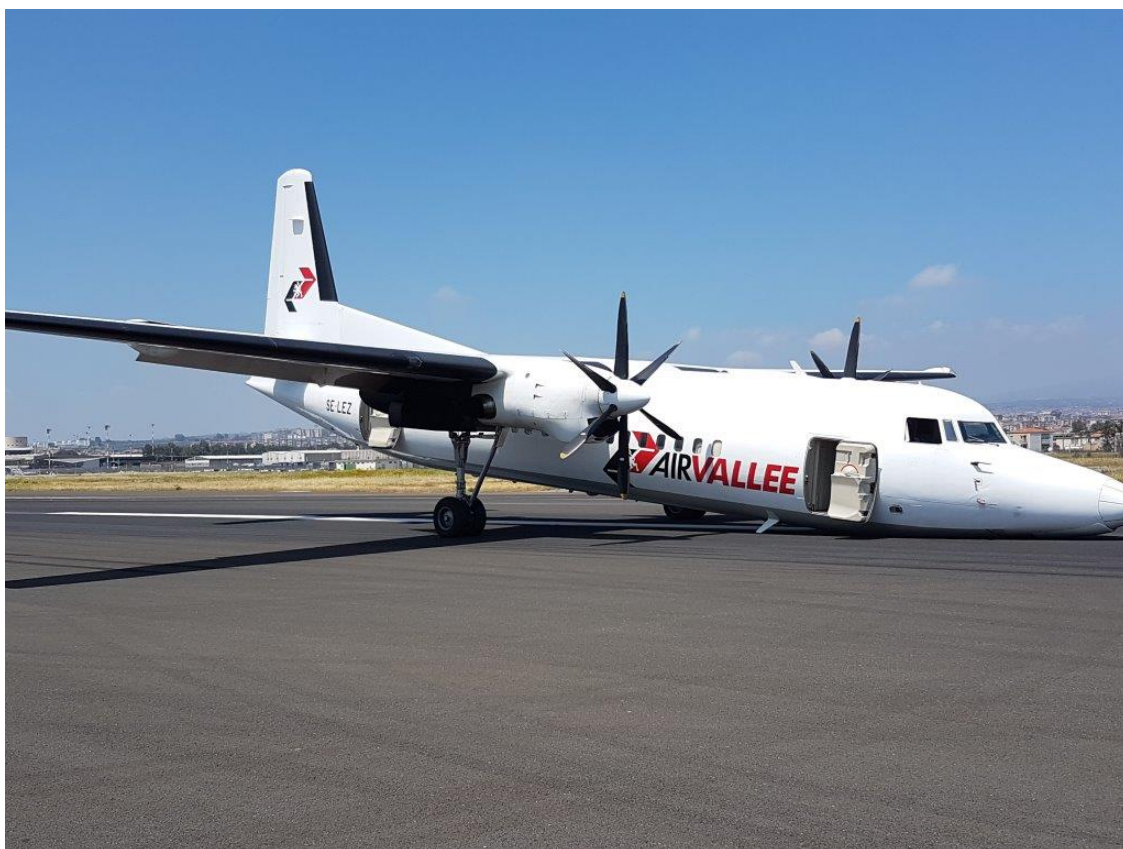
Foto 1: il velivolo fotografato poco dopo l'accadimento dell'evento.

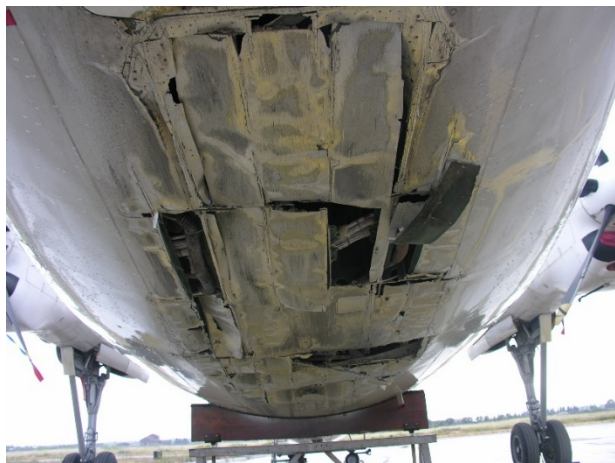
Foto 2: danni alla parte inferiore della fusoliera.

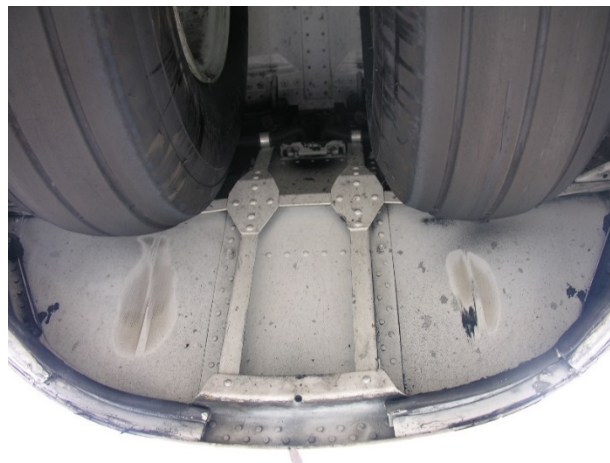
Foto 3: posizione di rinvenimento dei due pneumatici.

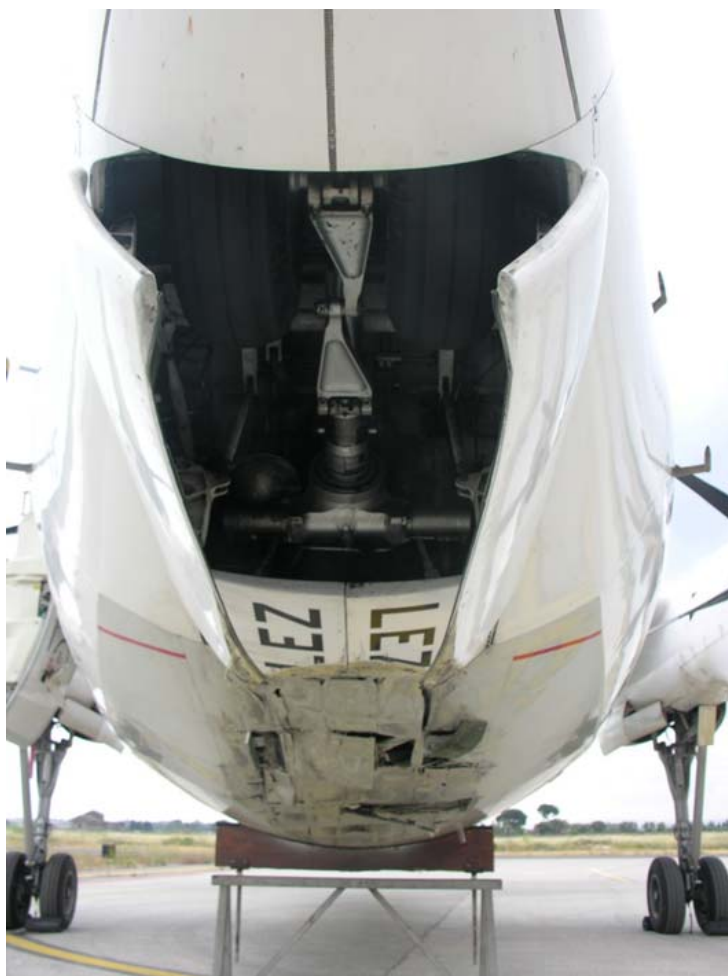
Foto 4: posizione di rinvenimento del carrello anteriore dopo la rimozione del velivolo dalla pista.

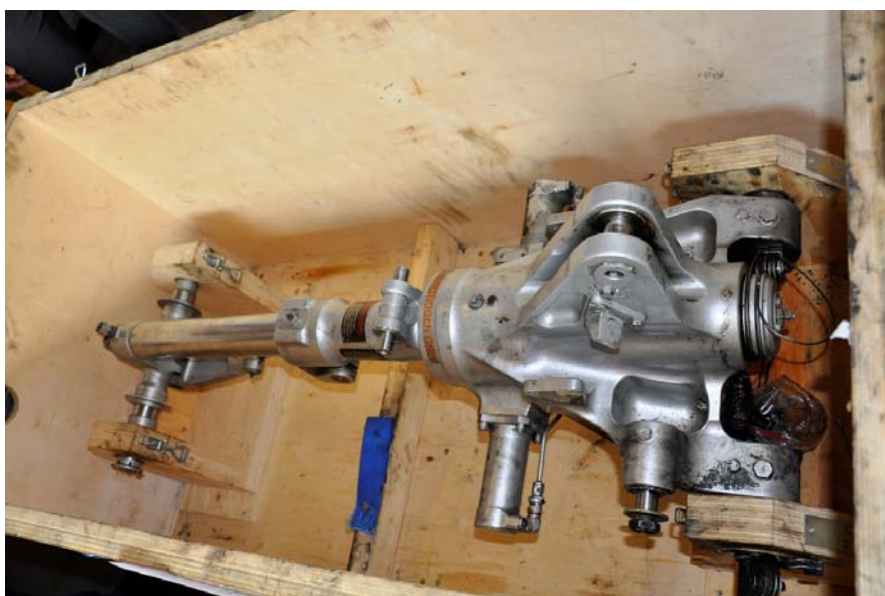
Foto 5: la gamba del carrello anteriore prima dell'esame condotto presso il costruttore del componente.

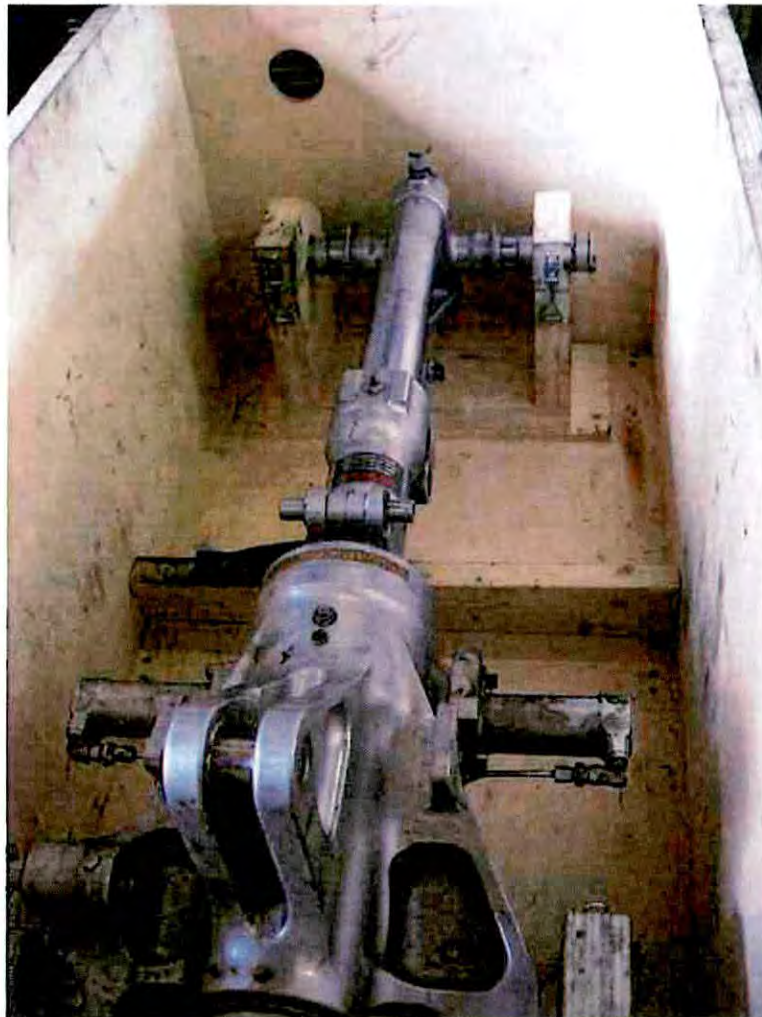
The box was opened and it was immediately noticed that the support blocks had been extended inside the carrier to accommodate the over-extended gear. The Torque Links were fully extended to a straightened position. There was no external evidence of damaged components. A measurement was taken between the gland nut and the end of the chrome plating on the slider with the gear still boxed: the measurement was recorded as 16 5/8 inch (422,3mm). By comparison, the same measurement was taken later with the Out Stop assembled and the dowels in place and was recorded as 13 3/4 inch (349,25mm). The general condition of the NLG was considered to be normal other than the position of the Torque Links and Sliding Member (Refer to Figure 4).

FIGURE 4: NOSE LANDING GEAR IN BOXED CONDITION

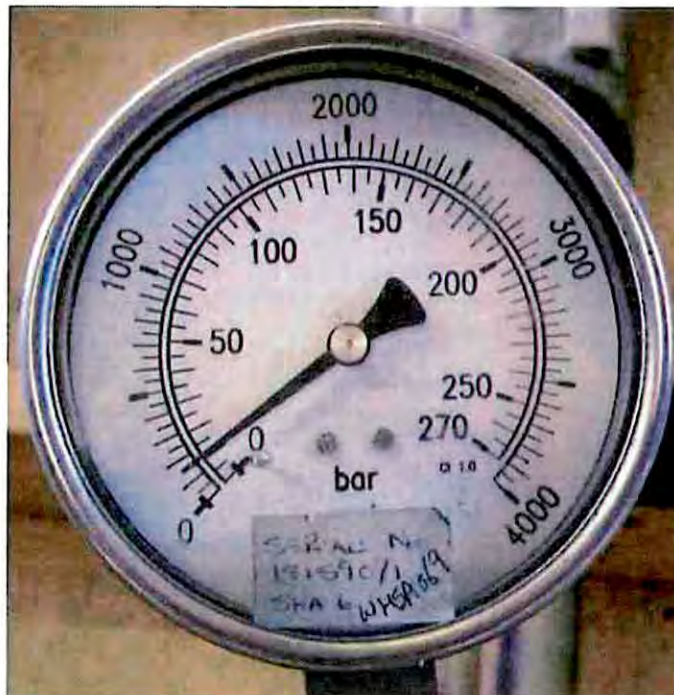
With the gear still boxed, the nitrogen pressure was tested using an analogue gauge to the inflation valve and was recorded to be 140psi as opposed to the correct value of 185-195psi (Refer to Figure 5). The ANSV stated that they had requested that the NLG be transported without altering the pressure of the gear from the installed condition.

FIGURE 5: NLG NITROGEN PRESSURE READING

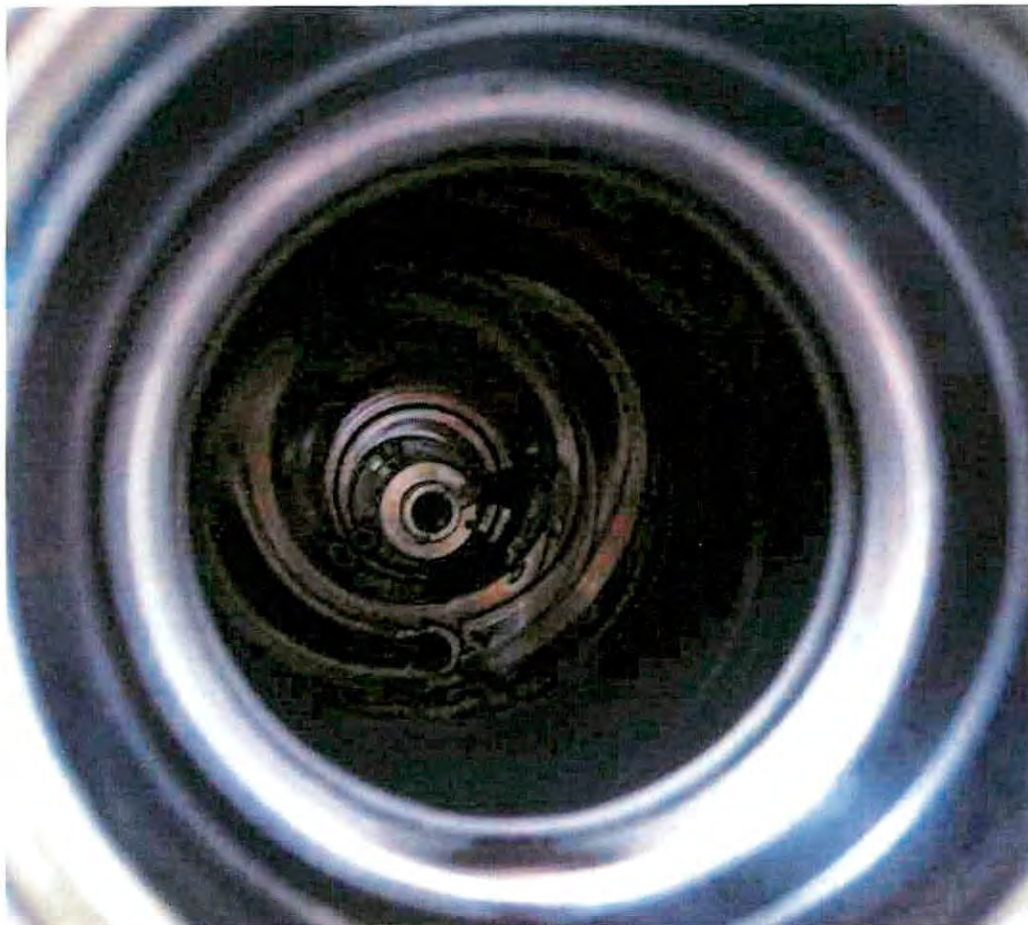
With the Sliding Member removed, the Valve Housing, the piston and the retaining dowels were visible in the top of the turning tube (Refer to Figure 6). These components were removed from the turning tube for further examination. There were no signs of a fracture or evidence of crack upon visual examination. The Valve Housing showed witness marks in the damping orifice slots, suggesting that the Valve Housing had been assembled in the incorrect orientation. Scribing marks were evident on the Sliding Member (P/N 201013304), Valve Housing (P/N 201013715) and Bearing Sleeve (P/N 201013734) indicating that this was a superseding installation according to Service Bulletin F50-32-60 (Ref. [1]). The identification marking on the Sliding Member was only visible under ten times magnification with a hand lens.

FIGURE 6: TURNING TUBE INNER BORE WITH PISTON, VALVE HOUSING AND RETAINING DOWELS VISIBLE

The identification marking that had been mechanically scribed on to the Bearing Sleeve was not a requirement of Ref. [1]. However, the scribed line was noticed to be facing the opposite direction to those scribed on the Sliding Member and the Valve Housing; it was upside down by comparison. It is believed that the significance of the scribed markings on the Valve Housing and the Sliding Member was not understood, and that the maintenance staff performing the seal replacement just prior to the incident did not notice that the Valve Housing was assembled in the incorrect radial orientation.

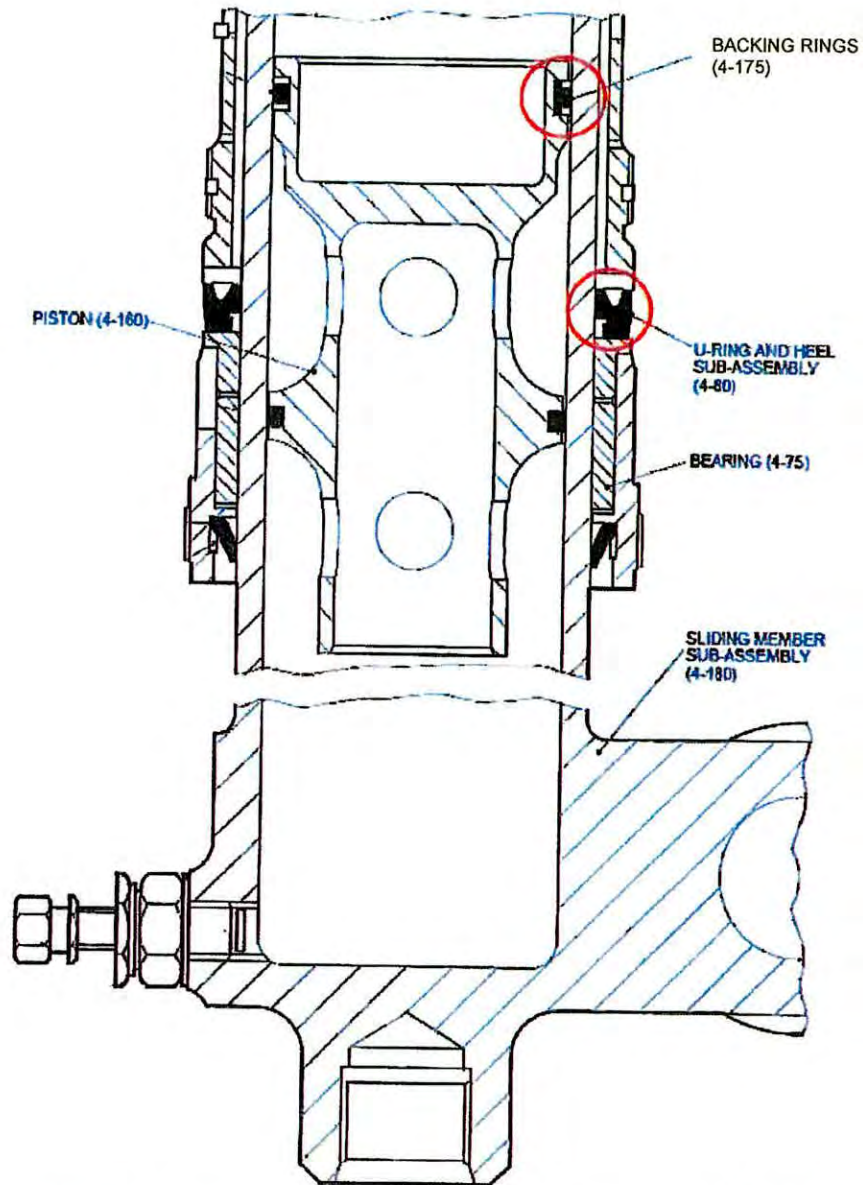
Examination of the seal assemblies was carried out. The Backing Ring from the Gland U-Ring and Heel Sub-Assembly (P/N 333-016-2454-41) was found to be installed in the wrong orientation. Additionally the backing rings (P/N 717042562) on the separator piston were installed upside down. Figure 7 highlights the position of the incorrectly installed sealing assemblies.

FIGURE 7: DIAGRAM HIGHLIGHTING POSITION OF INCORRECTLY INSTALLED SEALS WITHIN THE SLIDING MEMBER SUB-ASSEMBLY

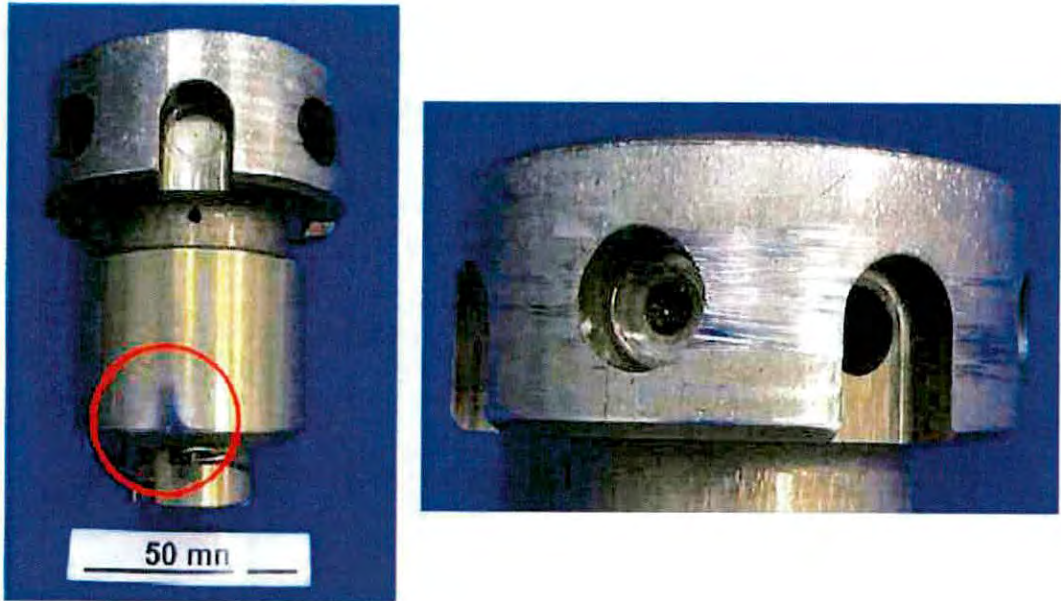
- Evidence of wear/scratching was observed in various locations on the outside diameter of the Valve Housing (refer to Figure 9)
- Circular scratches were observed in one orifice slot (refer to Figure 10)
- All four orifice slots contained scratches on the inner wall of the slot (refer to Figure 10)
- The Torque Link Apex Nut threads did not pass the Go-No Go test. Sectioning of the nut revealed an incorrect thread form.
- The hydraulic fluid sample was analysed using FTIR before and after filtration. The traces confirmed the hydraulic fluid to be mineral oil in accordance with MIL-5606. The water content was measured to be 41ppm, which is acceptable to PCS-7100.

FIGURE 9: WEAR/SCRATCH DAMAGE TO OUTSIDE DIAMETERS OF VALVE HOUSING

- Damage observed on the Valve Housing supports the conclusion of incorrect assembly causing the over-extension of the NLG. The damage witnessed to the valve housing suggests that the retaining dowels were assembled into the orifice slots rather than the dowel holes.
- The Torque Link Apex Nut thread did not conform to the design thread specification of 3/4"-16UNF-2B, explaining the excessive play observed between the nut and bolt. This is not considered to be significant, as the excessive play would not contribute to loss of mechanical Out Stop in the Shock Absorber and thus was not contributory to the root cause.
- Fluid analysis confirmed that the oil used in the Shock Absorber was mineral oil with acceptable water content.

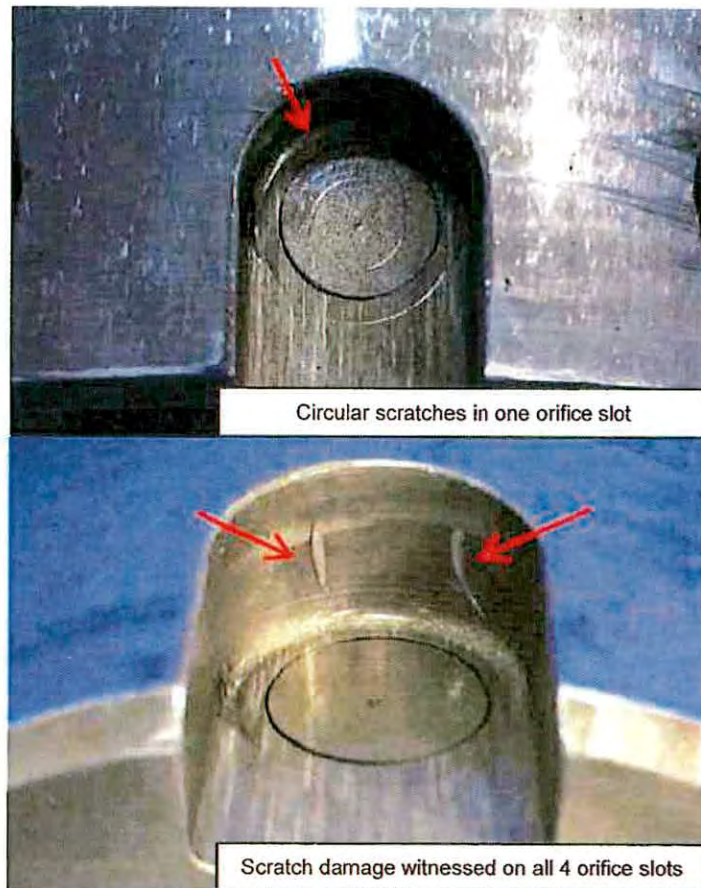
FIGURE 10: SCRATCH DAMAGE TO ORIFICE SLOTS OF VALVE HOUSING

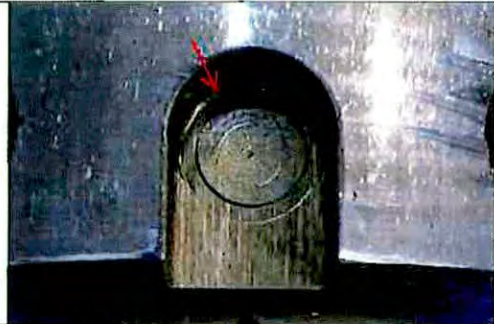
Figure 5: Circular scratches were also observed

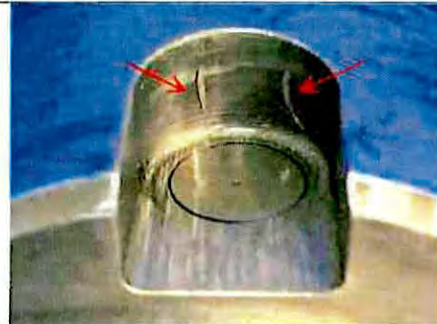
- Damage observed on the valve housing supports the initial conclusions of incorrect assembly causing the over-extension of the landing gear. It is believed that the retaining dowels were assembled in to the orifice slots, rather than the similar sized dowel holes.
- The torque link apex nut threads did not pass the Go-No Go test. Sectioning of the nut revealed an incorrect thread form, explaining the excessive play between the nut and bolt.
- Fluid analysis confirmed that the oil used in the shock absorber was mineral oil with an acceptable water content. Filtration found the presence of mainly aluminium particles, but also some cadmium, iron and copper particles.
- Analysis of the debris found in the turning tube confirmed the presence of aluminium and cadmium particles.

Figure 6: Typical damage seen on all orifice slots

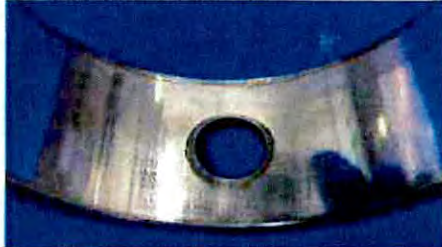
Figure 7: Most wear found on bearing sleeve ID nearest dowel hole 4

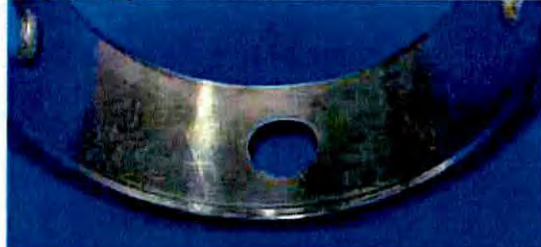
Figure 8: Least wear found on bearing sleeve ID nearest dowel hole 2

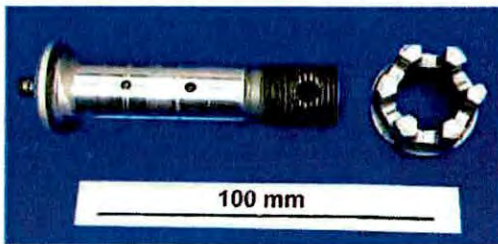
Figure 9: Apex bolt and nut

The thread specification for the apex bolt and nut are $\frac{3}{4}$ "-16UNF-2A and $\frac{3}{4}$ "-16UNF-2B respectively. A Go – No Go gauge was used to check the threads on both components. The bolt passed the test but the nut failed. The threaded regions on the Go and No Go ends of the gauge were able to pass through the nut threads, explaining the excessive play between the bolt and nut.

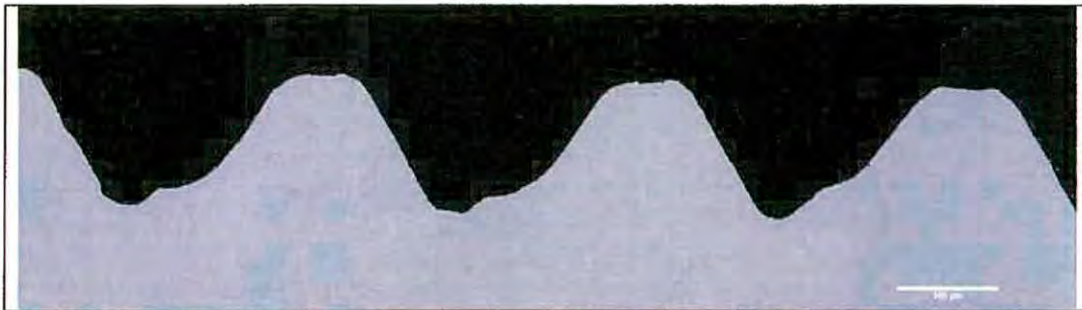
A microsection was taken through the nut to examine the condition of the threads. The thread profile was not uniform and discontinuities were seen in particularly in the roots of the threads (Figure 11). This was seen on all of the threads on the nut. The microsection was then etched in a 2% Nital solution to reveal its microstructure to check for any grain flow near the roots of the threads (Figure 12). Evidence of grain flow would suggest deformation, but no signs of any grain flow were observed. Microstructural examination confirmed an acceptable tempered martensitic microstructure. Cadmium plating was seen around the thread roots and was in good condition with an average thickness of 11 μ m (Figures 13 & 14). PCS-2101, which calls up DSS 5353, requires the cadmium thickness on threads to be 5 – 8 μ m, meaning the plating thickness is slightly above specification. The hardness of the nut was measured and found to be 421 HV 10kg. BS 5S 99 specifies a hardness range of 380 – 435 HV, and therefore is considered acceptable. Binocular examination of the bolt threads revealed them to be in good condition, although in some regions wear of the cadmium was seen (Figure 15).

Figure 11: Microsection taken through nut showing incorrect thread form.

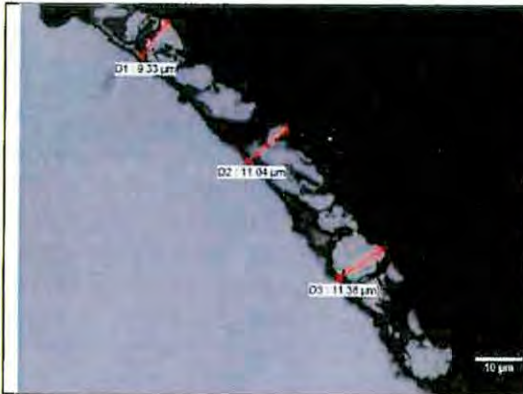
Figure 14: Cadmium plating observed to be an acceptable thickness

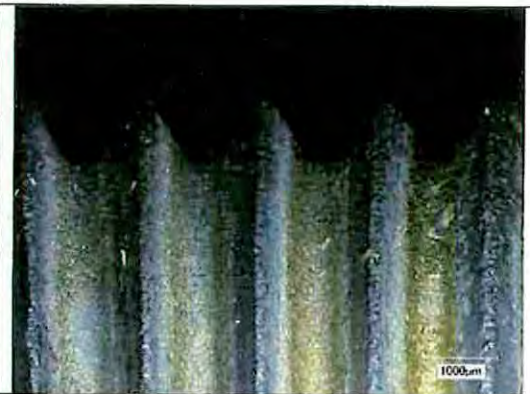
Figure 15: Threads on bolt in good condition. The absence of cadmium was observed on the thread flanks and crests. Some regions in the thread roots were also lacking plating

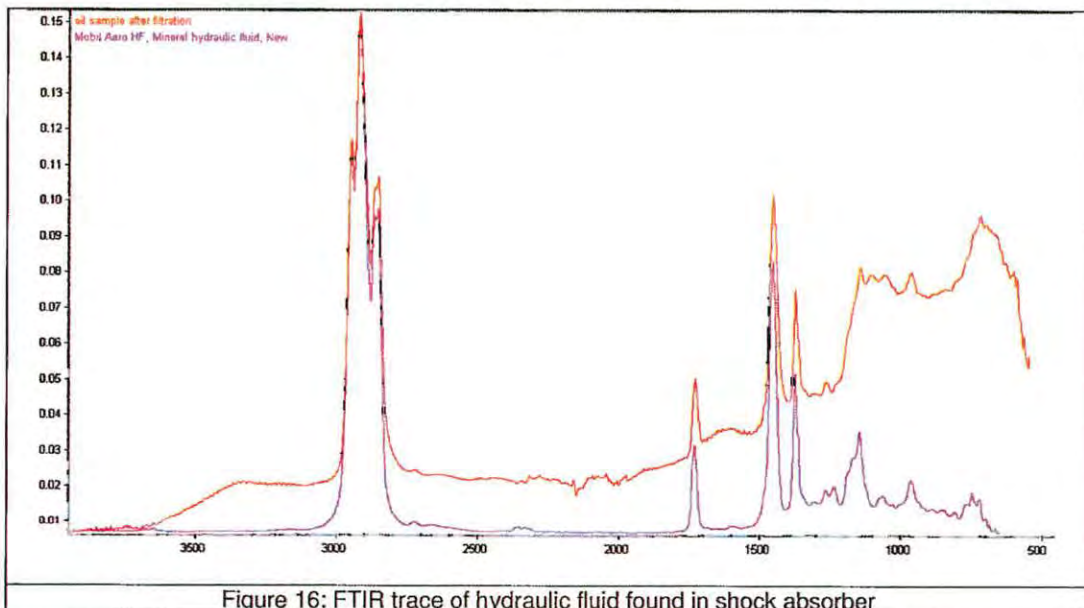
An oil sample obtained from the sliding tube was analysed using FTIR before and after filtration. The two FTIR traces produced did not differ significantly, and confirmed the hydraulic fluid to be a mineral oil in accordance with MIL-5606 (Figure 16). The water content of the oil was also measured and was found to be 41ppm. PCS-7100 states the water content should be <200ppm, and therefore this is considered to be acceptable. A number of metallic particles were observed on the filter paper after the filtration of the oil (Figure 17). SEM-EDX examination was performed on the filter paper to identify the metallic particles. The particles identified were mainly aluminium and cadmium, but some iron and copper particles were also found. The largest particle, which was aluminium, was measured to be 330 µm long (Figure 18).

Figure 16: FTIR trace of hydraulic fluid found in shock absorber

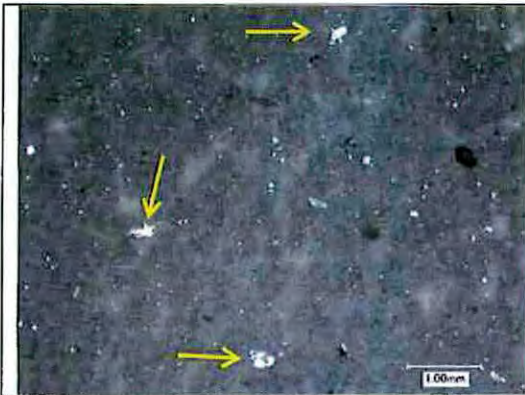
Figure 17: Metallic particles found after filtration of oil

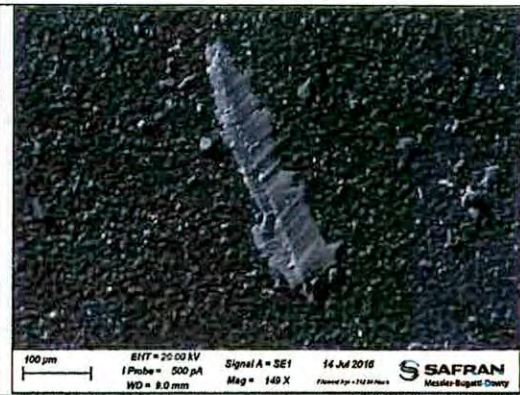
Figure 18: Aluminium particle found on filter paper

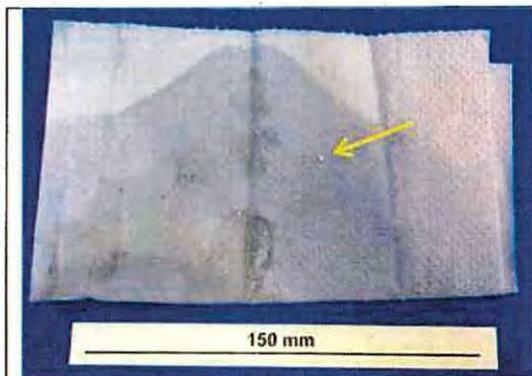
Some metallic debris which was collected from the turning tube after removal of the slider was also sent for laboratory analysis (Figures 19 & 20). SEM/EDX examination of these metallic particles was used to identify them. The larger block shaped particles, measuring up to 1 mm x 2 mm were aluminium (Figure 21). The long thin shards were an aluminium alloy, with the main alloying element being copper (Figure 22). A number of cadmium particles were also found, measuring up to 500 µm x 250 µm (Figure 23). Table 2 shows a breakdown of the chemical composition of each particle analysed. The valve housing is manufactured from aluminium alloy L160. The metallic debris is not believed to have come from the valve housing, as the compositions do not match (Table 2). The aluminium shard appears to be a 2000 series alloy.

Figure 19: Metallic debris as received

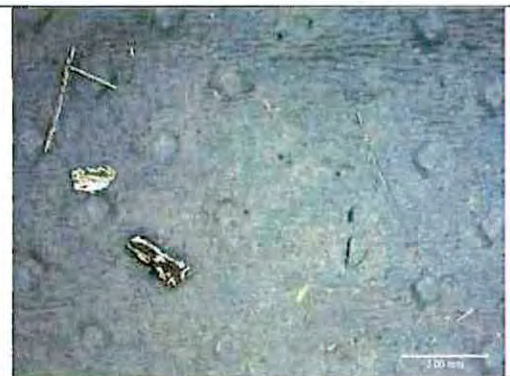
Figure 20: Metallic particles/shards identified to be aluminium

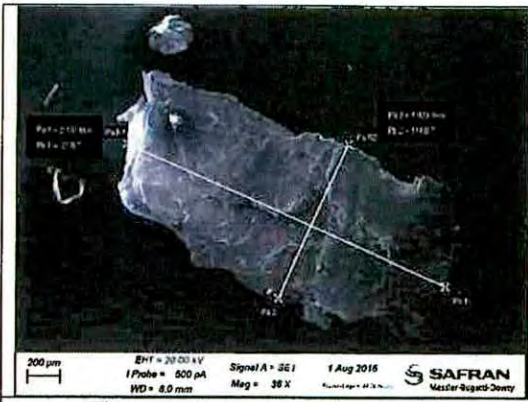
Figure 21: Large aluminium particle

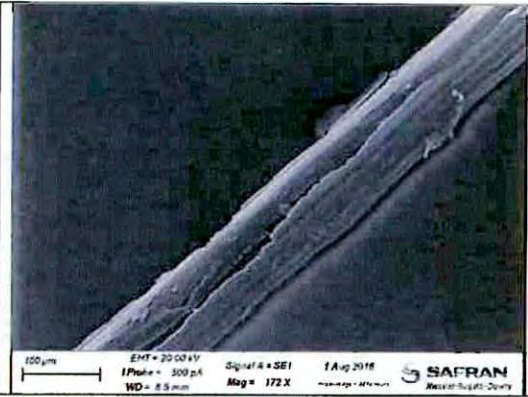
Figure 22: Aluminium shard

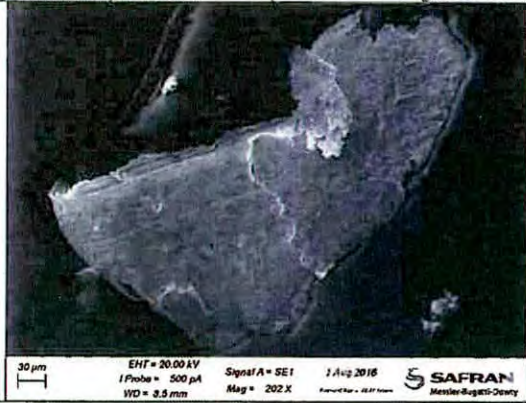
Figure 23: Cadmium particle
