FINAL REPORT

ACCIDENT
occurred to the
AgustaWestland AW609 aircraft registration marks N609AG,
in Tronzano Vercellese (VC),
on the 30th of October, 2015

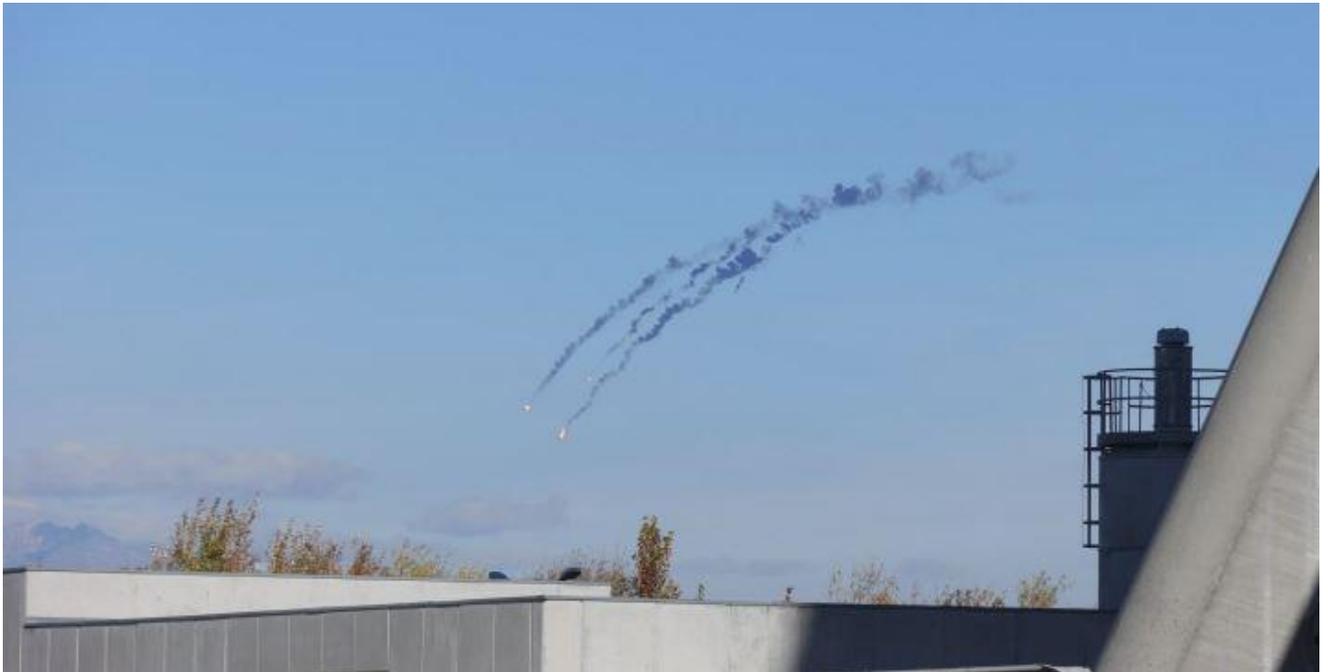
Photo 2: photo taken by a witness positioned by the electric plant "G. Ferraris".

A person, who was working inside the dismissed electric plant “Galileo Ferraris”, located 11,85 km S-SE from the point of impact of N609AG, observed the aircraft flying with a nearly level attitude with a slight wing inclination to the left, when a sudden explosion in flight disintegrated the aircraft itself, its remains on fire falling parabolically towards the ground. The witness in question shot photo 2, as attached.

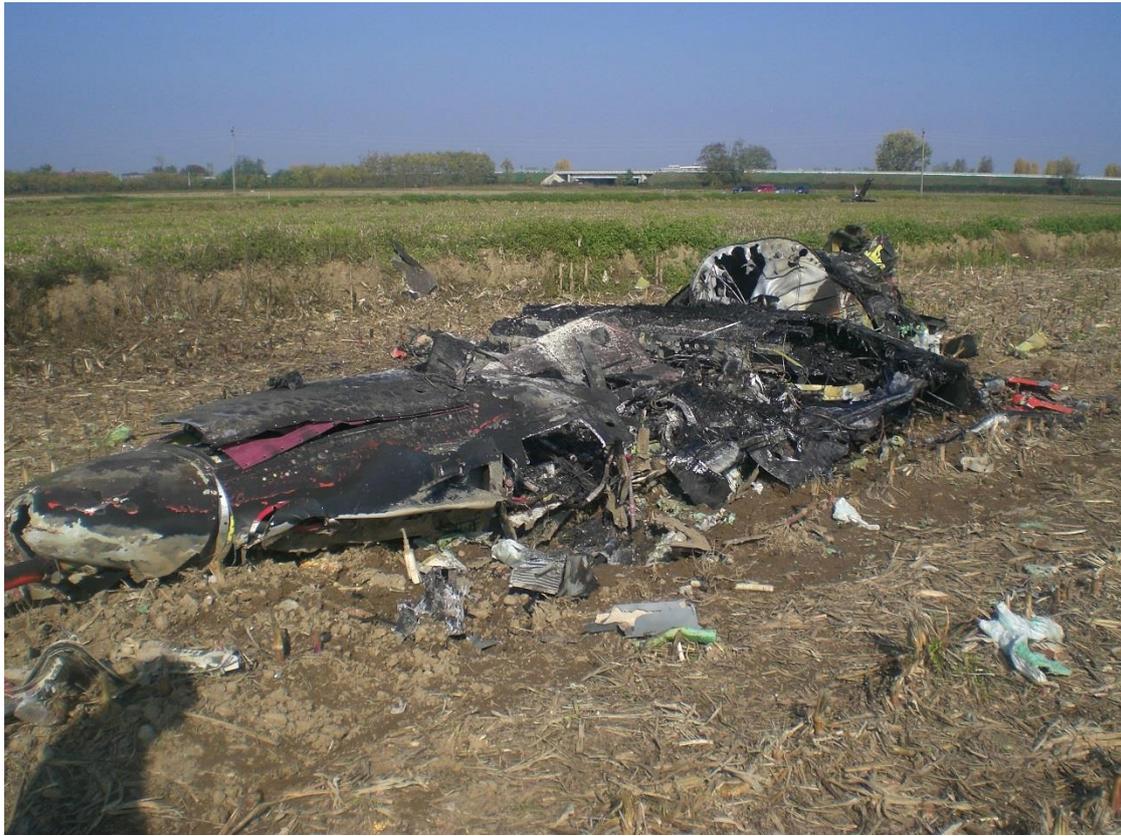
Photo 3: remains of the aircraft fuselage.

The fuselage (photo 3) constituted mainly of carbon fibre appeared substantially burnt, with evident signs of impact on the ground and upturned, whereas on great part of the tail fin evident signs of exposition to high temperatures were present.

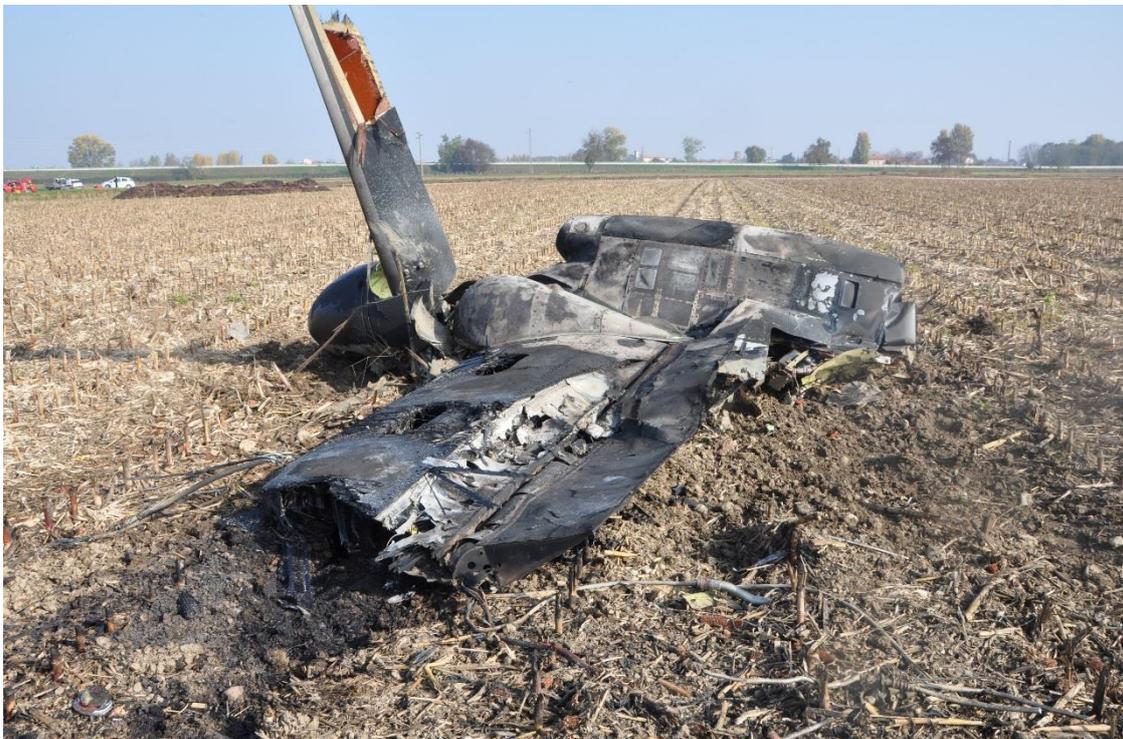
Photo 4: nacelle and parts of the left wing of the aircraft.

Excluding the fire that burnt the fuselage once on ground, documented by various videos and photos taken by local people, other fire evidences on the ground have been found in the field immediately surrounding the left nacelle (together with part of the wing attached). This evidence is coherent with the presence of fuel in the bladder tank (fuel tanks) still inside the wing torsion box, which could have still had a considerable amount of fuel Jet-A1 contained inside at the moment of impact with the terrain.

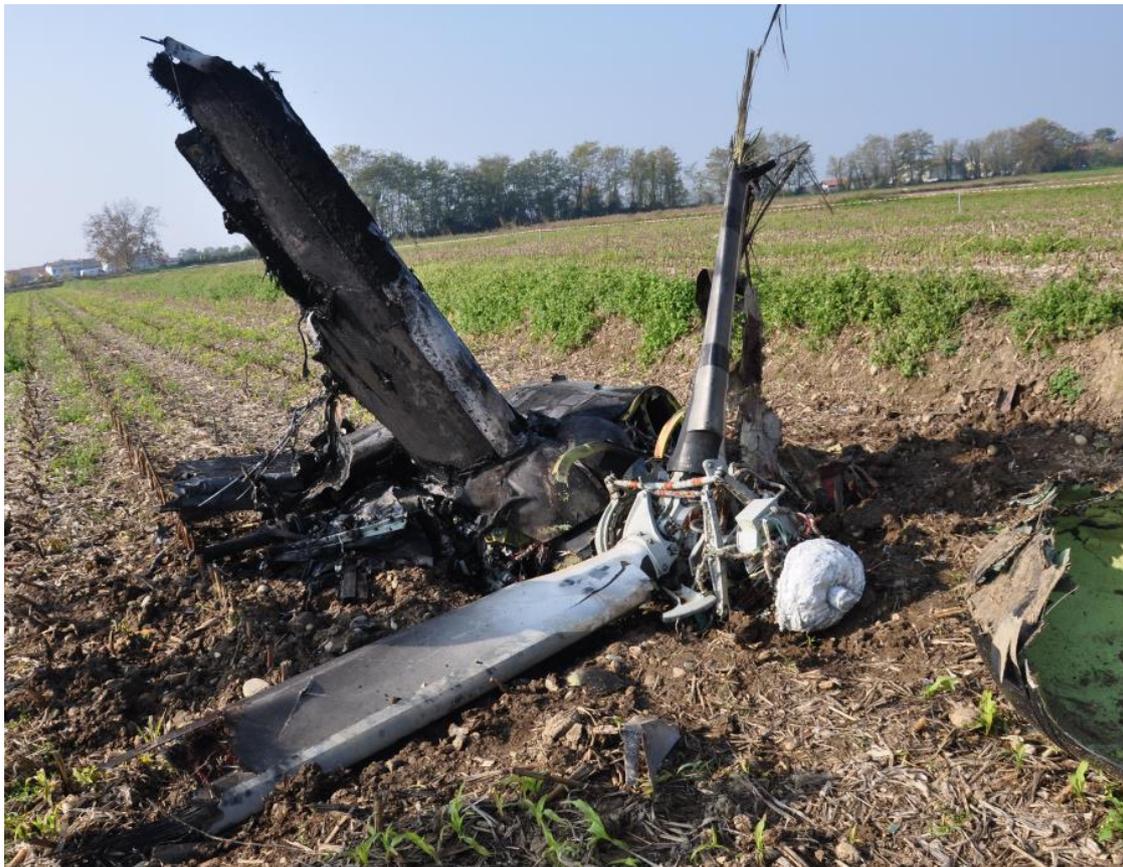
Photo 5: nacelle and parts of the right wing of the aircraft.

Around the right nacelle no signs of fire on the ground were found: the corn crops appeared intact.

In this regard, the photographic evidence found shows that during the descent parabola, the right nacelle was wrapped into flames. It is therefore reasonable to assume that the in-flight fire has burned all the fuel present into the right nacelle, thus making it impossible to propagate the fire once on the ground. Unlike what happened to the left nacelle, the bladder tanks were not found, but they were found together with the rest of the right half-wing.

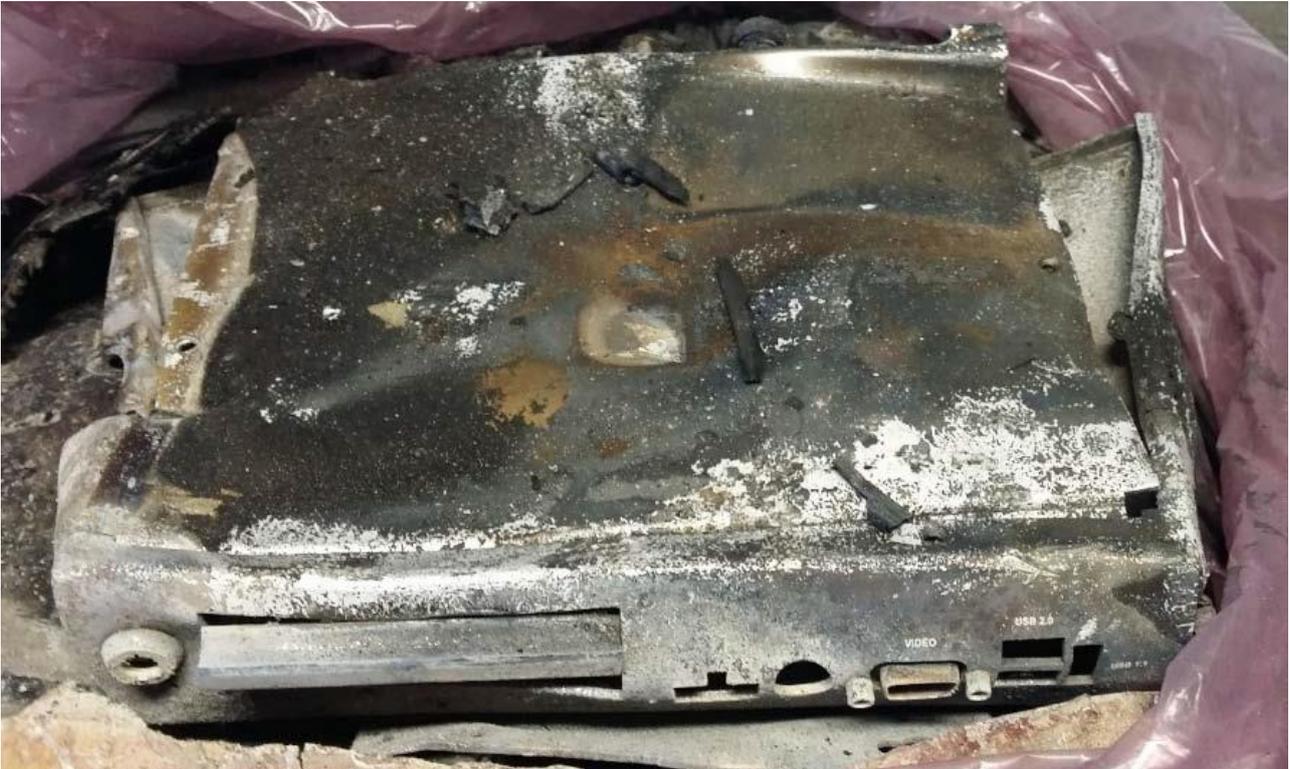
Photo 6: DVR system present on the aircraft.

Two cameras were also installed on board, one in the cockpit and one on the tail fin. The video images coming from this apparatus were recorded on a video recorder (DVR) equipped with an unprotected magnetic disc. The video recorder, even though extremely damaged, was salvaged in an attempt to acquire data; however after technical analysis performed on the component, it resulted destroyed. (photo 6).

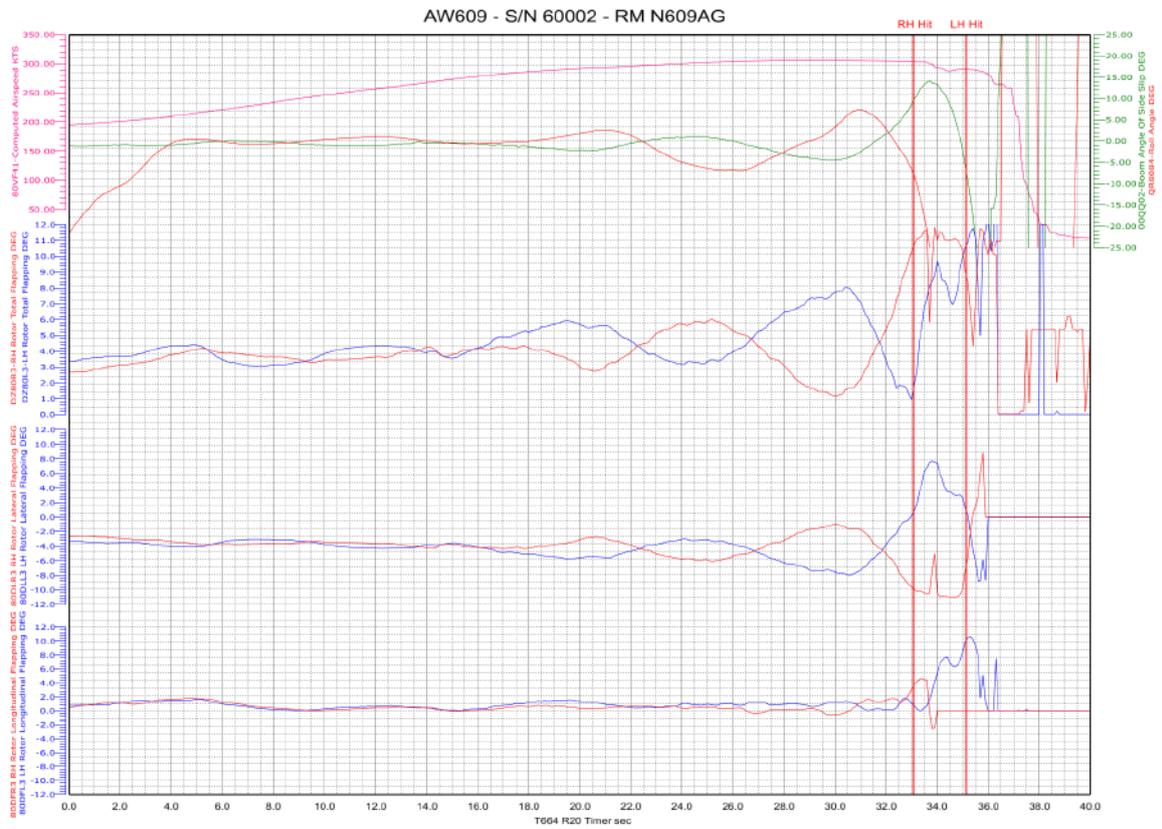
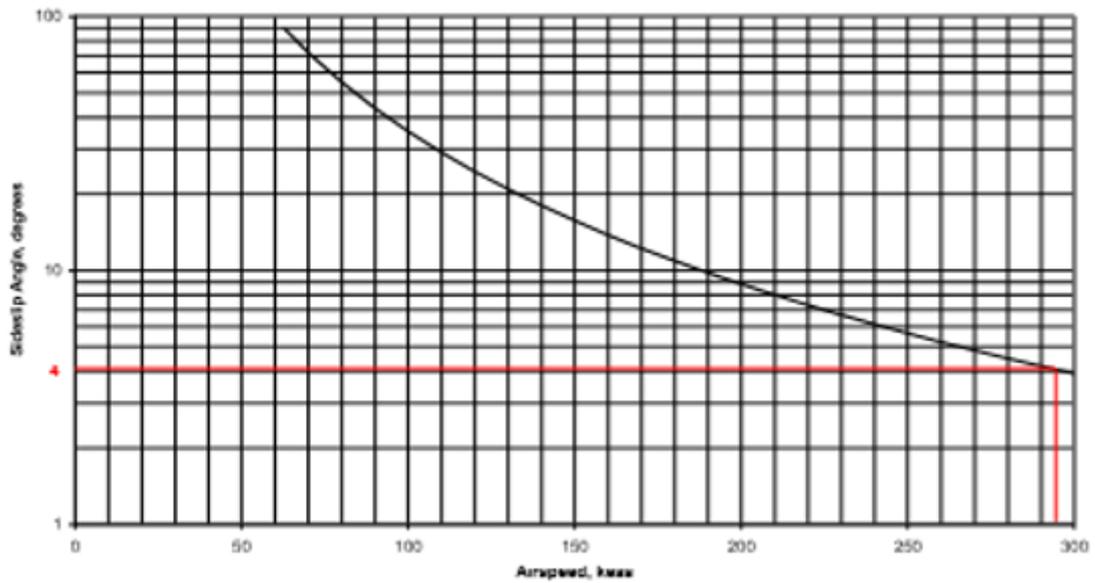
The excessive flapping was caused primarily by the sideslip angle reached by the aircraft, that exceeded, nearly two and a half times, the maximum flight envelope value at the speed of 293 knots (10,5 degrees as opposed to the 4 degrees maximum allowed) (figure 7 and figure 7a).

angle to reach values above the maximum allowed in those speed conditions (figure 7a).

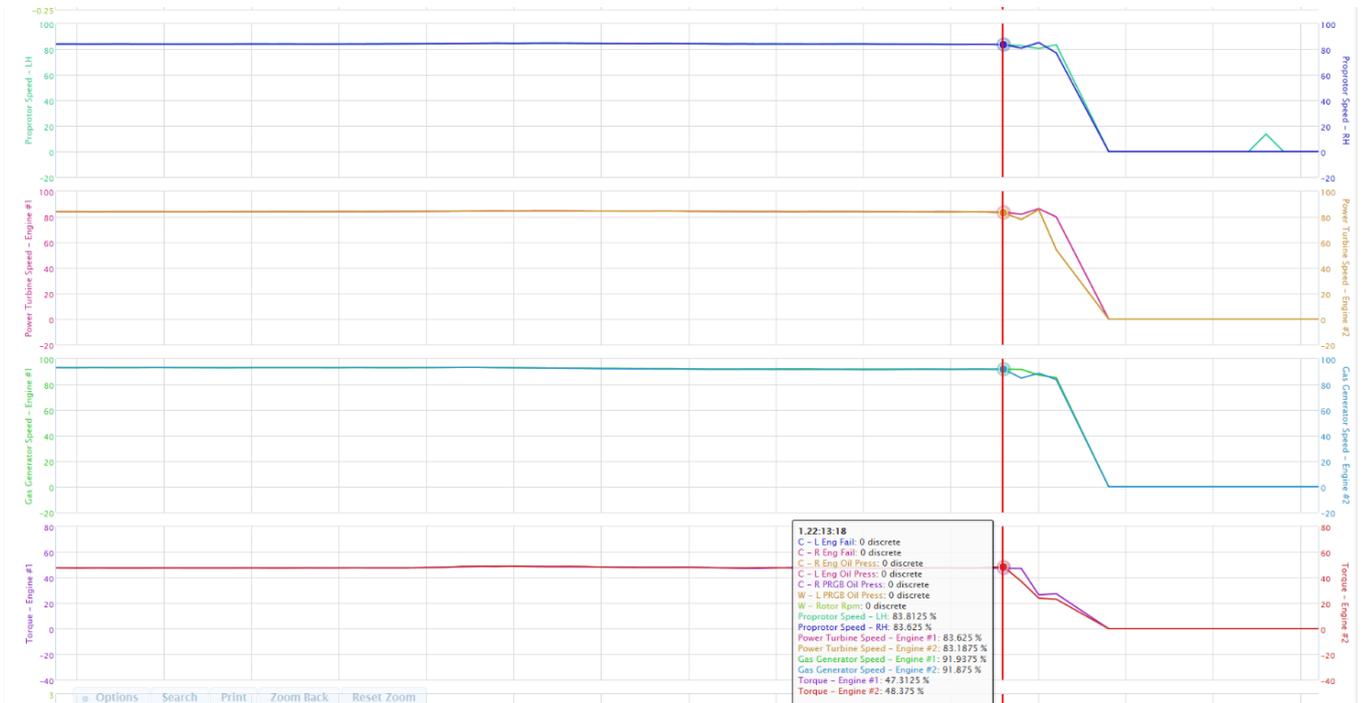
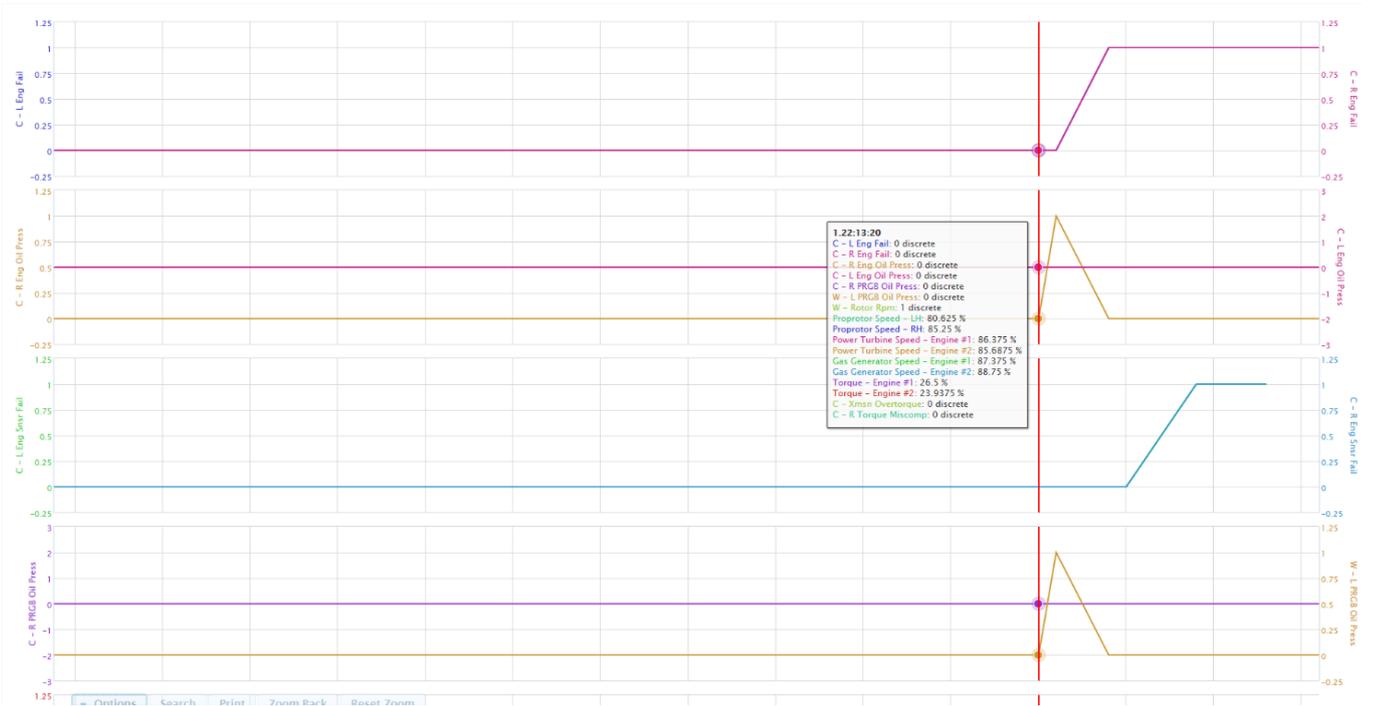
The main engine parameters have been investigated to verify their correct functioning. No anomalies were observed until the contact between the right propeller and right wing. In figures 8 and 9 the following parameters are reported: torque, oil pressure, oil temperature, power turbine speed, propeller speed and gas generator speed. Furthermore, from data it is evident that the engines continued to run even after propellers impact.

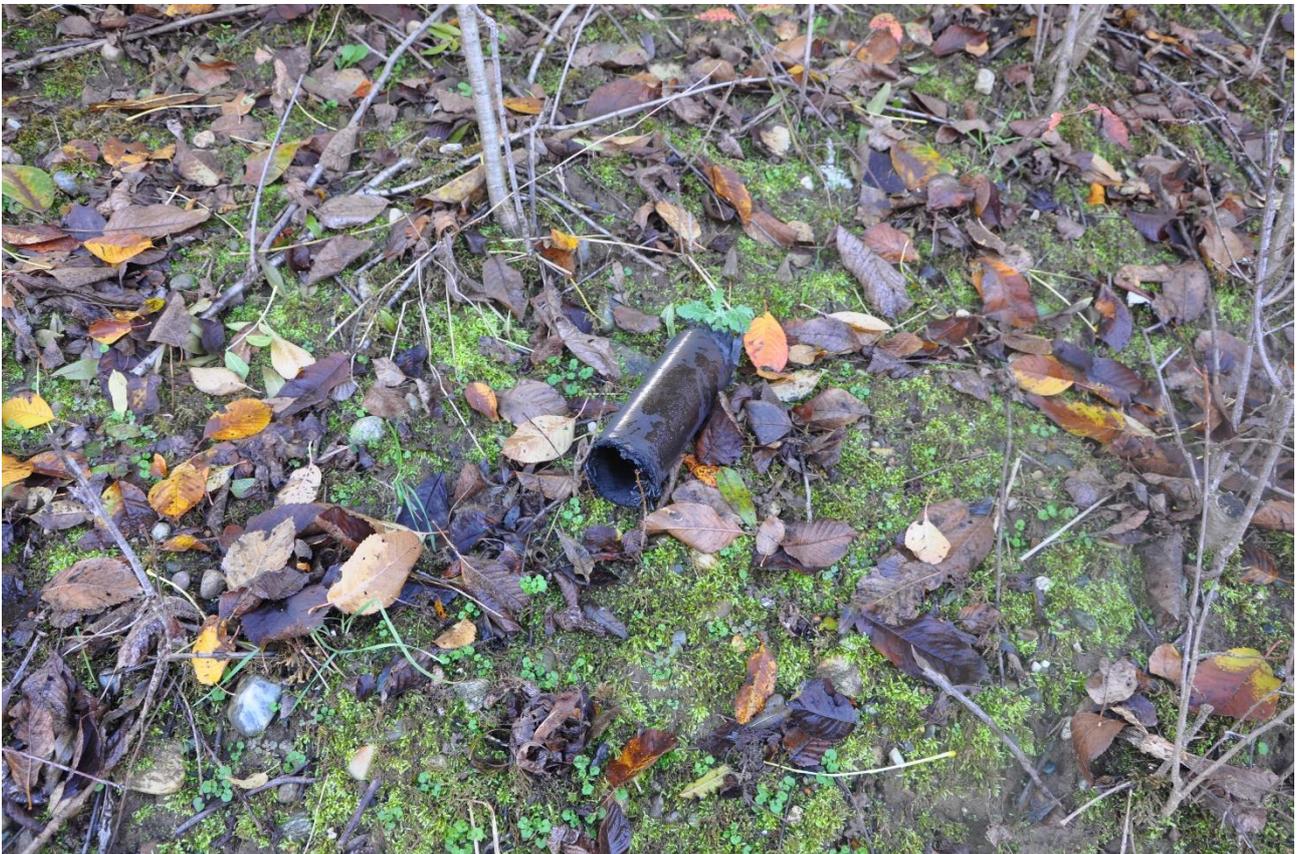
Photo 8: fragment of the ICDS.

In particular, the analysis of the torque value on the right and left engine reflected the already known aircraft asymmetries, which were always minimal. This brings us to believe that the transmission was working correctly until the time of impact of the right propeller with the right wing and this hypothesis is confirmed by the distribution of the debris: a fragment of the ICDS was found along the distribution line in the direction of motion after fragments of the right rotor and right wing (photo 8, fragment ICDS).

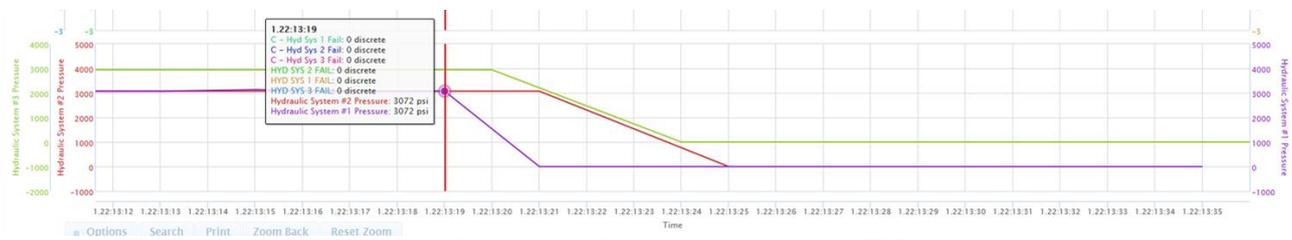
Figure 10: functioning of the hydraulic systems (FDR data).

The AW609 has three independent hydraulic systems, that erogate a pressure of 3000 PSI. These systems functioned correctly until the first contact between the right propeller and wing (figure 10). In detail, for the hydraulic system (figure 10a), due to the location of the tubes (figure 10) it's evident that the failure of systems 1 and 2 was the direct consequence of the interference between propellers and wings. For system number 3, it's feasible to consider that the accelerations subjected by the nacelle, following the contact between propellers and wings, had induced the disconnection of the pipes.

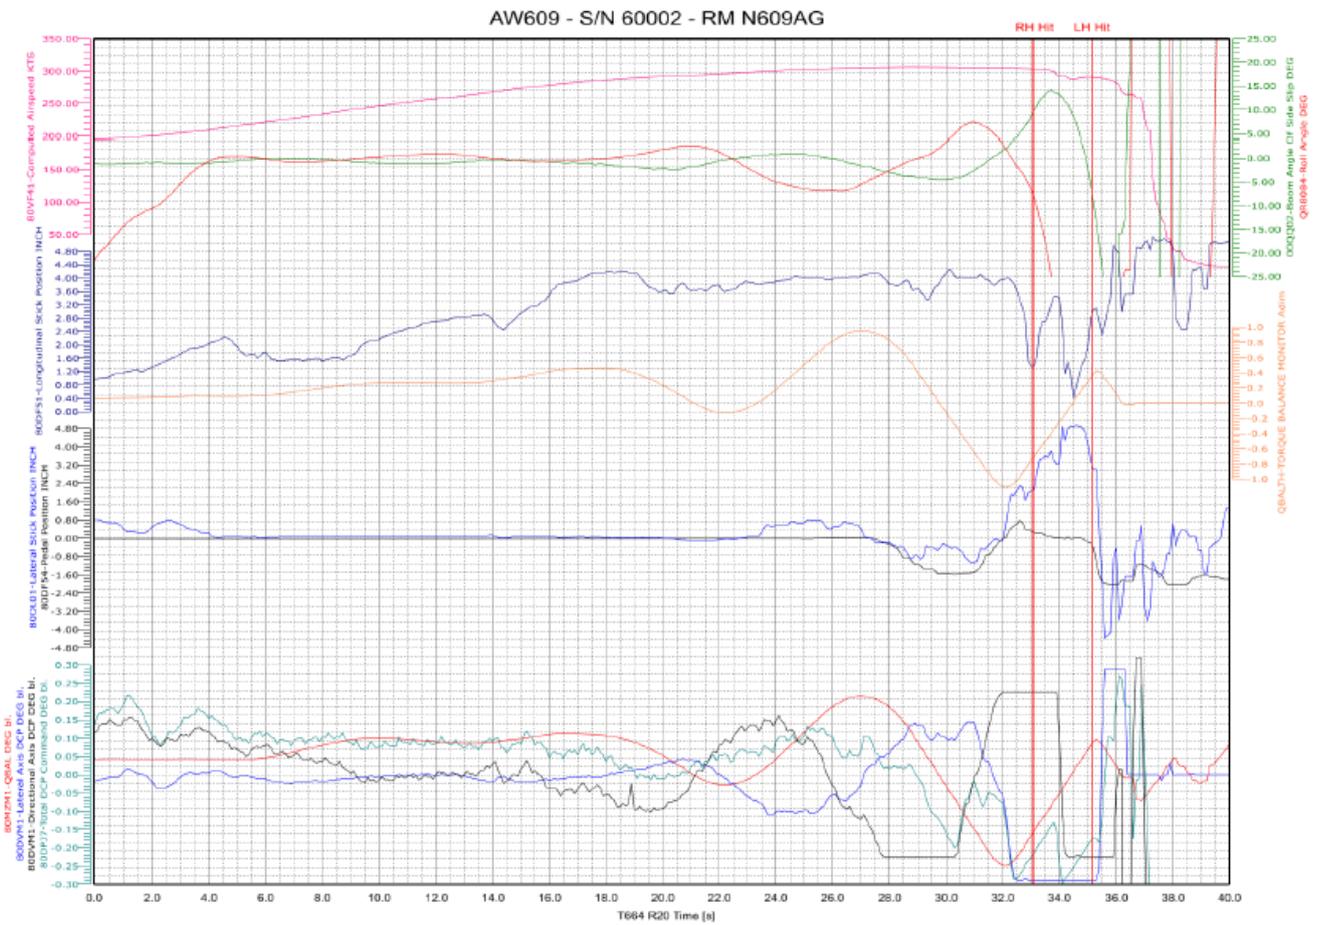
Figure 19: FTI data regarding flight mechanics and input from the pilot.

The third dive, test R20, was commenced during a left 180° turn. After rollout, a slight lateral-directional oscillations have begun to develop (roll at t=4 sec. and yaw at t=5 sec. and further on) such as to cause an “out-of-trim” condition by the FCS developed (figure 19).
