PRELIMINARY REPORT

ACCIDENT
aircraft Enstrom 480B registration marks N-480W,
Fundres (BZ),
10th of May 2017

PRELIMINARY REPORT
ACCIDENT
Enstrom 480B registration marks N-480W

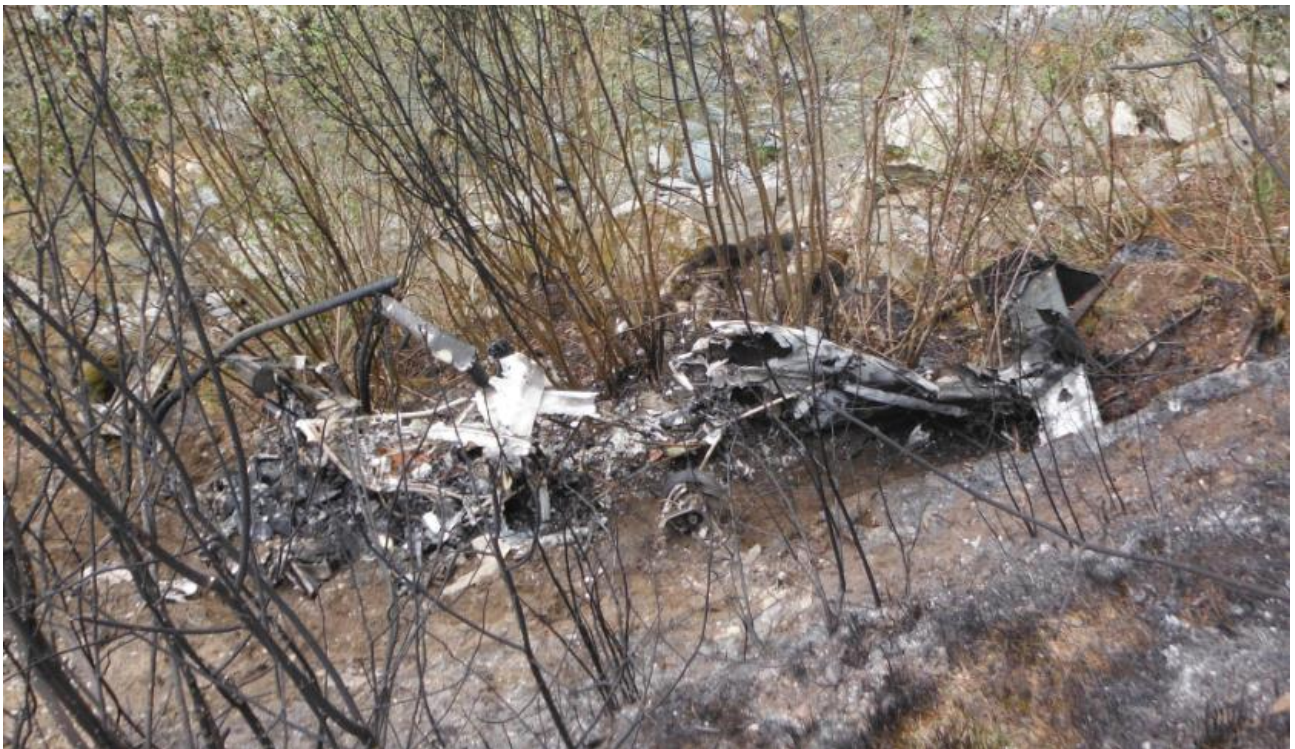
At the main wreckage site it was possible to observe the almost vertical path of impact trajectory, confirmed by a reduced impact area and the damage to a power line in the close vicinity which interfered with the tail-cone assembly and tail rotor. Signs of power cables interference have been detected on tail rotor shaft assembly, suggesting an inverted position of the helicopter just before the ground impact.

The main wreckage rolled into a river bed, while main rotor transmission assembly was projected approximately 10 meters over the impact point.

Photo 1: main wreckage at the accident site.

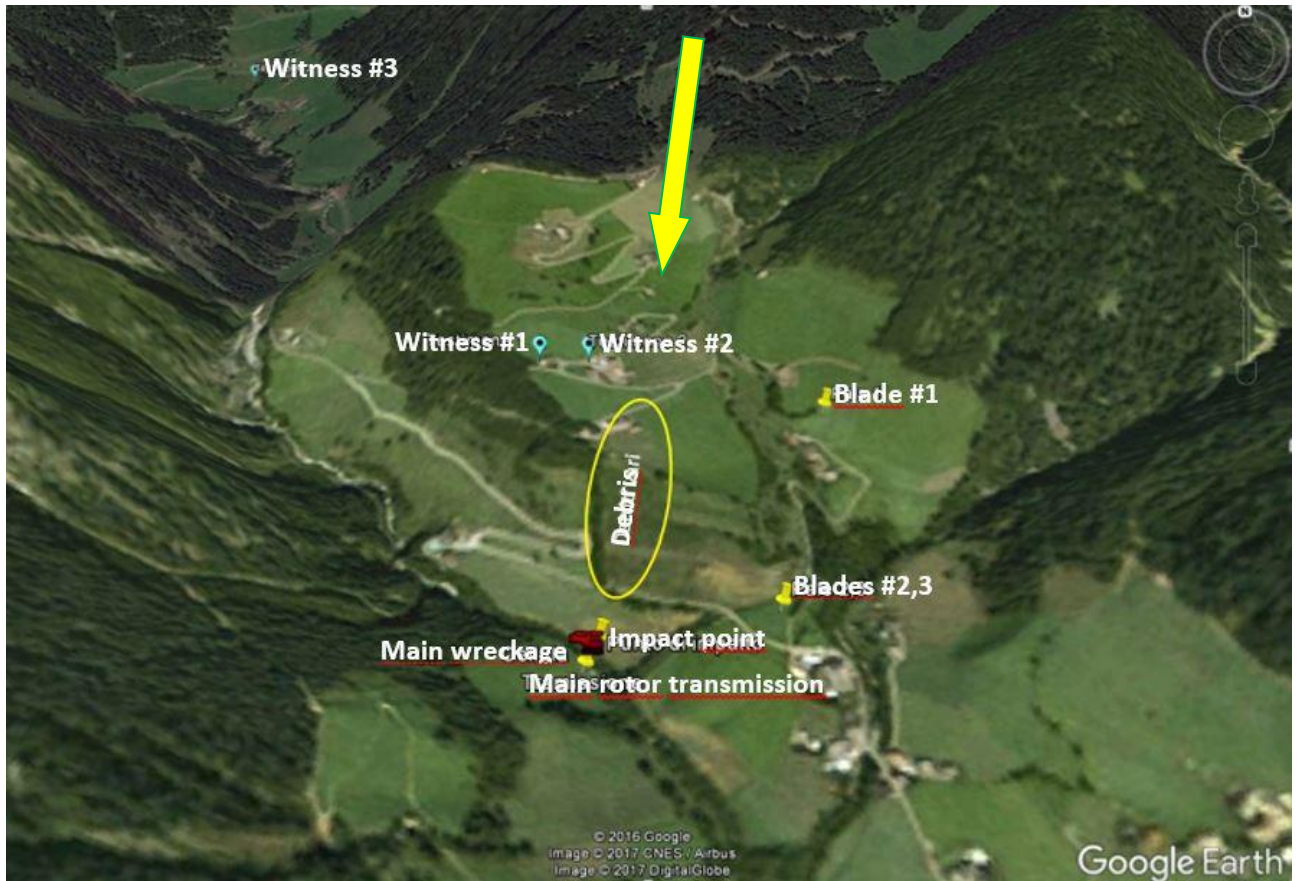
Debris were found in an area of approximately 200 meter wide 500 meter long, with one of the main rotor blades at the farthest point from main wreckage. The two other blades and the main rotor head were laying at approximately 200 meters from main wreckage. One of the remaining blades was separated from main rotor hub, while the other was still attached.

Figure 1: debris distribution and eyewitnesses' position.

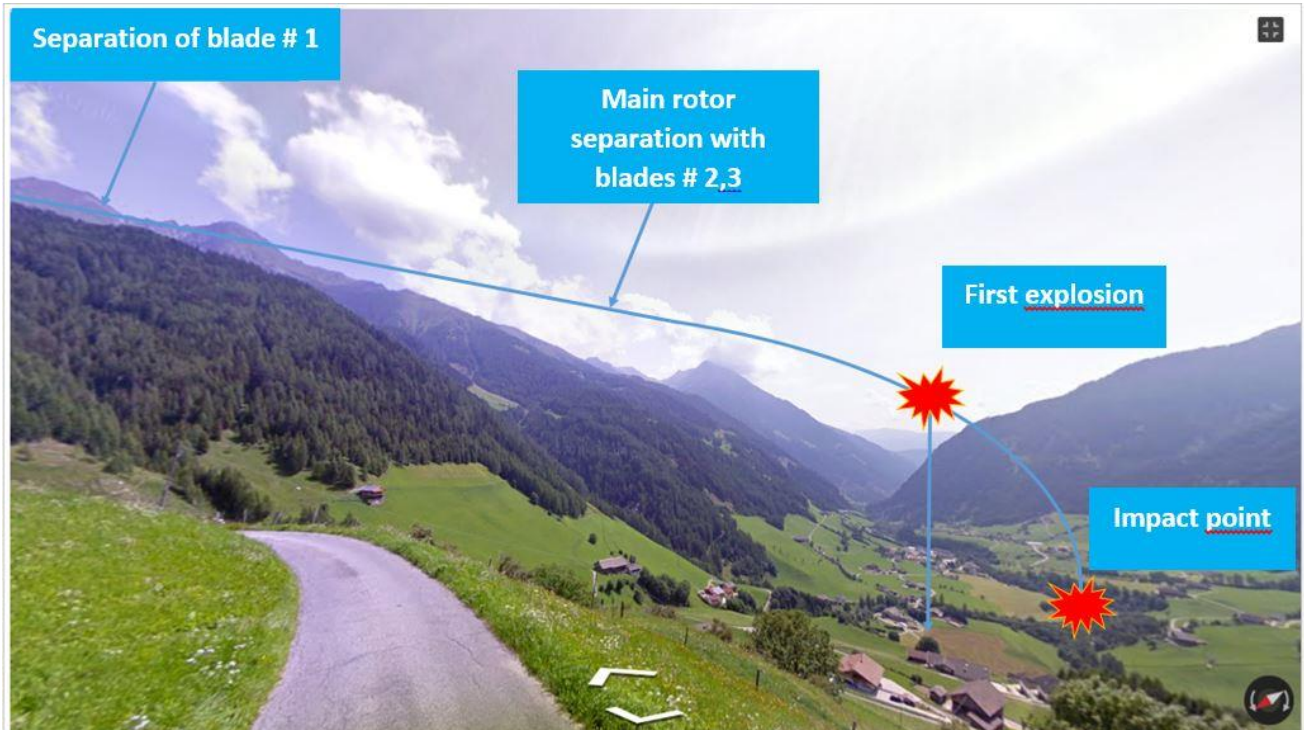
During a VFR⁶ flight from Bolzano Airport (LIPB) to Linz airport (LOWL), helicopter suffered an in-flight break-up with one main rotor blade separation followed by the separation of the main rotor hub and the remaining two blades. The helicopter exploded/took fire in flight and impacted the ground with a second explosion.

Interviews confirmed the time of event and the loss of helicopter parts during flight before initiating heavy oscillations and exploding/catching fire, impacting the ground in a close to vertical parabolic trajectory.

Figure 2: probable reconstruction of the sequence of events.

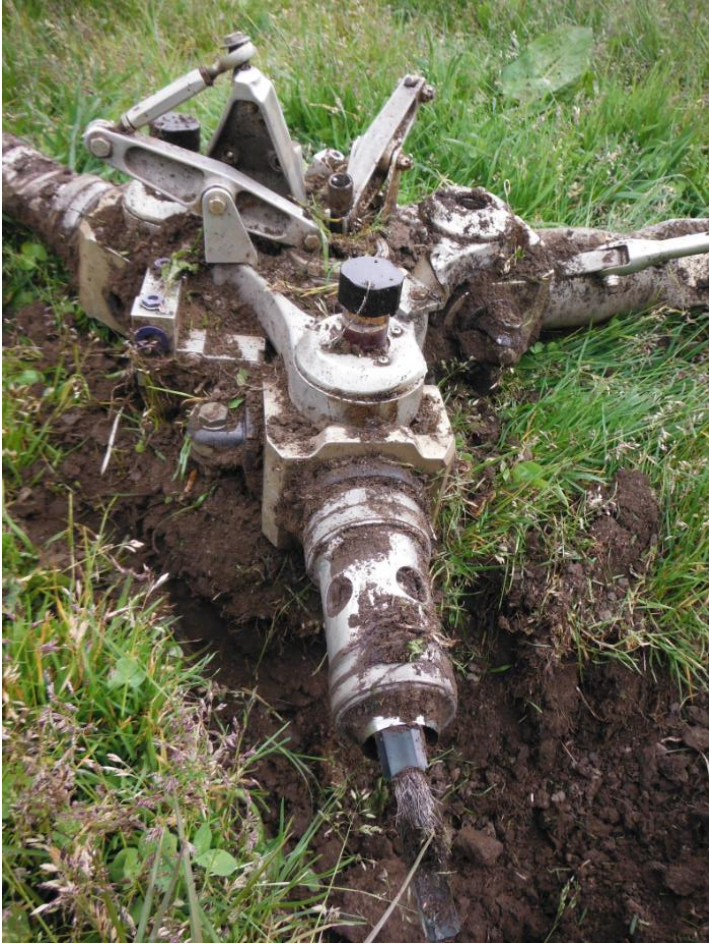
Main rotor hub assembly was showing the failure of the tension/torsion straps (T/T straps) of the two blades which separated from the main rotor. The lug of the main rotor blade in close proximity of the rotor hub was lying close to its blade, while one of the dumpers was missing.

From the evidence acquired at this stage of the investigation, it has been determined that one of the main rotor blades separated in flight due to a T/T strap failure. The consequent increase of vibrations possibly led to the complete separation of main rotor

Photo 2: main rotor hub and failed T/T strap.

For the above reason, the T-T straps and manufacturing records from the same lot number as the suspect T-T strap, as well as the straps from the previous and next lot number have been quarantined by the T/T strap manufacturer.

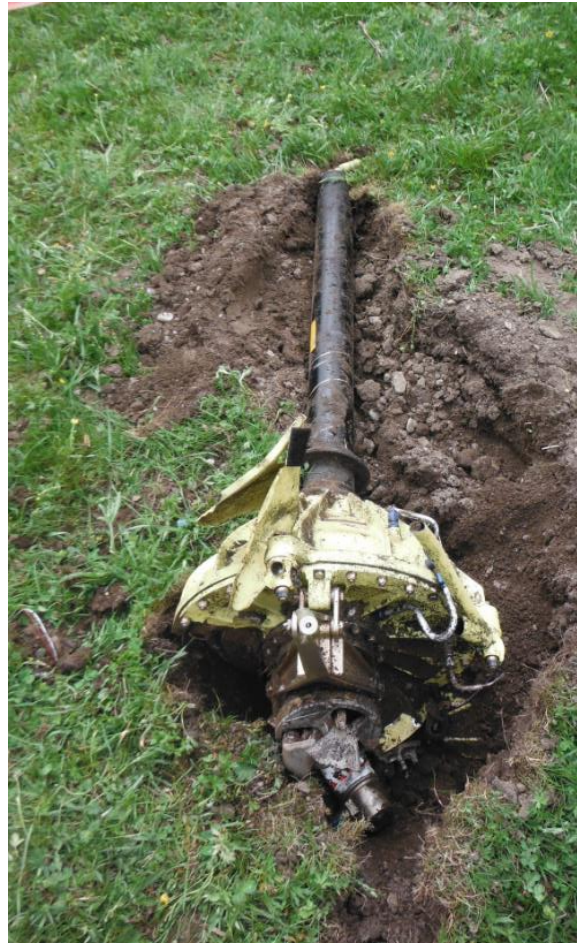
Photo 3: main rotor transmission assembly.

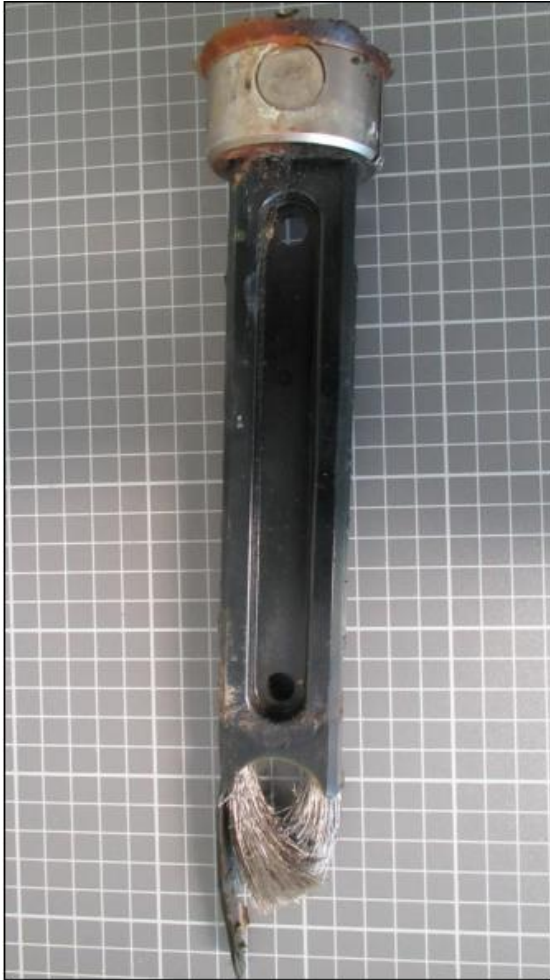
The general geometry of the wires suggests a failure driven mainly by tension solicitation. No visible sign of torsion. Optical microscopy highlights on a large part of wires fracture surfaces characterized by 45° planes.

Photo 4: T/T strap #1.

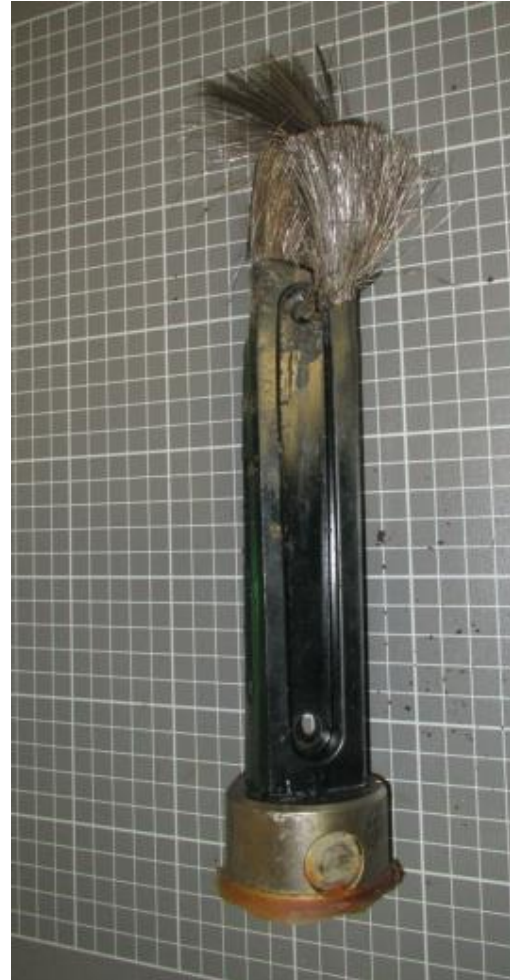
The general geometry of the wires a failure driven by a combination of torsion and tension solicitation. Optical microscopy highlights on a large part of wires fracture surfaces characterized by 45°.

Photo 5: T/T strap #2.

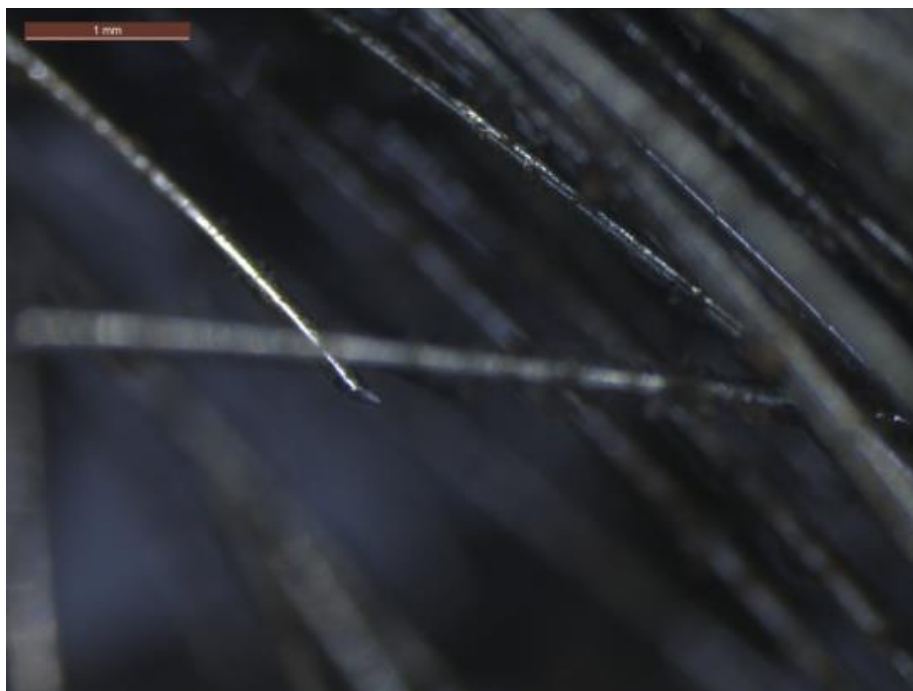
Photo 6: 45° planes on T/T strap #1.

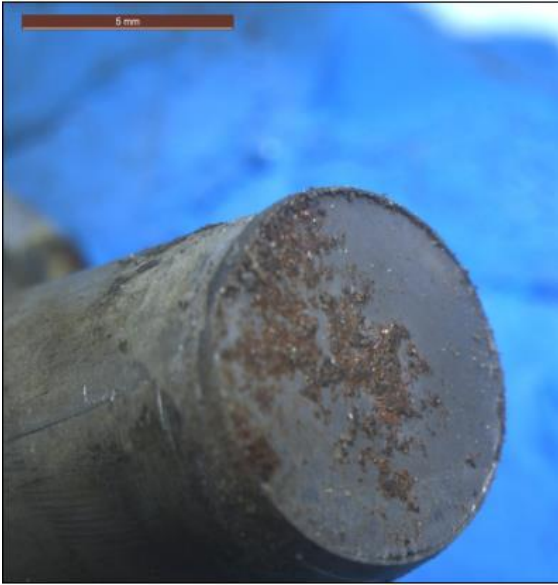
The dumper relevant to the main rotor blade which remained attached to the main rotor hub was not found at the accident site. The attachment bolt was found fractured. The morphology of the fracture surface is totally flat, very fine bright grains. The fracture surface was observed by optical microscopy and it appeared to be highly hammered. A small amount of corrosion was found on it (presumably subsequent to the fracture). The length of the remaining fragment of the bolt was not flush with the assembly.

Photo 7: dumper bolt.

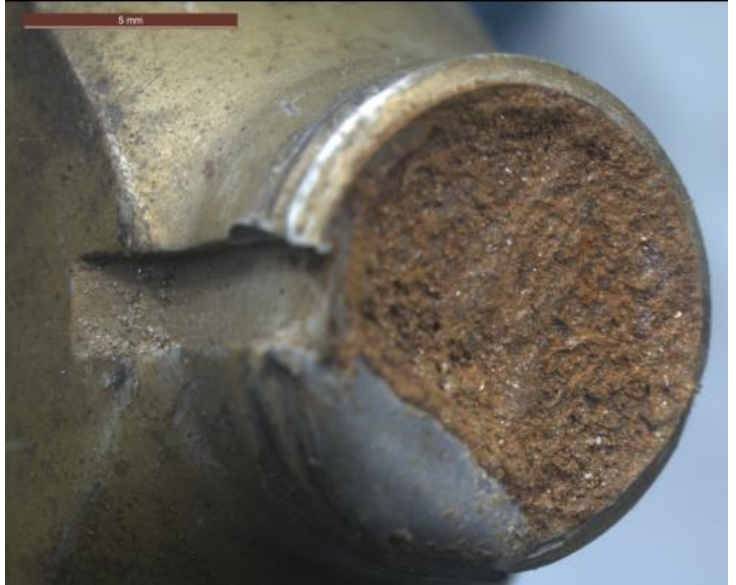
The lug of missing dumper was also found fractured. The morphology of the fracture surface is totally flat with a heavy grade of corrosion. A small part of fracture surface was on a different (higher) plane, not corroded and heavily hammered.

Photo 8: dumper lug.

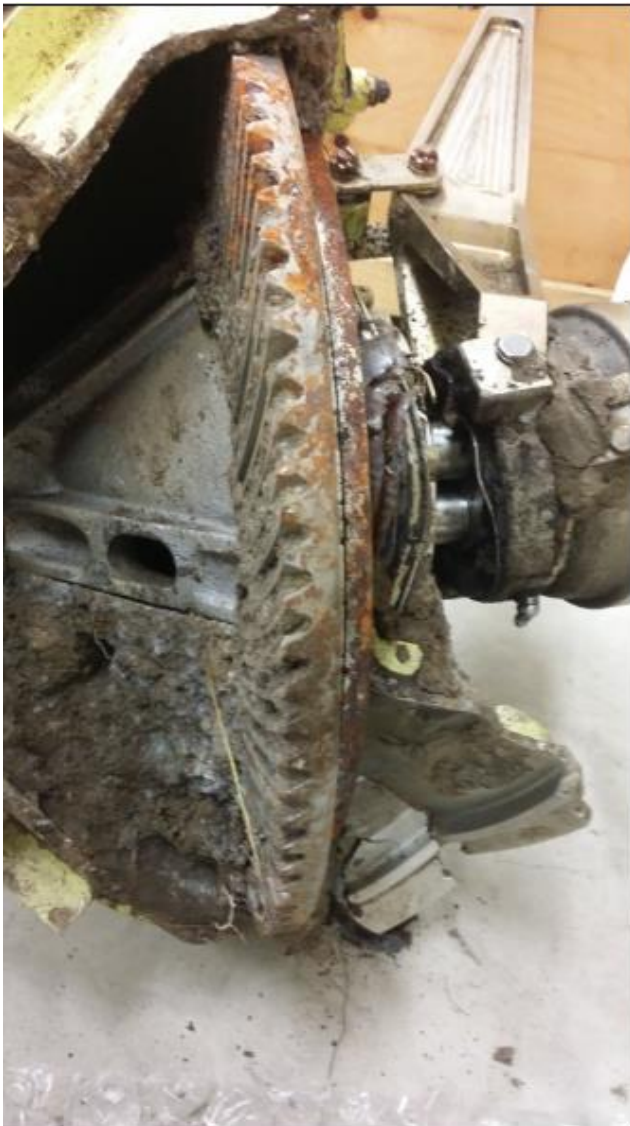
The mast was heavily deformed therefore it was not possible to verify the free rotation. However the gearbox case was broken and it was possible to observe the internal gearing. This, beside the generalized light corrosion (most likely post-crash), did not show any particular sign of damage. Teeth were apparently in good condition. On the mast signs of rotation were found.

Photo 9: transmission gear box.

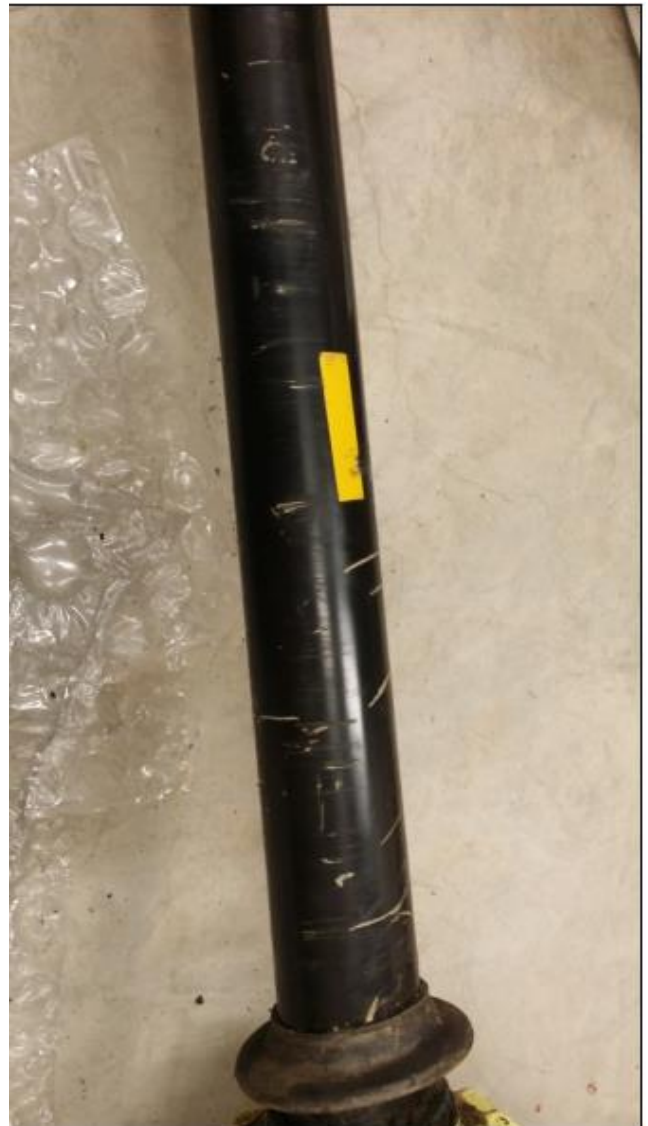
Photo 10: main rotor transmission mast.
