SAFETY RECOMMENDATION

A. N. S. V.

Subject: accident occurred on Trieste-Ronchi dei Legionari airport (LIPQ) to the Diamond DA42 “TwinStar” registration marks S5-DNE, on April 11th, 2010.

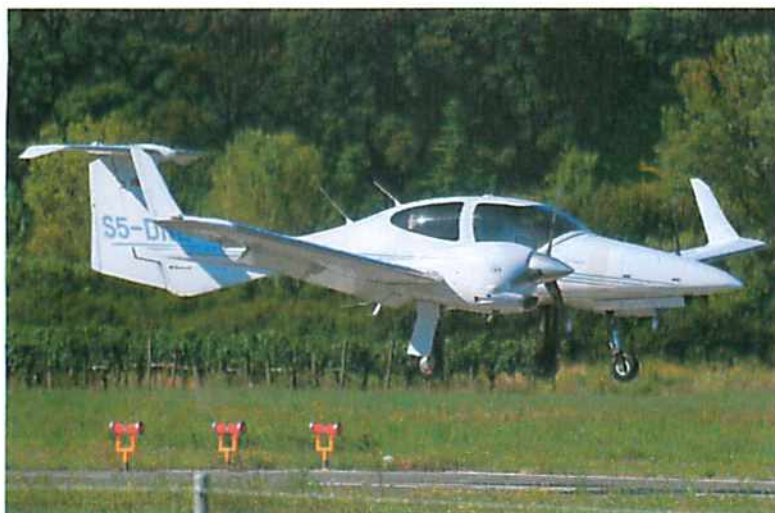
Picture 1: Diamond DA42 "TwinStar".

On April 11th, 2010, a Diamond DA42 “TwinStar” (picture 1) registration marks S5-DNE, due to landing gear extension problems during approach to Portoroz airport (LJPZ), diverted to Trieste-Ronchi dei Legionari airport (LIPQ) to land on a safer runway, with the left main landing gear not down.

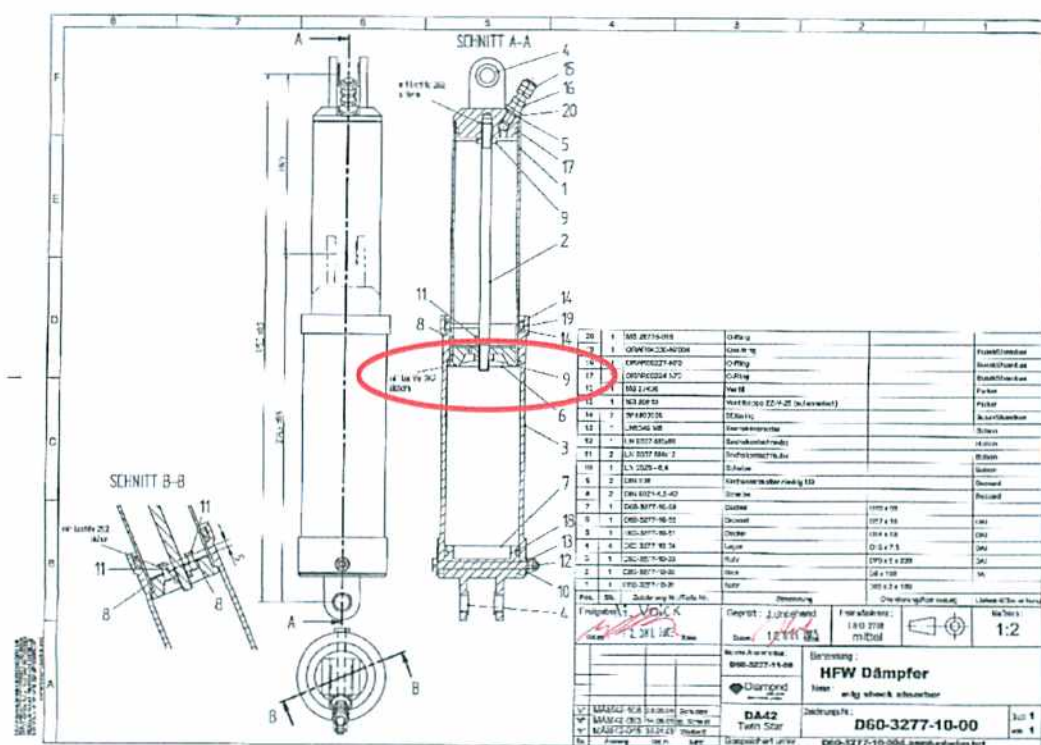
Figure 1: Main Landing Gear Dumper Scheme.

The event was due to the unscrew of the nut (item “9” on figure 1) that made the shock absorber longer than the project requirements.

The investigation and the analysis performed demonstrates that the method chosen by Designer to lock the item “9” on the figure 1 appears to be not adequate. In addition it is not possible to inspect it without the removal and disassembly of the whole shock absorber.

- an additional inspection should be asked as soon as possible to the Operators/Owner of the aircraft now in operation, in order to check the component for the installation of the item “9” - figure 1, on all dumpers not yet modified as per RSB 42-089/1 (ANSV-14/351-10/1/A/11);
- the different choice on the nut locking method stated on the RSB 42-089/1 should become “mandatory” since the previous solution adopted by Designer (application of Loctite 262 only) appears to be not sufficient at all (ANSV-15/351-10/2/A/11).

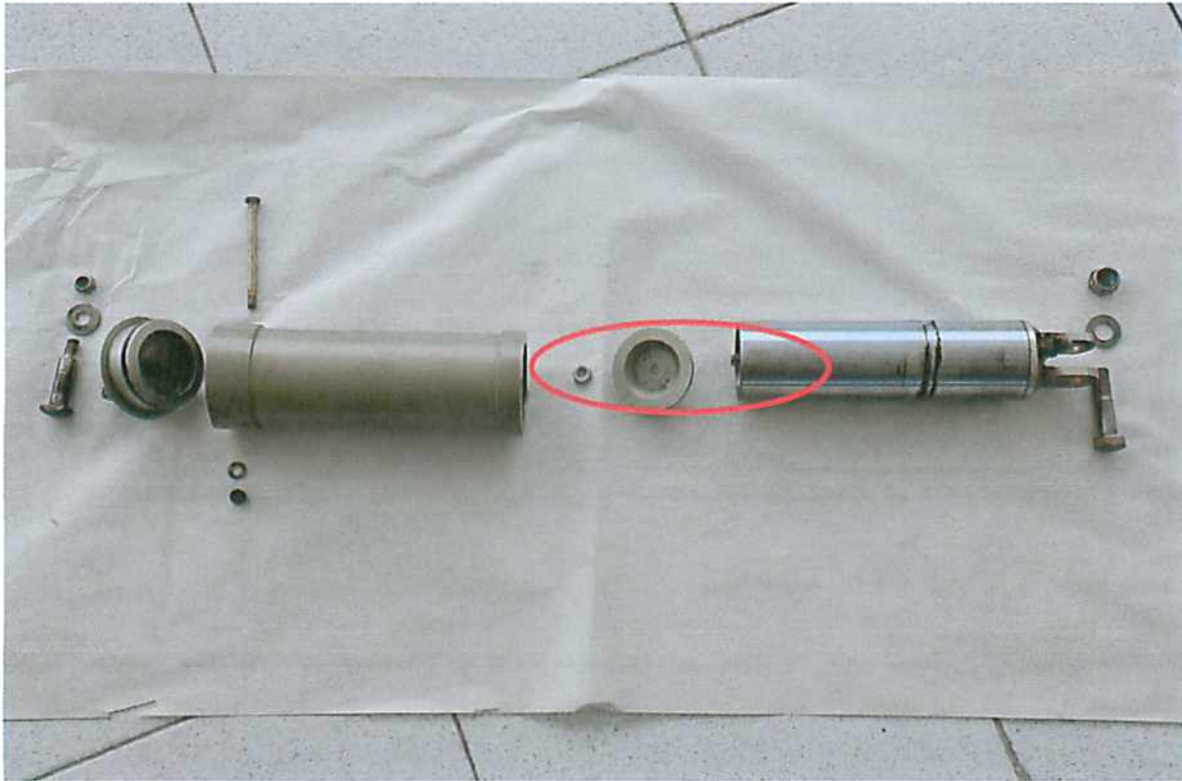
During visual inspection performed on the left main landing gear, an over-length of the related shock absorber has been noticed (P/N D60-3277-10-00, S/N 031623 34328 HEG). At the presence of the Diamond representative, the ANSV investigator asked to proceed with the component disassembly (see picture 2). The nut identified on the figure 1 as item "9" has been found completely unscrewed. Infact it has been found in the oil drained during the disassembly operation.

The microscope analysis showed the presence of “red residual” on the threads of item “2” in the position of item “9”.

FT-IR spectrum analysis on this “red residual” confirm that their chemical characteristics are compatible and comparable with Loctite 262.

Picture 2: left main landing gear shock absorber disassembled.

The analysis have demonstrated that the Loctite 262 had been applied on the item “9” but we cannot be sure if it has been tightened as prescribed by the AMM.

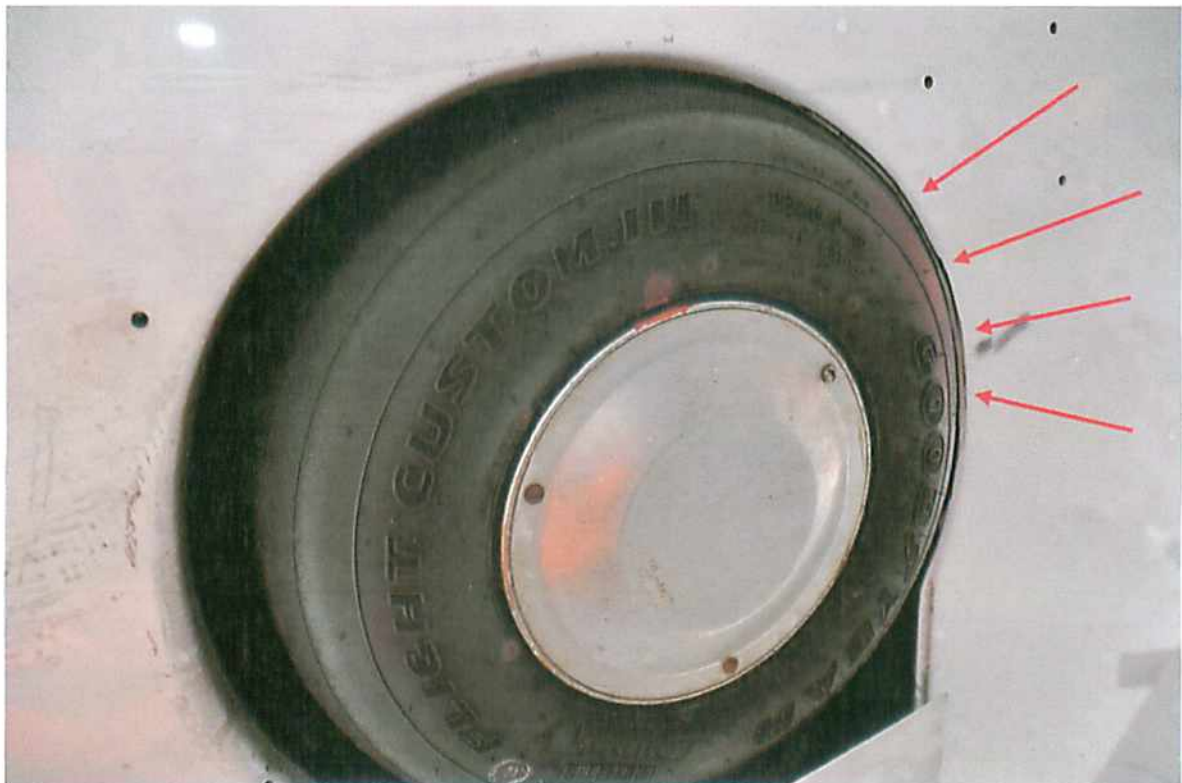
The nut loss, made the dumper longer than the project requirements, so after *last retraction* the landing gear remained locked in “up position” due to the interference between the wheel and the airframe (see picture 3).

Picture 3: interference signs on the airframe close to the left main landing gear.
