SAFETY RECOMMENDATION

Subject: serious incident occurred on September 9th 2010 to Antonov An-124-100 registration marks RA-82079 (equipped with Ivchenko Progress D18T engine series), Turin-Caselle airport (Italy).

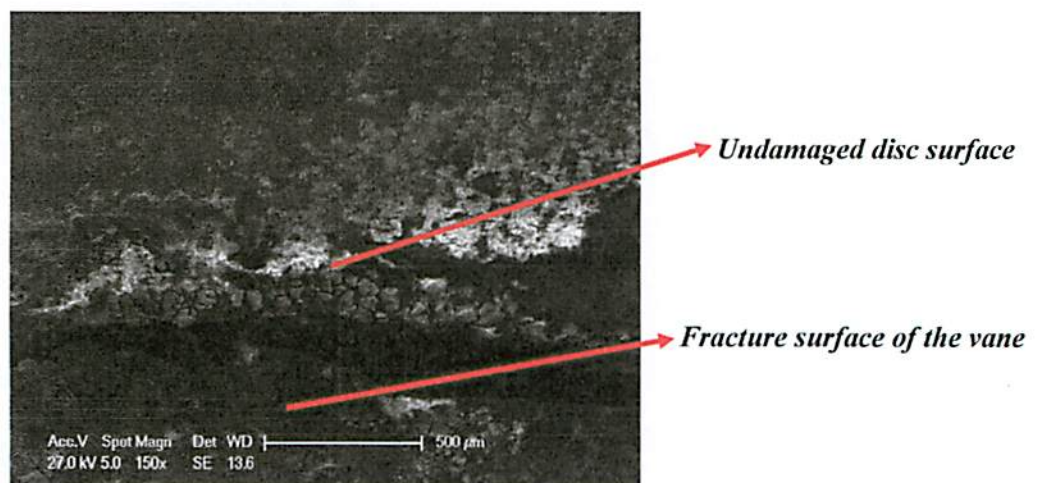
All the investigated fracture surfaces of the 5th stage showed a strong contamination. It is worth noting that the fracture surfaces of the vanes are characterized by a degree of surface alteration which is very similar to the one observed on the disc and on the undamaged vanes. An example is shown in figure 1 which refers to the fractured vane labeled as N° 2 (HPC 18T.01.05.050-03, 5th stage vanes, fragment of upper half-ring with vane N° 2 - fracture, attached to the external ring) and figure 2 which is an EDS spectrum of the surface of the disc of the specimen N° 1 (HPC 18T.01.05.050-03, 5th stage guide vanes with vane N° 2 - fracture surface, attached to the internal ring). In figure 1 has to be noted that the morphology of the undamaged disc surface (which has been exposed to operating conditions for a long time) and the one of the fracture surface of a vane are similar.

Figure 1: SEM micrograph of fracture surface of specimen N° 2.

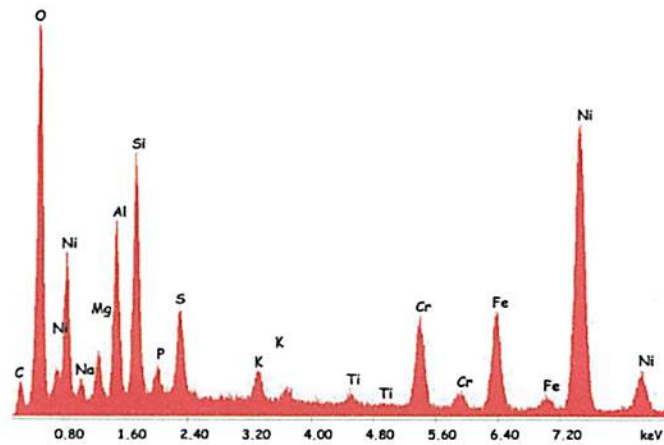
Figure 2: EDS spectrum of the disc surface for the specimen N° 1.

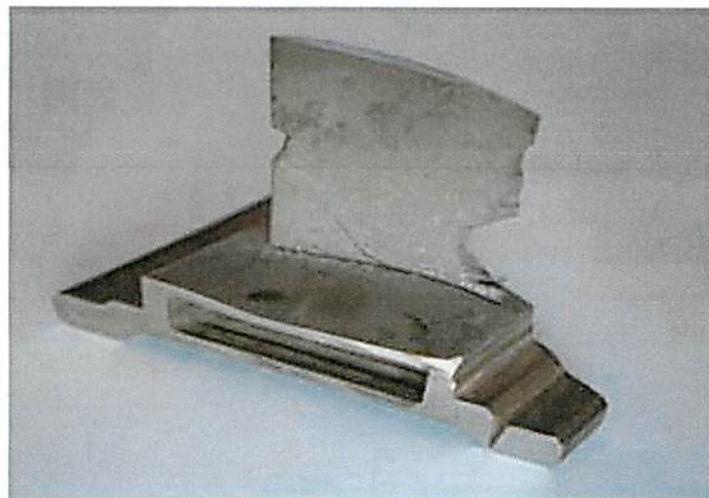
On the contrary, the stator vanes which have impacted signs appear to be heavily deformed (see figure 3). They show a ductile fracture surface and are contaminated to a lesser extent in comparison with the vanes fractured close to the zone of attachment to the ring. This fracture surface has features which are similar to the ones detected on the ductile fracture surfaces of the specimen of the 6th stage (disk fragment of HPC 18T.01.06.016-01 N° 680I 6th stage with fracture at the place of tenon disengagement from groove N° 94).

Figure 3: fragment of upper half-ring 5th stage with vane N° 1 - external ring.

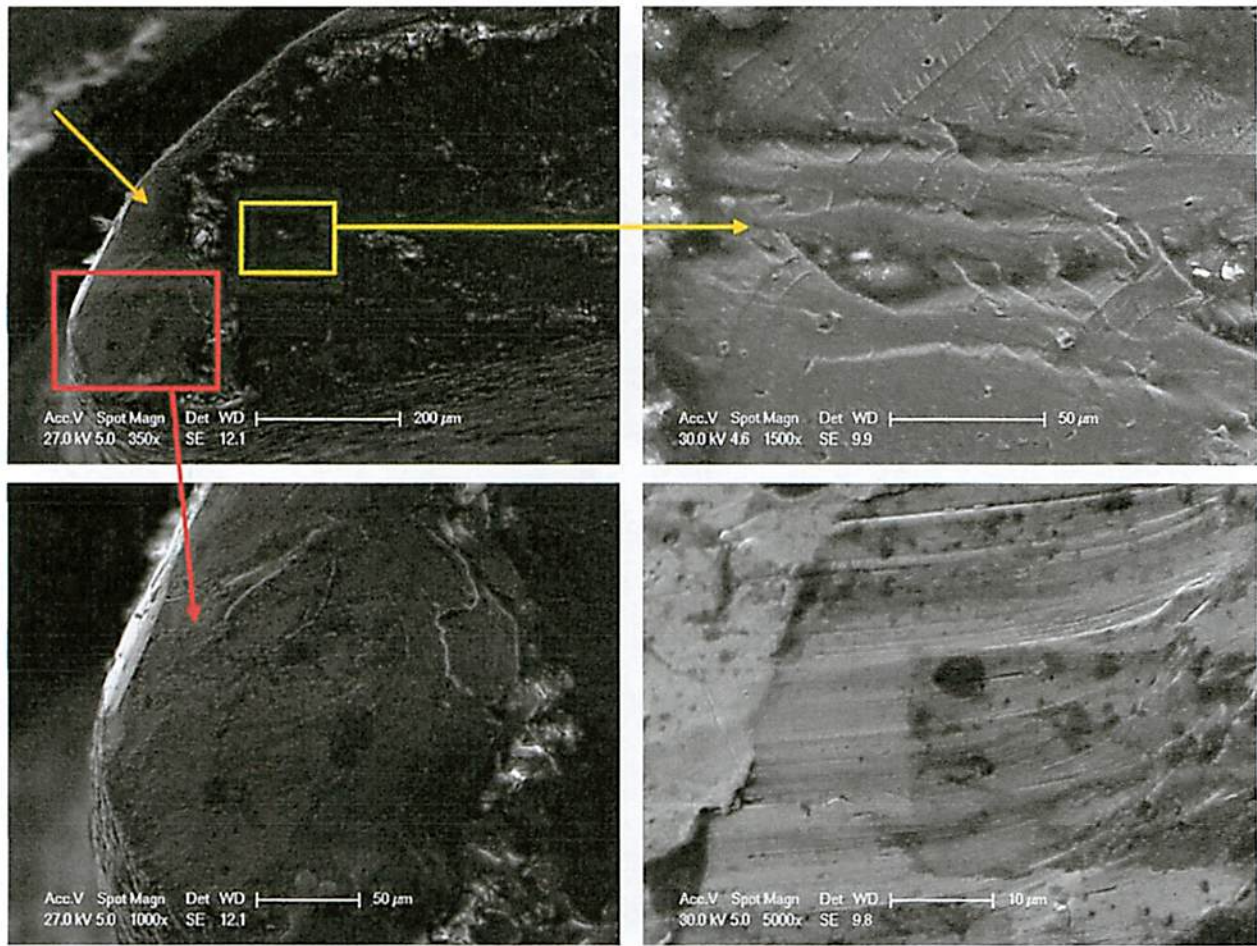
Figure 4: SEM micrographs of the fracture surface of specimen N° 2 showing fatigue striations.

This is likely to suggest that the fracture surfaces of the 5th stage have been subjected to the operating conditions for a longer period than those of the 6th stage. From the fractographic analysis it can be supposed that the fracture of the vanes of specimens N° 1 - 2 occurred prior to the catastrophic failure of the 6th stage.
