**Subject: safety recommendations on the accident occurred on September 29<sup>th</sup> 2013, at Rome Fiumicino airport (Italy), to A320-200 registration marks EI-EIB.**

## **1. Synopsis**

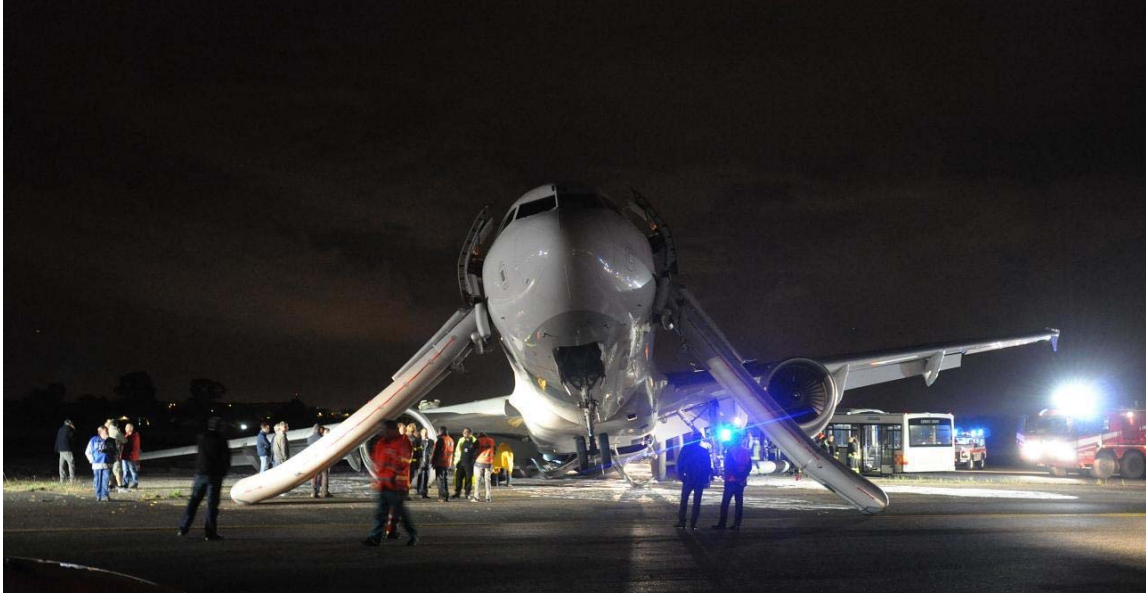
Approaching Rome Fiumicino airport RWY 16L, the aircraft touched down on the runway at 19.00 UTC with the right LG only partially extracted (picture 1). At landing, the mass of aircraft was 58.864 kg (DFDR data).

The flight crew shutoff both engines just before touchdown. The aircraft came to rest after scraping the right engine just few meters off the runway (RH side); the subsequent evacuation was uneventful and no injuries were suffered.

**Picture 1: aircraft just after the accident.**

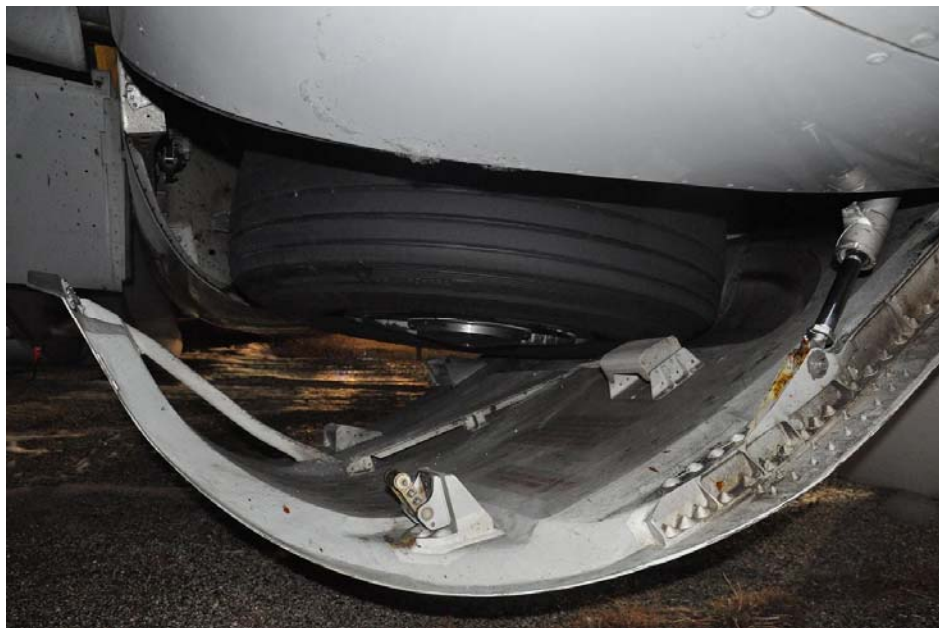
While on site, the investigators noticed the right MLG door actuator only partially extended and the right MLG not in the up-lock position, but stuck on the door (the door was not touching the terrain and no signs of ground contacts were present on it – picture 2). At removal of the jammed actuator, the door fully opened and the gear correctly extended and locked.

**Picture 2: right main landing gear partially open.**

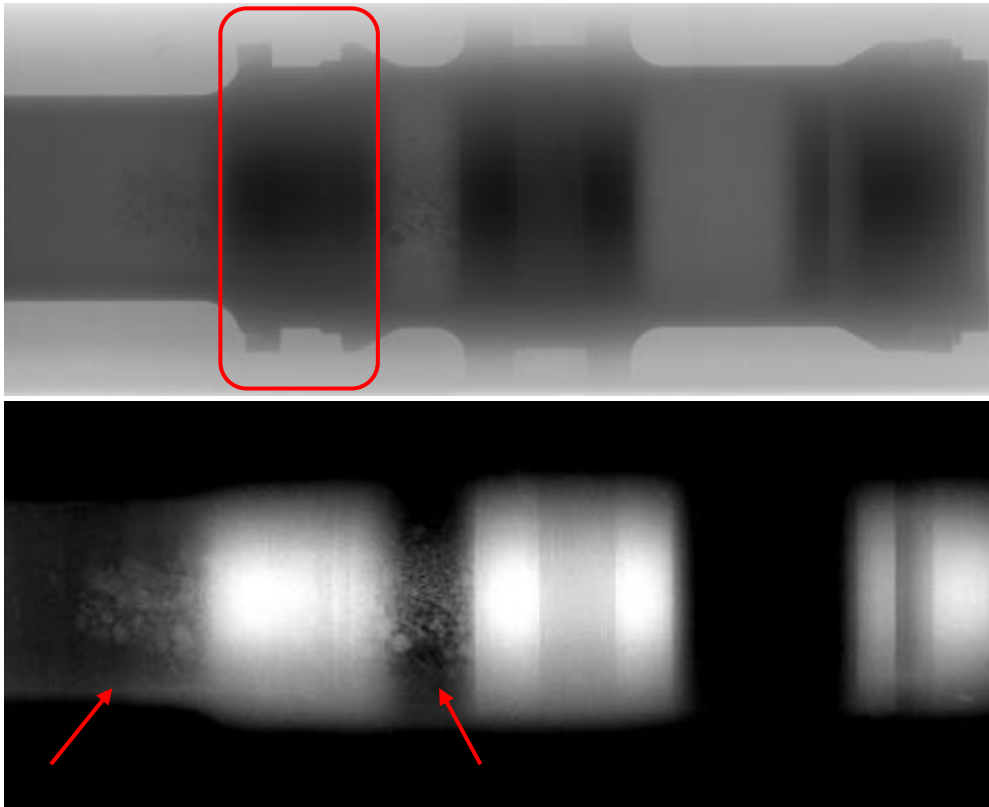
Early X-Ray analysis carried out at the labs of the Italian Air Force on the failed actuator (P/N 114122012, S/N CH0907025) revealed the presence of heavy debris in the damping housing (picture 3) together with the absence of some damping components (only the retaining ring appeared to be present - red box on picture 3).

**Picture 3: evidences from X-Ray analysis.**

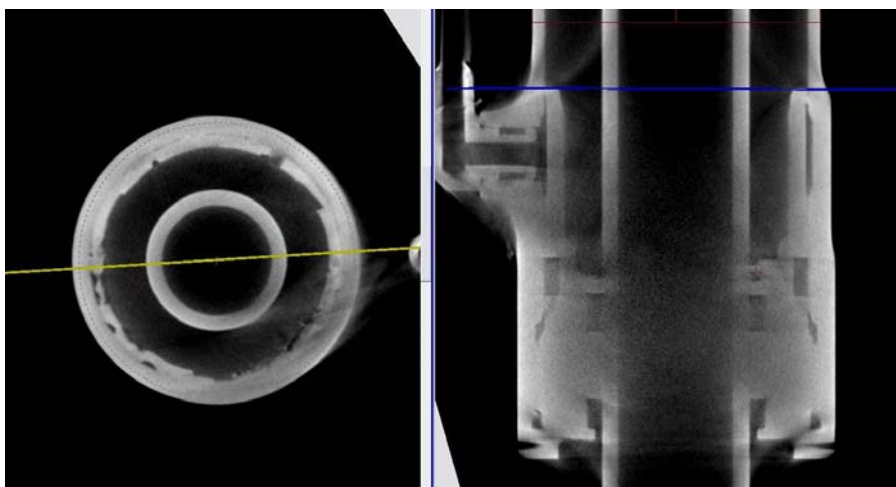
The following CT scan carried out at Astrium facilities (Bordeaux, France) confirmed this condition and clarified that only the retaining ring was present on the damaged area. In addition damages on the lip of the damping housing were detected (picture 4).

**Picture 4: evidences from CT scan.**

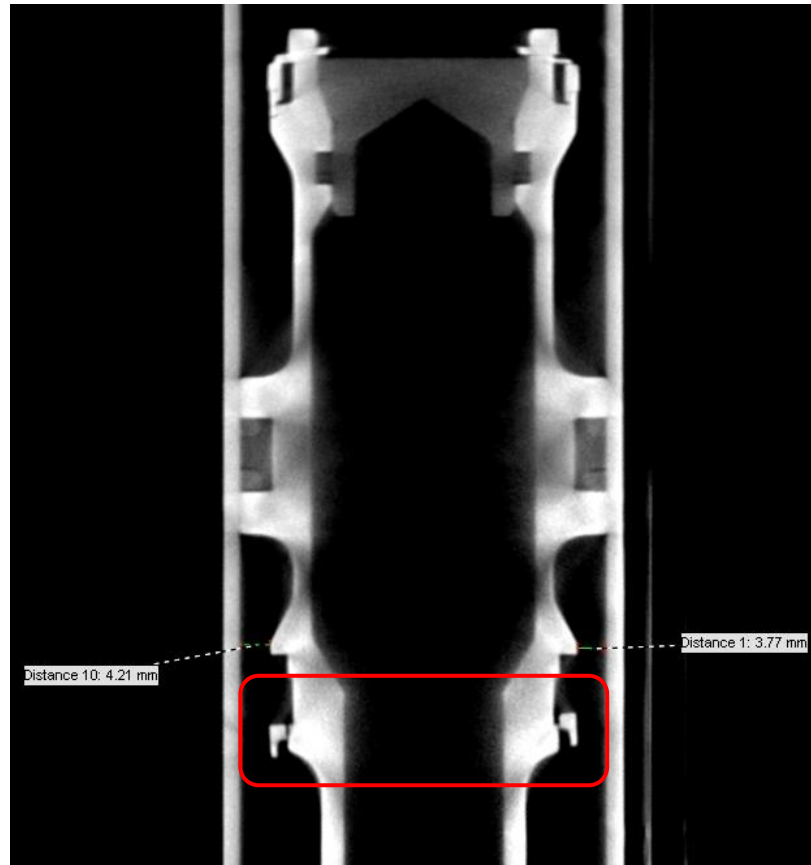
The retaining ring has been found out of the design position (picture 5).

**Picture 5: evidences from CT scan.**

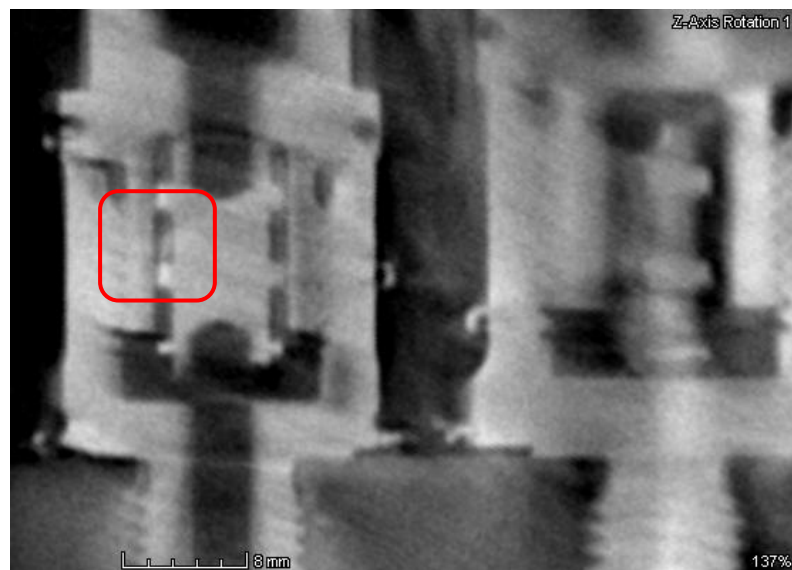
Presence of one debris is showed on picture 6 in the restrictor area (retractor one).  
CT scan of the left door actuator (not failed one) showed all internal components in their correct position.

**Picture 6: evidences from CT scan.**

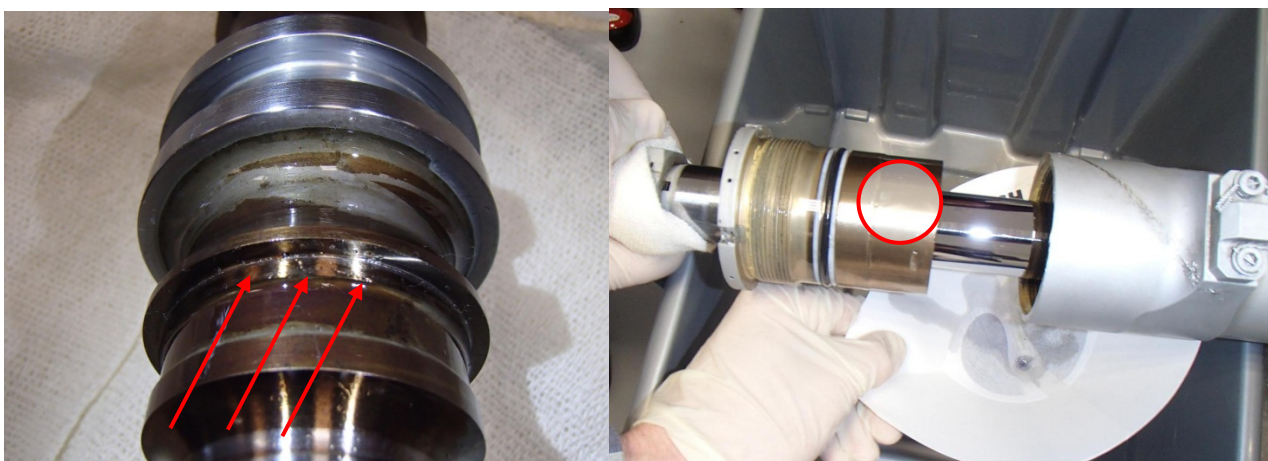
The disassembly provided full confirmation of all the above mentioned evidences on the right actuator, while on the left one, presence of contamination was clearly shown (picture 7-8, red arrow and circle).

**Picture 7: contamination found on LH MLG door actuator.**

Finally, some additional concerns comes from the clear signs of oil contaminations found on the “not failed” actuator on the two last events (left for the AZ event and right for the Wizzair one). In fact, this condition could be thought as representative of a contamination distributed within the landing gear hydraulic system components that could represent a technical problem for the system itself and not only for the actuator.

ANSV recommends to take into consideration that the debris coming from a failed actuator have been found inside the actuators “not failed” on both accidents occurred on 2013. With reference to the maintenance actions required by the AD 2011-0069R1 (same as about the PAD 13-125R2), if a faulty actuator is found, the required corrective action is to remove it and to install a new one. No actions required about the hydraulic system that has been found contaminated during both the investigations. ANSV strongly recommends to ask for the proper technical actions to be carried out on the hydraulic system of the landing gear doors to be sure that contamination is not present in case of a landing gear door actuator removal in consequence of the actions prescribed to identify an internal damage (ref AD 2011-0069R1 and PAD 13-125R2).

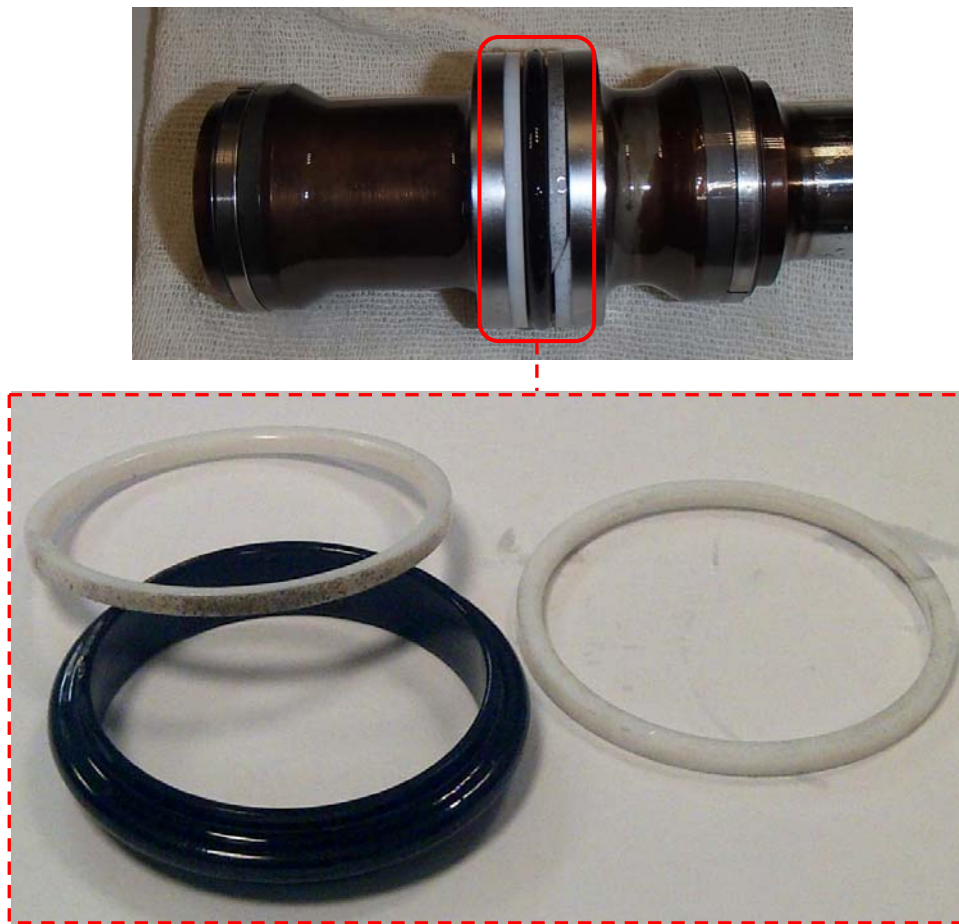
**Picture 8: contamination found on LH MLG door actuator.**

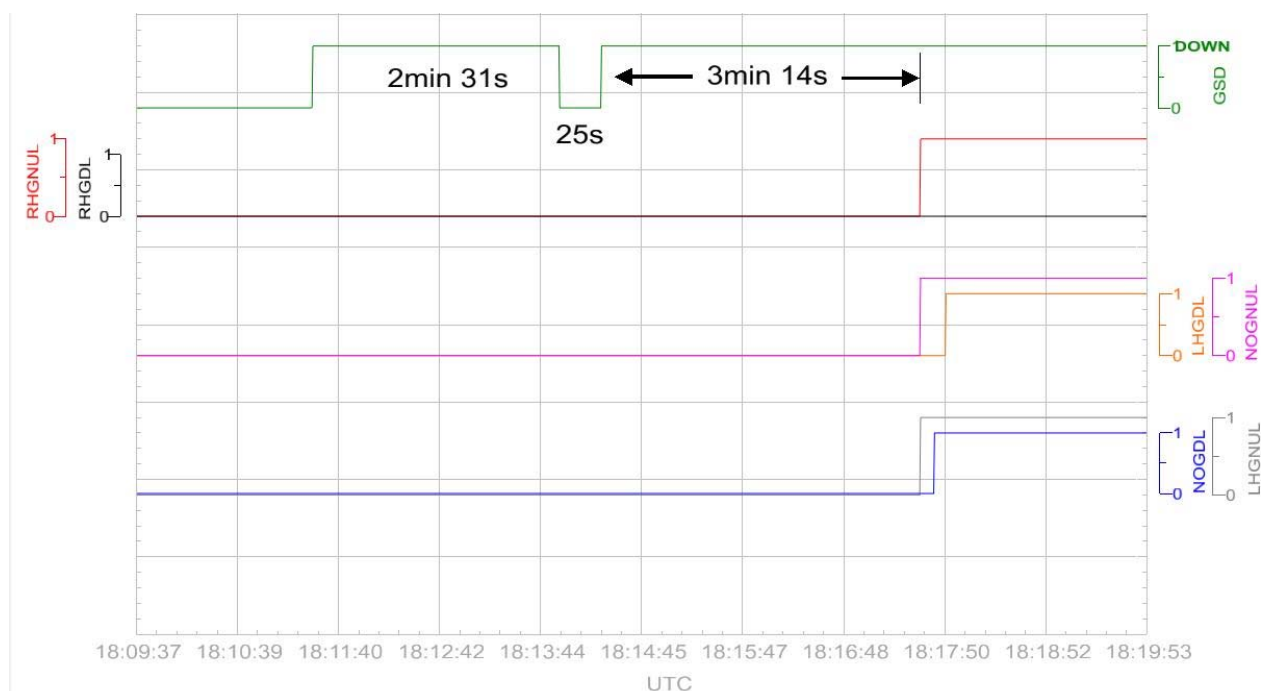
In terms of operational procedures, DFDR data showed that before applying the gravity extension procedure, the crew had executed the following sequence of actions:

- normal extension of the L/G with lever set in “DOWN” position for 2’31” with indication of “L/G GEAR NOT DOWNLOCKED”;
- g-force manoeuvre at 1,75g (DFDR data);
- recycle of the landing gear by moving the lever in “UP” position for 25”, followed by repositioning it “DOWN”;
- 3’14” later, activation of gravity extension.

This sequence of actions shows that the crew recycled the landing gear lever once and waited for more than 2 minutes with the gear selected down before starting the landing gear free fall procedure, as requested by the OEB 209/1 dated Feb 2011 and following modifications (OEB 44.00 dated 25 Nov 11 and OEB 44.01A issued on 30 May 2012) that recommends the flight crew, if ECAM triggers the “L/G GEAR NOT DOWNLOCKED” warning, to wait for 2 minutes after the recycling of the landing gear, before extending the landing gear by gravity.

**Picture 9: L/G timing commands from FDR data.**
