Subject: safety recommendations on the accident occurred on June 8th 2013, at Rome Fiumicino airport (Italy), to A320-200 registration marks HA-LWM.

1. Synopsis

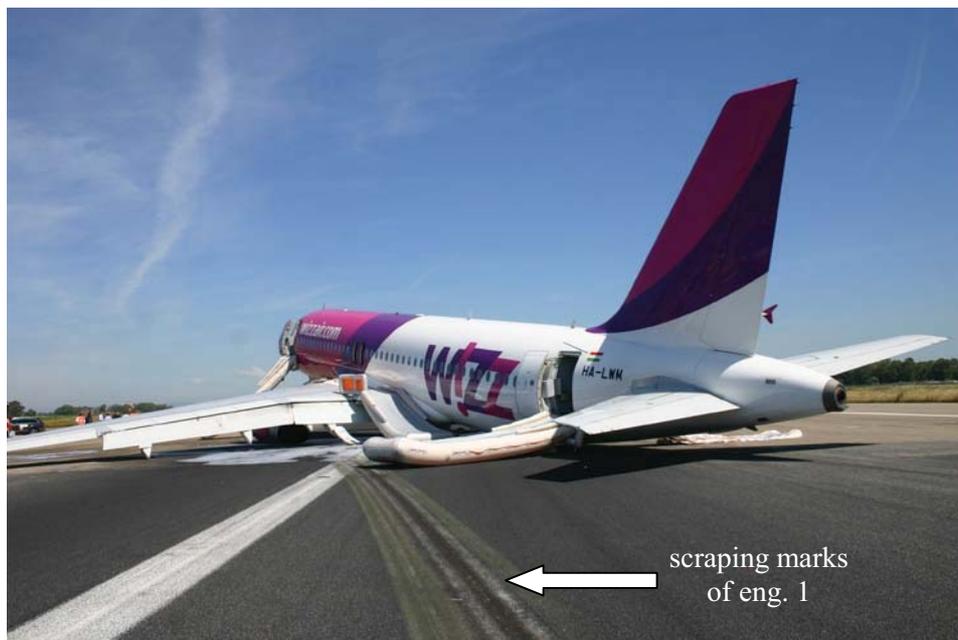
Photo 1

The flightcrew shutdown the left engine just before touchdown and the right one a few seconds later. The aircraft came to rest after scraping the left engine on the runway for about 1200 m (photo 1); the subsequent evacuation was uneventful and no injuries were suffered.

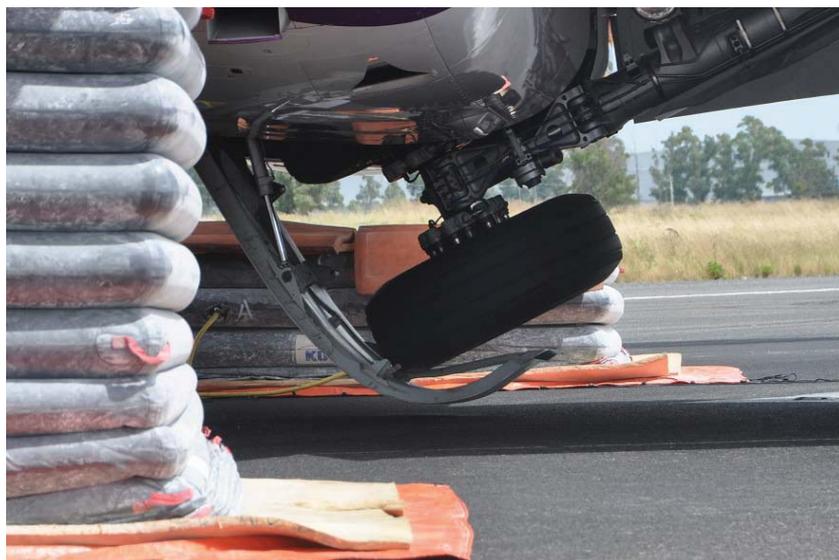
Photo 2

While on site, the investigators noticed the left door actuator only partially extended and the left LG not in the uplocked position, but stuck on the door also when the aircraft was lifted by airbags (photo 2). At removal of the jammed actuator, the door fully opened and the gear correctly extended and locked.

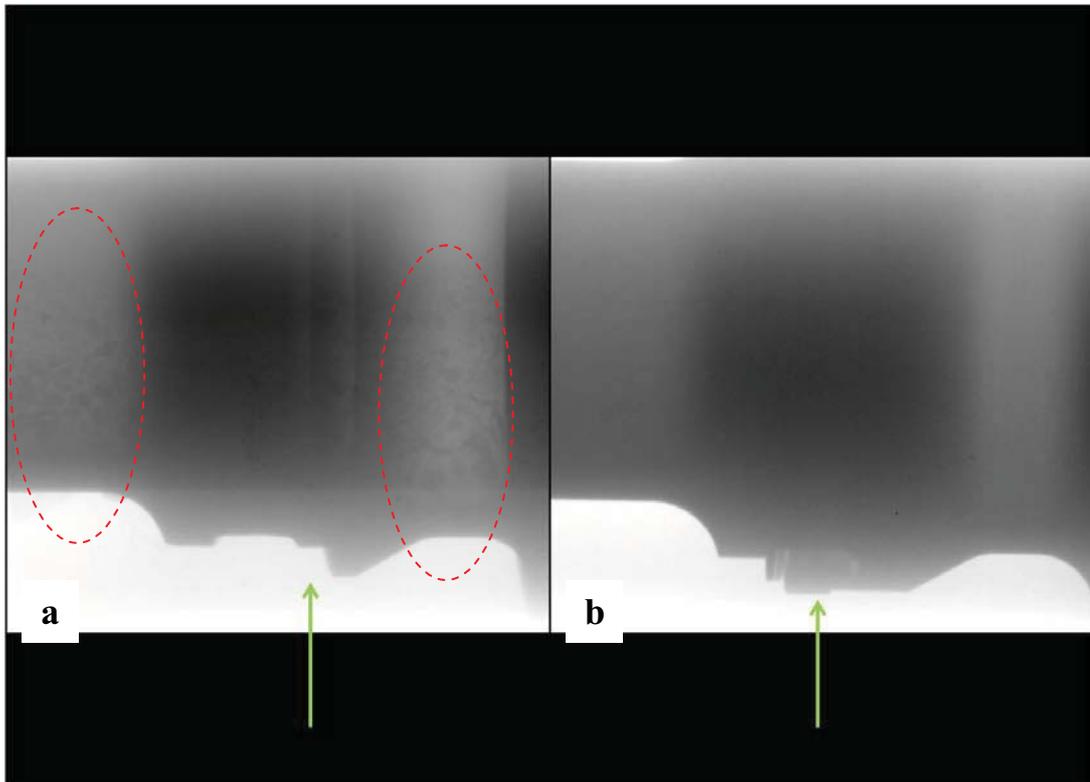
Photo 3

Early X-Ray carried out at the labs of the Italian Air Force on the failed actuator (P/N 114122-012, S/N CH1122581) revealed the presence of heavy debris in the damping housing (photo 3a, dashed lines) when compared to a new one (photo 3b); this finding was accompanied by the absence of some internal parts in the same area, presumably retaining ring, damping ring and spiraloX (arrows in photo 3a).

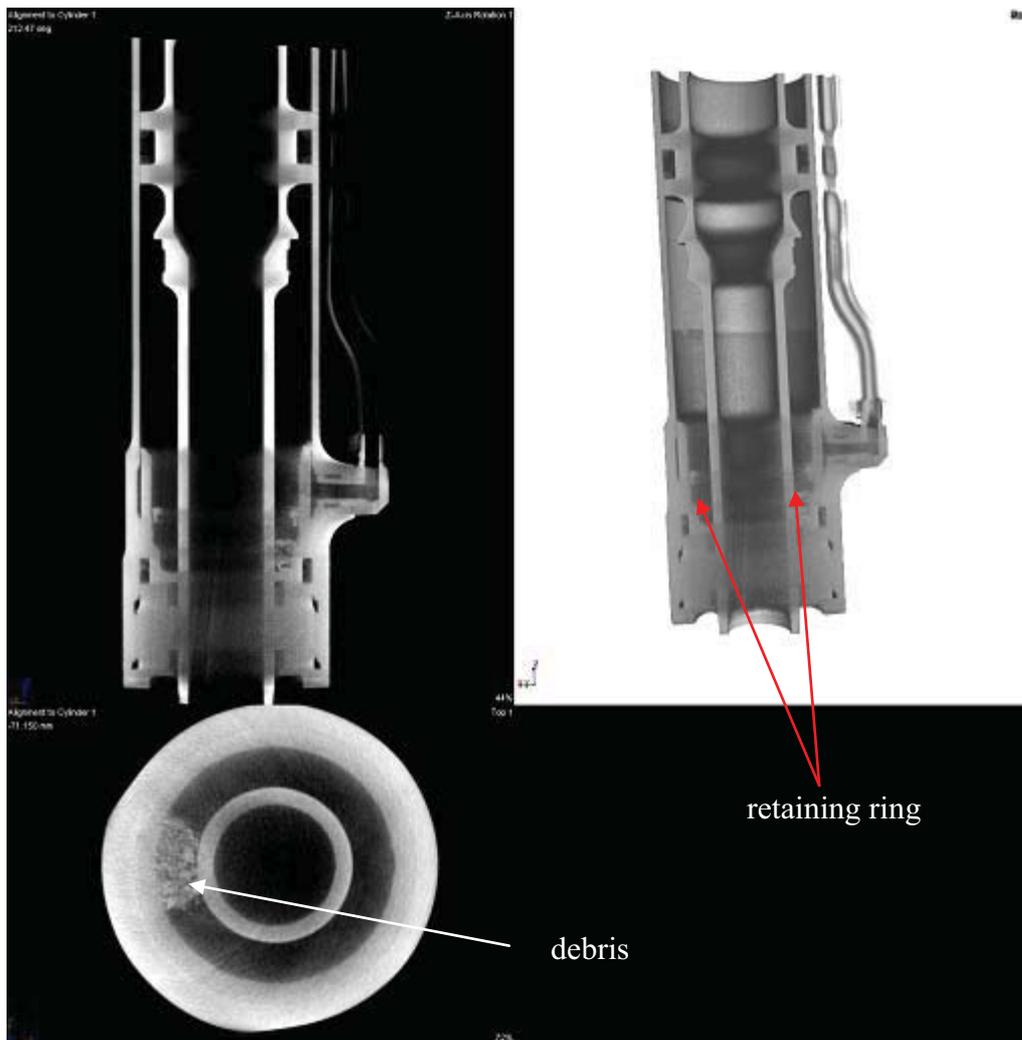
Photo 4

The following CT scan carried out at Astrium facilities (Bordeaux, France) confirmed this condition and clarified that debris was due to the spiraloX and the damping ring, as well as the damages on the lip of the damping housing, while the retaining ring was eventually shown twisted, but integer, stuck inside the damping housing (photo 4).

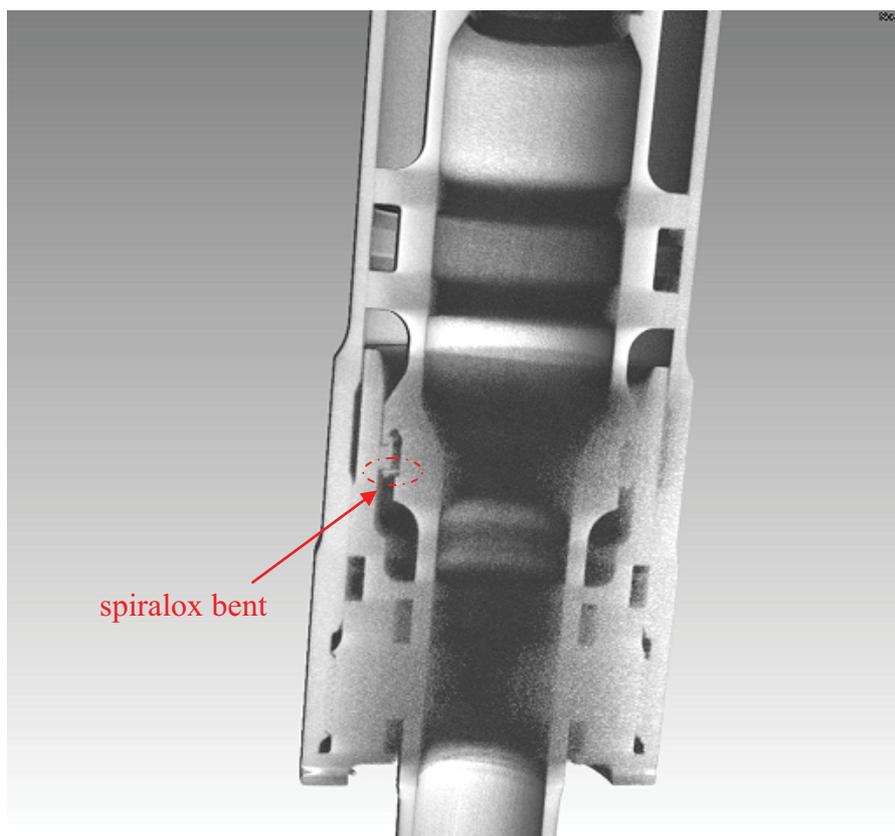
Photo 5

CT scan of the right door actuator showed all internal components in their correct position, but the spiralox appeared to be bent (photo 5).

The disassembly provided full confirmation of all the above mentioned evidences on the left actuators, while on the right one, in addition of the dishing of the spiralox, it showed some presence

of debris most likely associated with an initial deterioration of the edge of the damping housing that was also observed.

Finally, some additional concerns comes from the spiralox dishing and some damages of the damping housing observed on the right door actuator while still showing regular and efficient performance. In fact, this condition could be thought as representative of an early stage of ongoing degradation that may lead to failure in an unknown number of cycles.
