PRELIMINARY REPORT

ACCIDENT

**aircraft Jodel D.140E registration marks F-PMGV
and aircraft AS350 B3 registration marks I-EDIC,
Rutor glacier (AO),
25th January 2019**

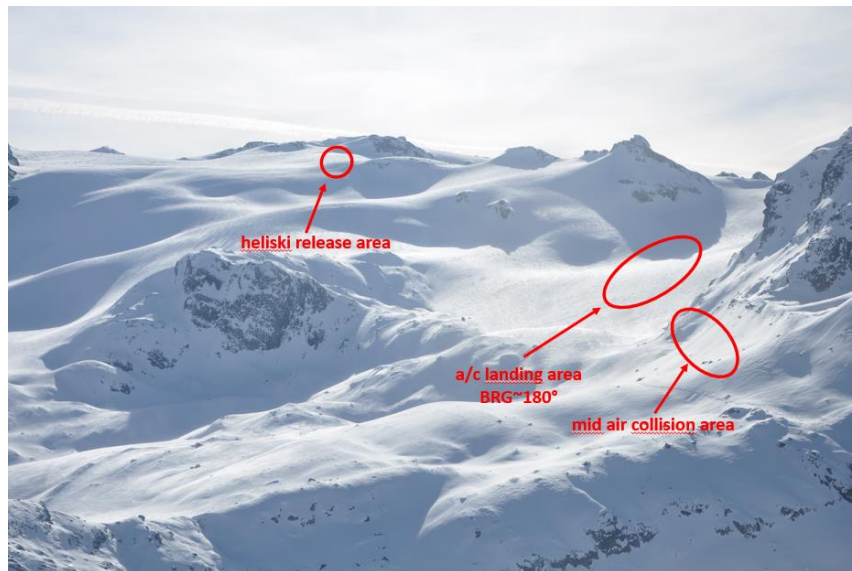
The I-EDIC helicopter and the F-PMGV airplane experienced a mid-air collision in an area close to the Rutor glacier, at an altitude of about 2700 m, around 13.30' UTC (photo 1).

- the mid-air collision between the two aircraft occurred with the airplane higher than the helicopter;
- the first contact occurred between the airplane lower right side and the helicopter main rotor;
- after the first contact between the two aircraft, the airplane broke up in flight, separating in at least 4 sections: the engine, the wings, the canopy and the tail; all these elements were found on the ground separated from each other (photos 2, 4, 5 and 6);
- after the first contact, the helicopter suffered serious damages to the main rotor blades, which likely prevented the helicopter from maintaining control in flight, with subsequent crash to the ground (photo 9);
- the collision between aircraft occurred with both of them having a ground track substantially headed south, consistent with the hypothesis they were flying toward the glacier landing areas (photo 1).

Photo 1: mid-air collision area, glacier landing area, heliski release area.

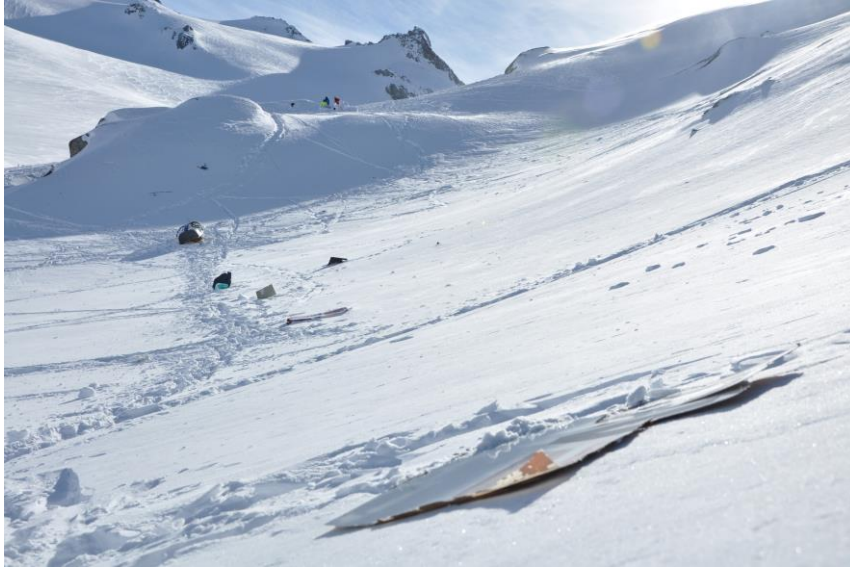
Photo 2: area of dispersed wreckages and parts.

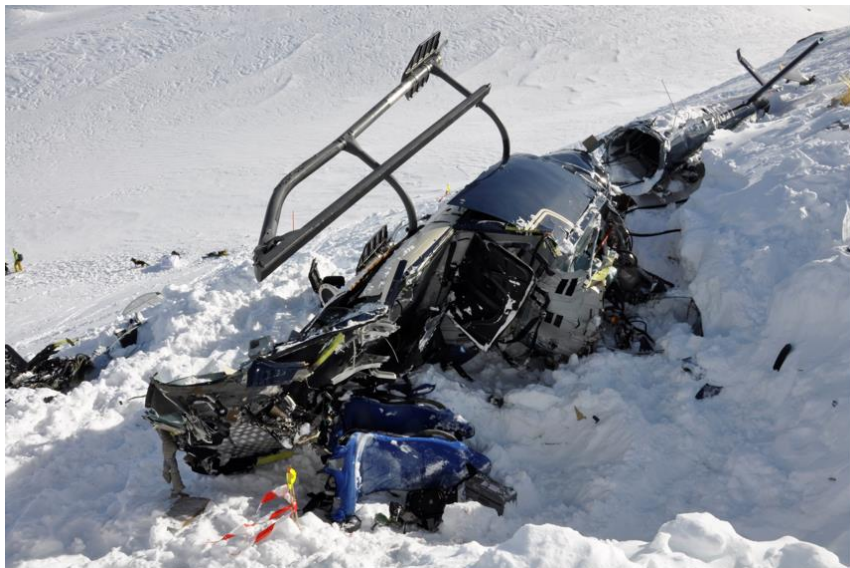
Photo 3: helicopter main wreckage.

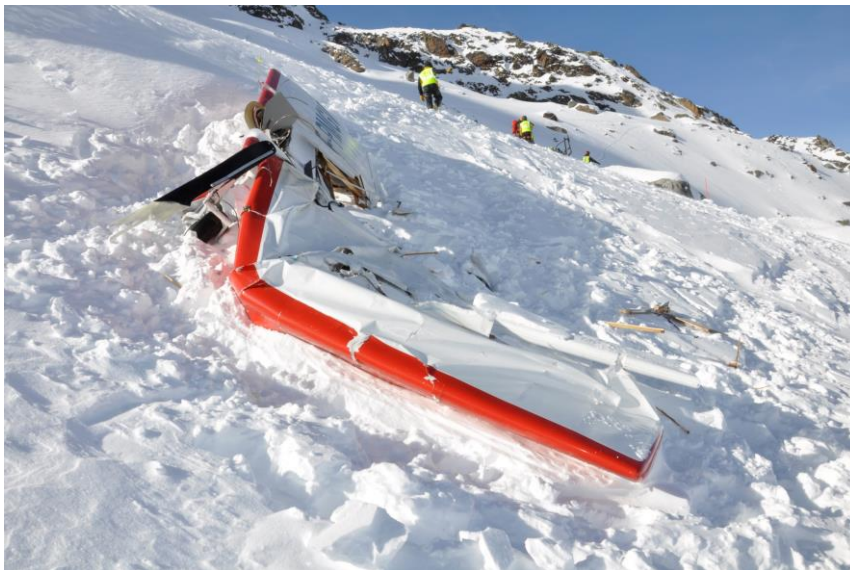
Photo 4: aircraft wing.

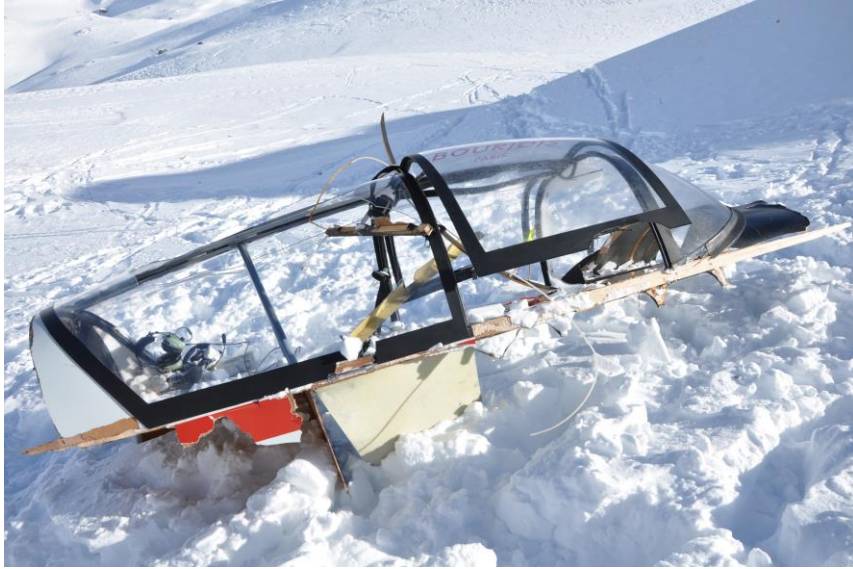
Photo 5: aircraft canopy.

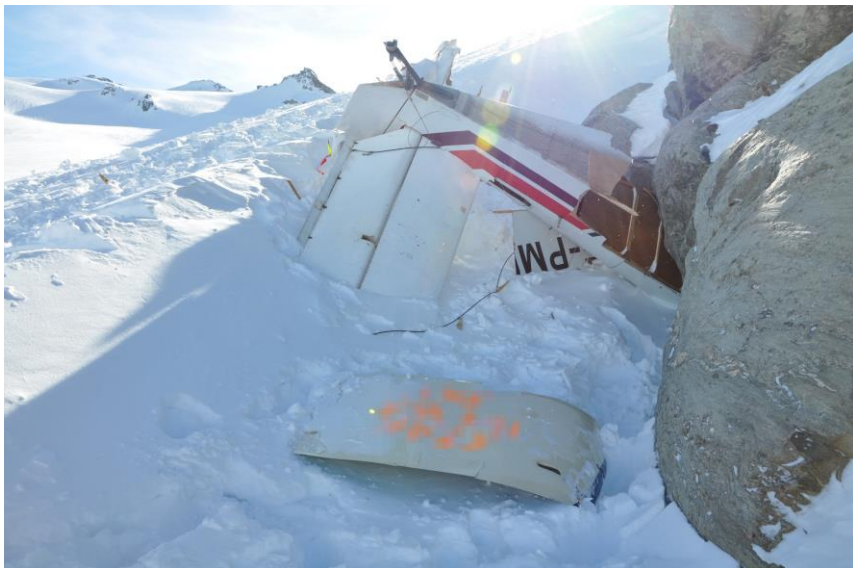
Photo 6: aircraft tail.

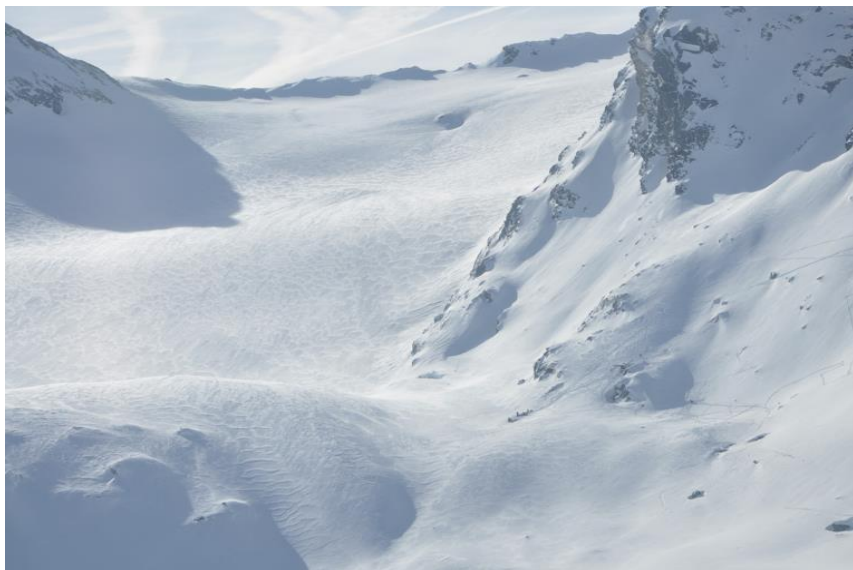
On the Rutor glacier, several ski tracks were found, most likely left by aircraft take-offs and landings (photos 7 and 8).

Photo 7: glacier aircraft landing area.

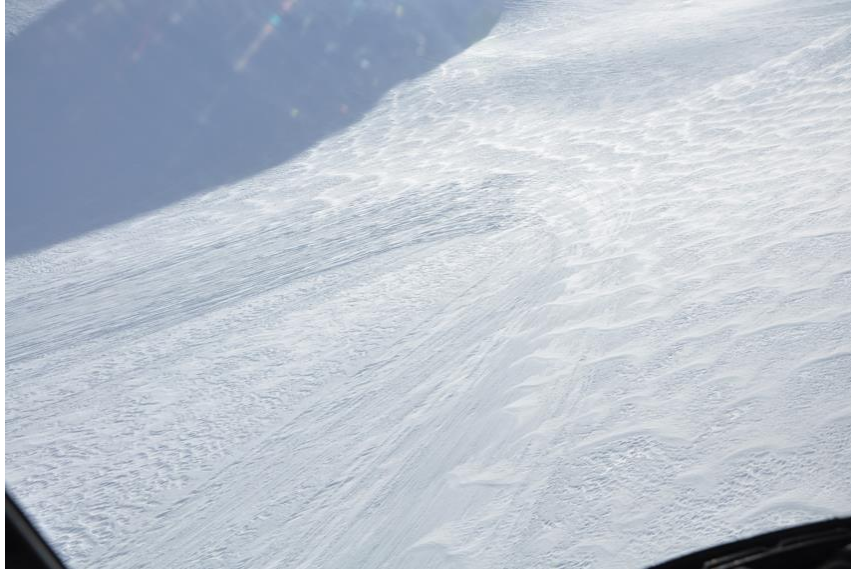
Photo 8: aircraft ski take-off and landing markings.

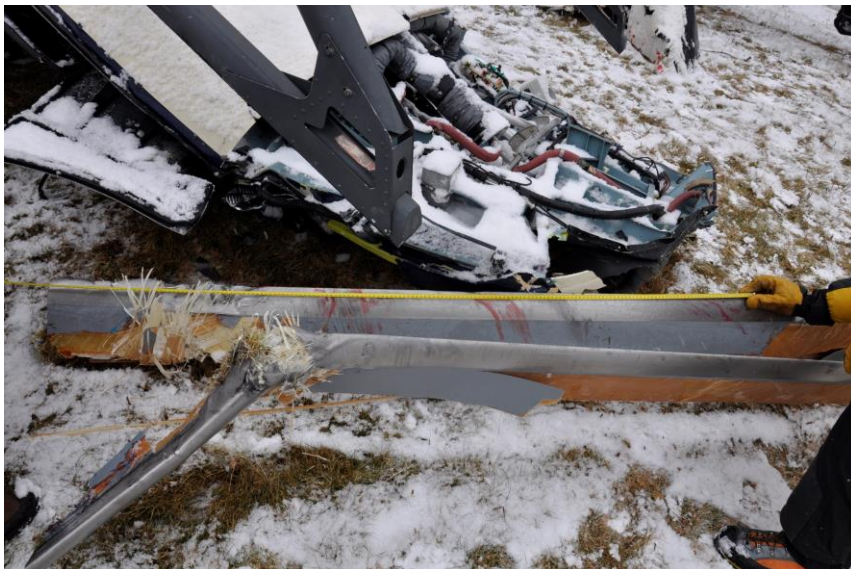
Photo 9: helicopter main rotor blades damages.

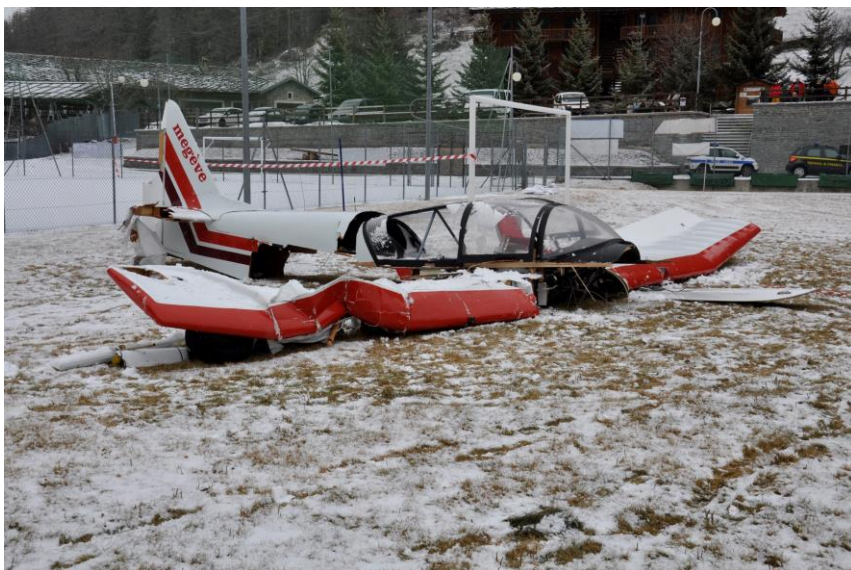
Photo 10: aircraft wreckage reconstruction.
