FINAL REPORT

SERIOUS INCIDENT
To B737-800, Registration EI-DAV,
On approach to Rome Ciampino and Fiumicino Airports
September 7th 2005

AGENZIA NAZIONALE
PER LA SICUREZZA DEL VOLO

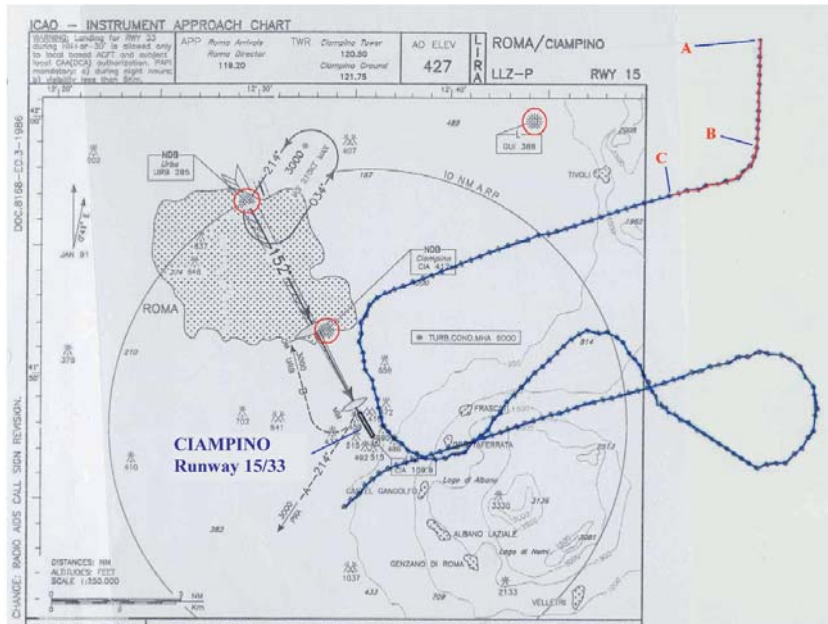
Figure 1: The path of the aircraft approaching CIA, positions A, B and C.

Initially the crew accepted to proceed towards Guidonia, but soon after, they asked again to proceed directly to the Outer Marker because of adverse weather conditions over Guidonia (ref. position “A” in figure 1).

At 12.03.47 Rome ACC air traffic controller, realizing that RYR 9672 was not proceeding towards the Outer Marker as instructed, asked for how many more miles they needed to maintain the present heading. The crew answered with the following not very clear communication («We intercept ... to the Outer Marker and we need further descent RYR 9672»), requesting clearance for further descent (ref. position “B” in figure 1).

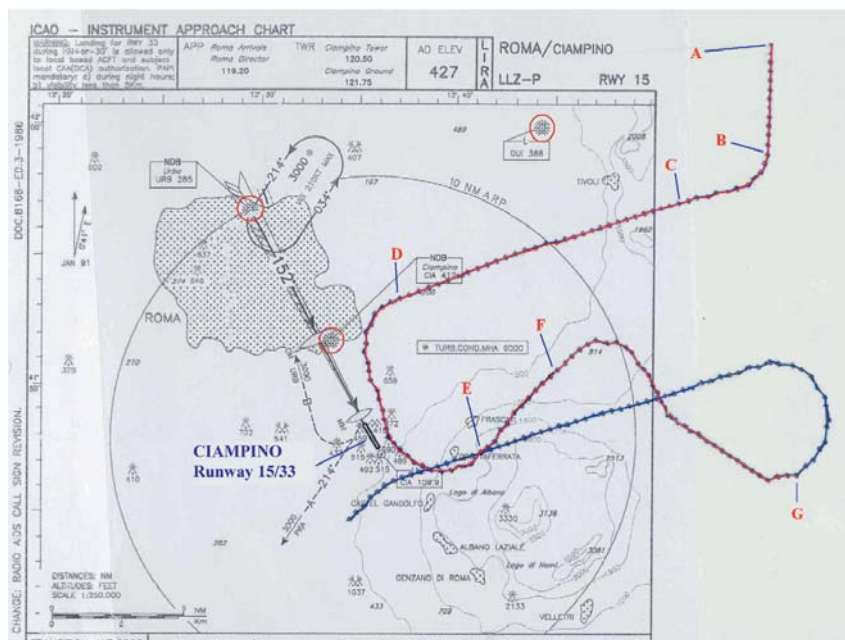
Figure 2: the path of the aircraft on approach to CIA, positions D, E, F and G.

At 12.07.11, RYR 9672 turned left onto an heading of approximately 170° (ref. position “D” in figure 2).

Rome ACC air traffic controller asked if they could continue the left turn until heading 290°, but RYR 9672 replied that it had to maintain a heading of 050° to avoid the storm. At 12.10.13, RYR 9672 requested to turn to the right to avoid large cloud formations on its left, and received clearance to assume heading 150° (ref. position “F” in figure 2).

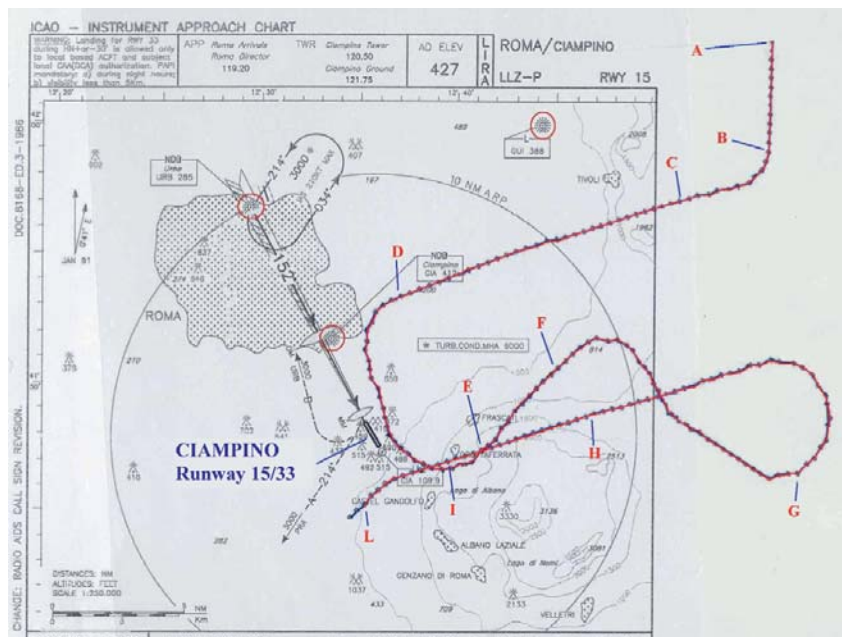
Figure 3: the path of the aircraft in approach to CIA: positions H, I and L.

At this point RYR 9672 requested information about the weather conditions at Ciampino. Rome ACC requested in turn if RYR 9672 had the field in sight, and receiving a negative reply, insisted with the instruction to continue to maintain altitude 5000 ft (minimum safe radar altitude - ref. position “H” in figure 3): «ACC: maintain 5000 ft due to minima radar we have below to you the Cavo Mountain».

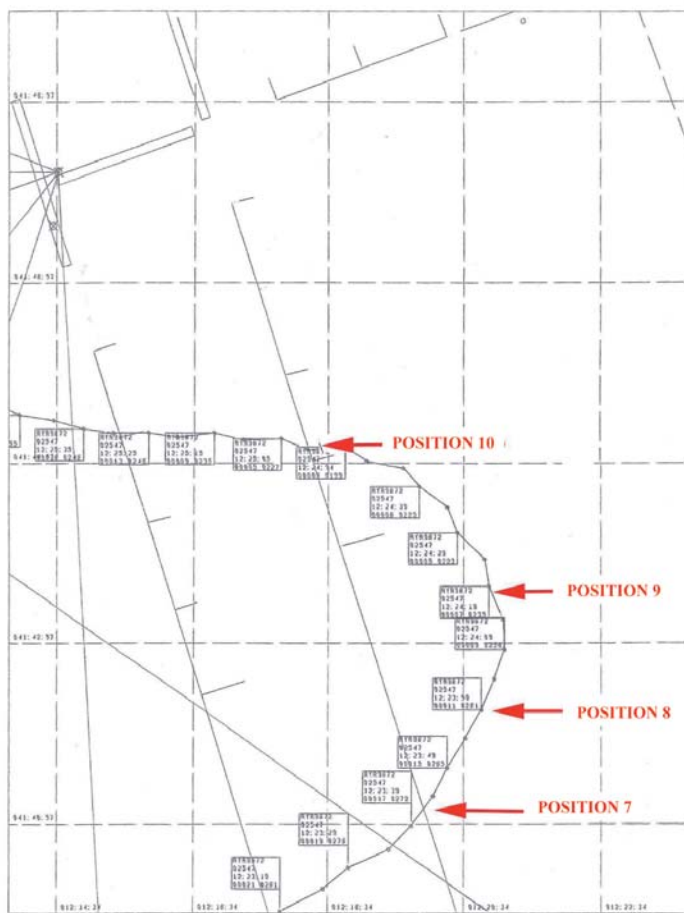
Figure 5: Radar tracking with indication of the positions referred to.

At 12.23.43, RYR 9672 crossed Runway 34R centreline extension at an altitude of approximately 1650 ft, on heading 030° and a speed of approximately 270 knots, about 3 nautical miles behind ISG 332, who was proceeding on the ILS of the same runway 34R with a slower speed (ref. position n. 7 in figure 5).

At that moment the aircraft was on a heading of 022° turning left, with a speed of 265 knots and at an altitude of approximately 1300 ft (ref. position n. 8 in figure 5). The air traffic controller did not inform RYR 9672 that the altitude, indicated on the Instrument Approach Chart, for that position was 2200 ft, while the aircraft was flying at 1300 ft, 900 ft too low. The captain declared that at about this altitude the aircraft encountered a strong downdraft (*microburst*). RYR 9672 replied: «Stand-by 9672».
