FINAL REPORT

**ACCIDENT
Occurred to the helicopter
AS350 B3 registration marks I-AMVV,
at Monte Miravidi, La Thuile (AO),
January 7th 2020**

The accident occurred on January 7th 2020, at 10:53 UTC (11:53 local time), at Monte (Mount) Miravidi, La Thuile (AO), and involved the helicopter AS350 B3, registration marks I-AMVV.

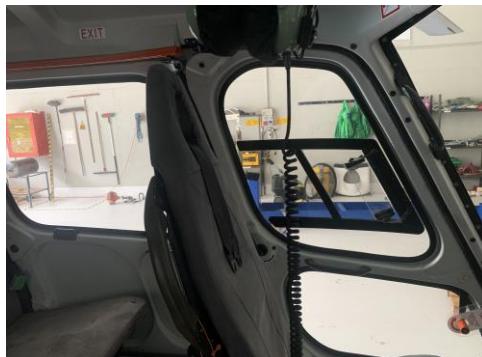
For the left side, the visibility available to the pilot is instead provided by the windows on the front and rear door on the left side. Such visibility available does not allow the pilot to see the lower left side of the helicopter, on which the basket is installed.

Photo 5: heli left side visibility from the pilot seat.

Text: ANSV recommends to request the manufacturer Airbus Helicopters to evaluate the possibility of implementing retro-vision systems that would provide the pilot with the fullest and widest possible view of the left side of the AS350 helicopter, currently only partially available.

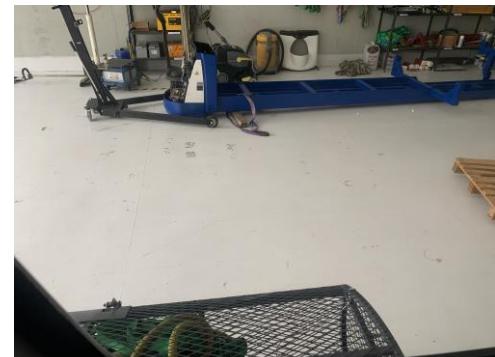
Photo 6: heli left side and basket visibility from the left rear seat.

The view of this area of the helicopter is possible partially from the left front seat, almost completely from the left rear seat. The manufacturer Airbus Helicopters supplies as optional equipment also high visibility doors, both front and rear, which allow a better visibility of the left side by the pilot, usually used for central hook operations. Such installation does not allow to have sliding rear doors on board.

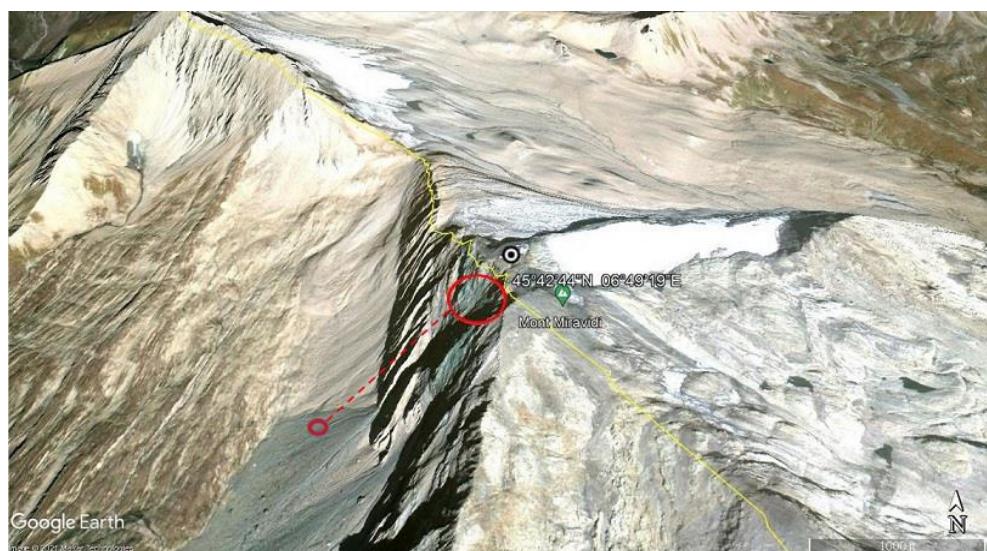
The skier's fall occurred seconds after the helicopter took off towards the French side, particularly steep, and the impact against the rocks occurred in the area indicated by the red circle in the picture below.

Photo 11: fall area and trajectory, final position on the snowfield of the skier's body (Google Earth Pro)

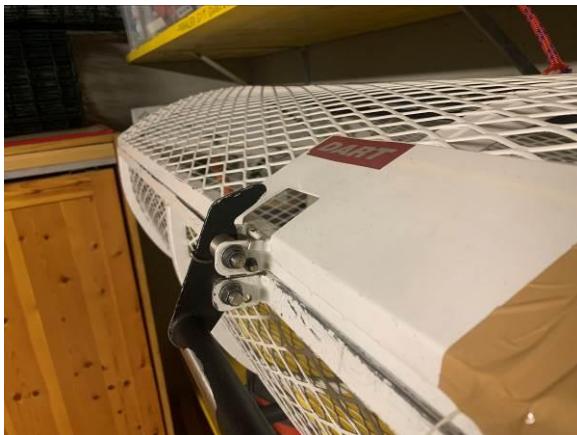
The probable point of attachment is the front linkage of the basket closing system, which, however, does not show any deformation in its protruding parts.

Photo 12: Front and left-side basket closing system

- No damages are present on the two protrusions of the basket closing system, as result of the engagement of the task specialist on the ground.

Motivation: the protrusions on the closing system of the utility basket D350-607-041A, manufactured by DART Aerospace, while not a cause in the I-AMVV accident, still pose a hazard to operators during operations conducted on the ground around the utility basket.

Text: ANSV recommends to request the manufacturer DART Aerospace to evaluate the possibility of modifying the closing mechanisms of its baskets, in order to remove protrusions potentially dangerous during ground operations around helicopters equipped with such products.

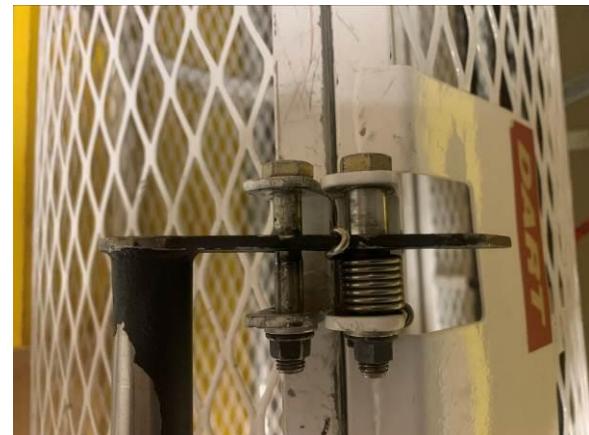
Photo 13: Detail of left-side basket closing system

- The utility basket installed on board is certified for use on the AS350 B3 helicopter and was correctly operated and maintained.
- There is no damage on the basket due to accidental hooking of the ski instructor/task specialist, there is a protruding hook on the basket which is part of the locking mechanism.

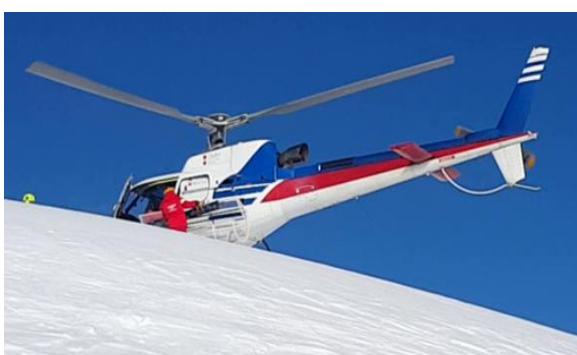
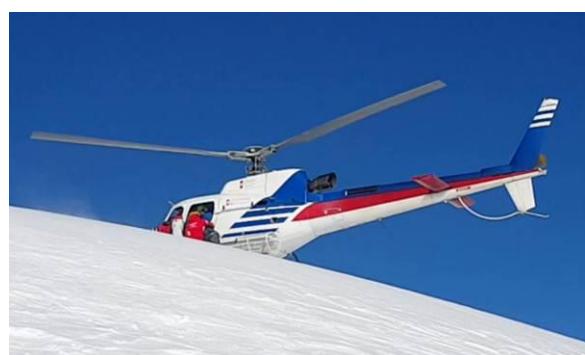
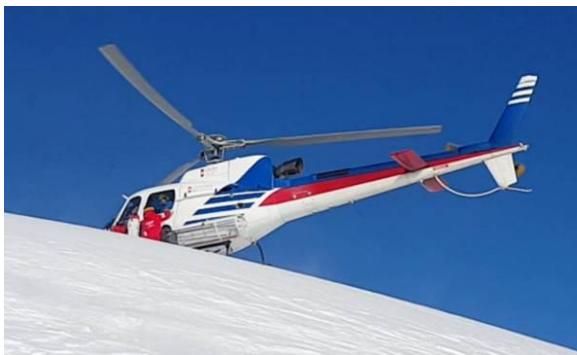
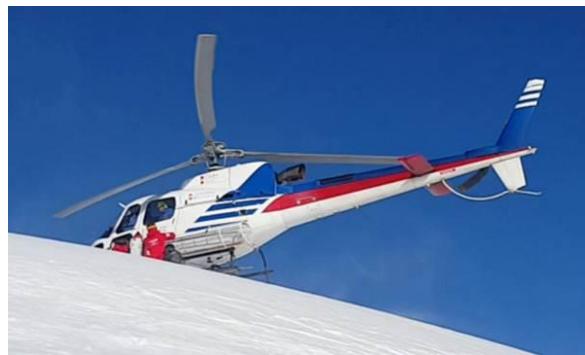
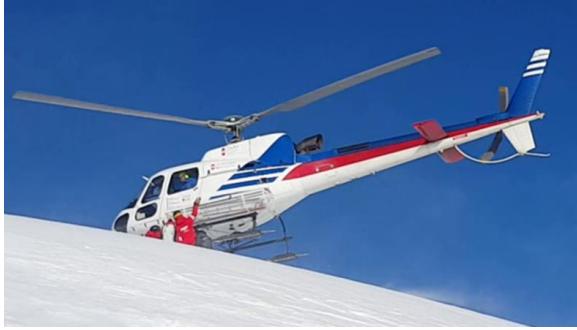
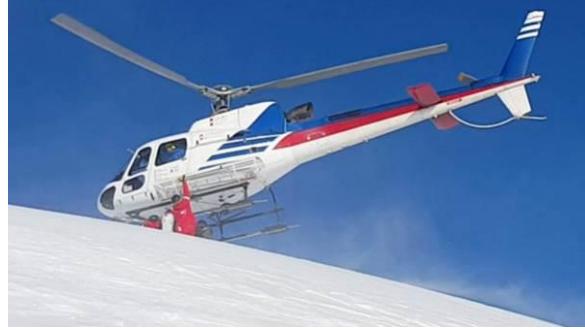
Below a series of frames from the landing of the ski instructor/task specialist and the 3 skiers, to the take-off of the helicopter with the ski instructor/task specialist remained attached to the basket.

The images apparently show a continuous eye contact between the embarked task specialist and the ski instructor/task specialist on the ground during door closing operations and in the initial phase of takeoff.
