FINAL REPORT

ACCIDENT
occurred to the aircraft
Seamax M-22 identification marks I-7608,
in Buccella (Vigevano, Pavia),
14th February 2021

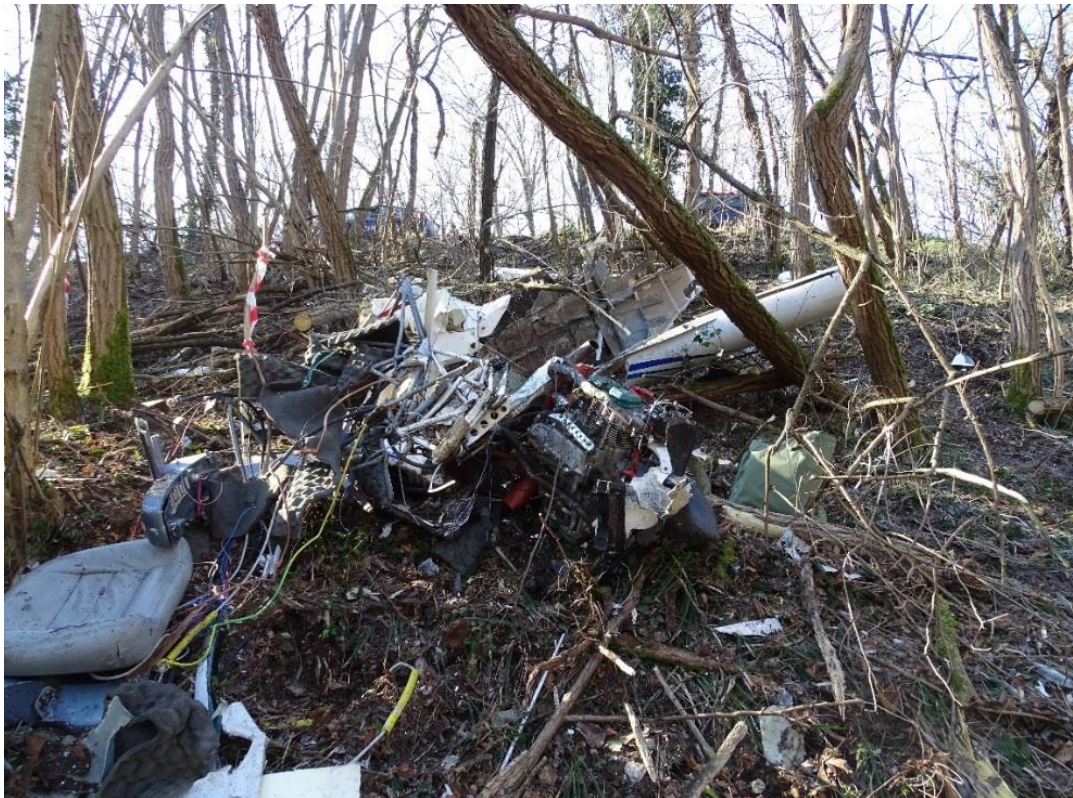
The main wreckage of the aircraft (photo 6) was found in an ditch with medium size vegetation at position 45°20'46.4"N 008°51'29.8"E. The place where the main wreckage rested was about 8 km from the take-off airfield.

Photo 6: view of the main wreckage.

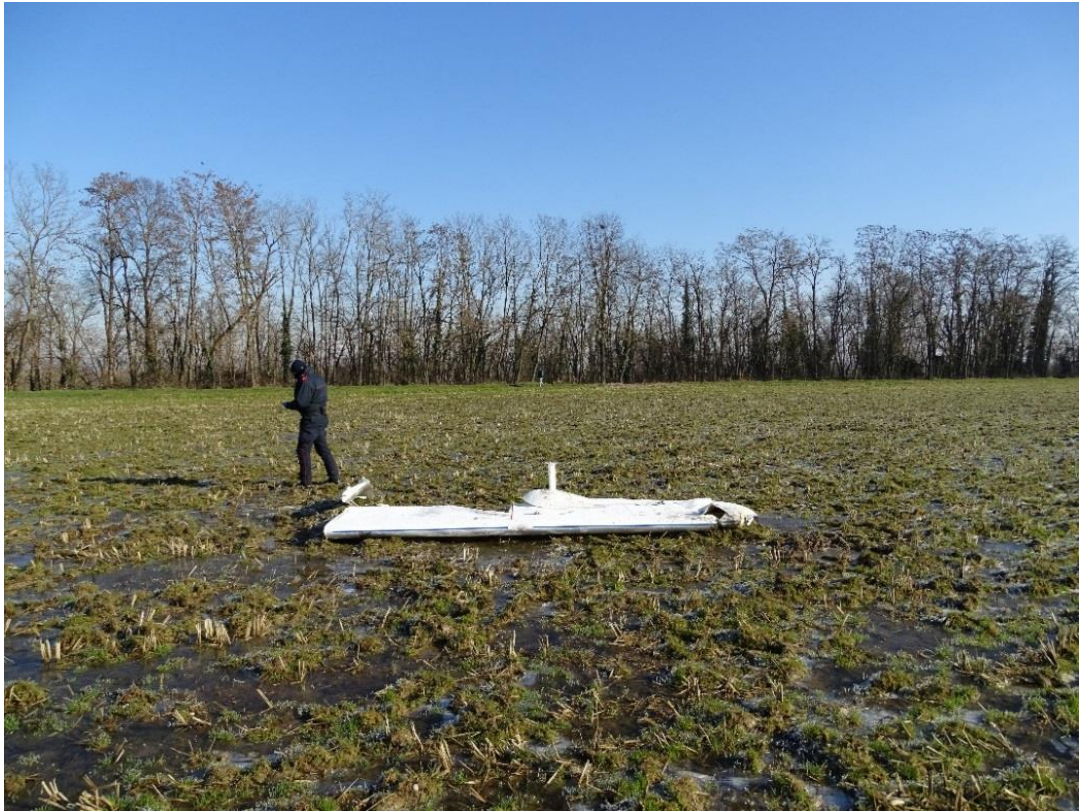
The right wing (photos 7, 8, 9 and 10) was found at coordinates 45°20'44.7"N 008°51' 22.5"E, approximately 170 m from the main wreckage, in a large rice field. The wing in question was complete, from the root to the tip. A strong smell of fuel was present on site. The leading edge showed no dents or impact marks. The *T-shape connection* was fractured approximately 10 cm from the beginning of the spar. The aileron was tied to the wing at the connection points; it still showed perfect functionality from the *link*, which had separated from the rest of the control line. The flap was tied to the wing at the left hinge only (inner, adjacent to the wing root) and had a tear at the right hinge (outer, further away from the wing root).

Photo 8: right wing at the site where it was found.

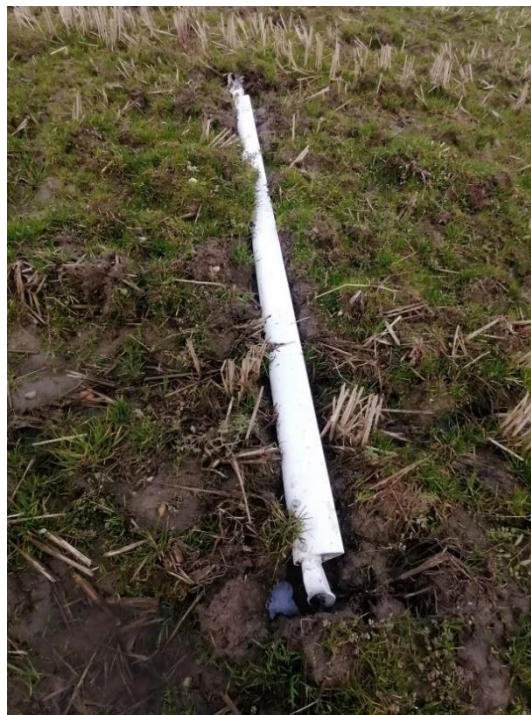
The wing strut of the right wing was found few days after the accident, about 50 m from the relevant wing.

Photo 9: wing strut of the right wing where it was found.

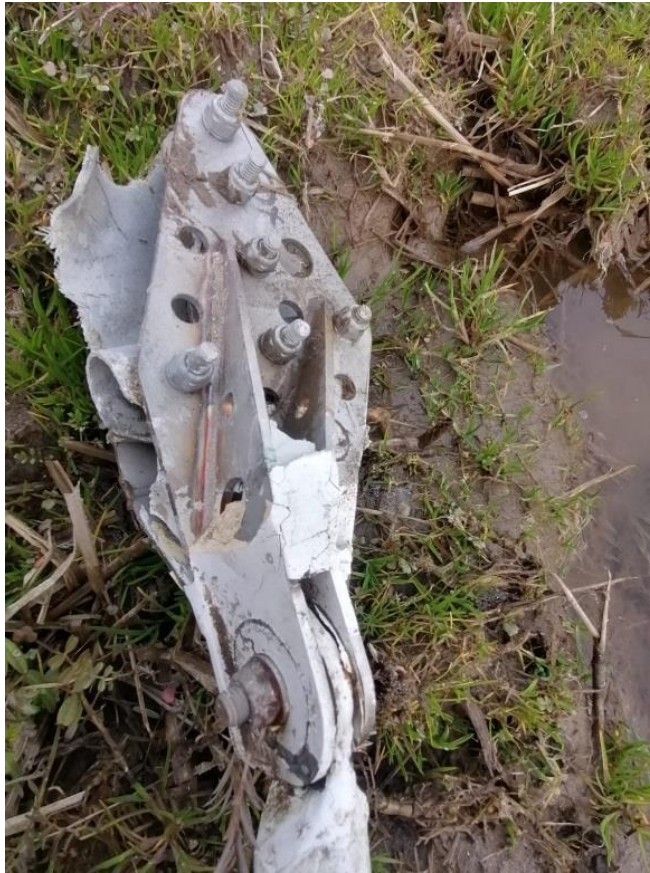
Photo 10: detail of the right wing strut: lower fixing point detached from the fuselage.

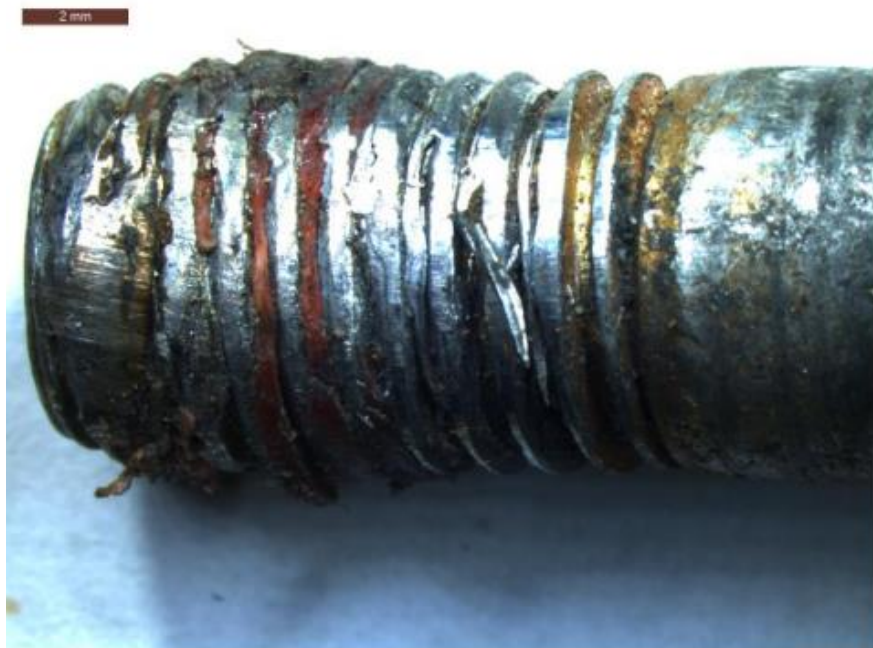
The connection point of the wing strut to the the wing was intact. Near to the wing, the screw of the upper part of the wing strut was found with what it was presumed to be its washer. The screw had no nut, but showed deformations and traces of synthetic material, probably belonging to the self-locking nut (photo 11).

Photo 11: view (optical microscope) of the screw securing the wing strut to the lower part of the right wing.

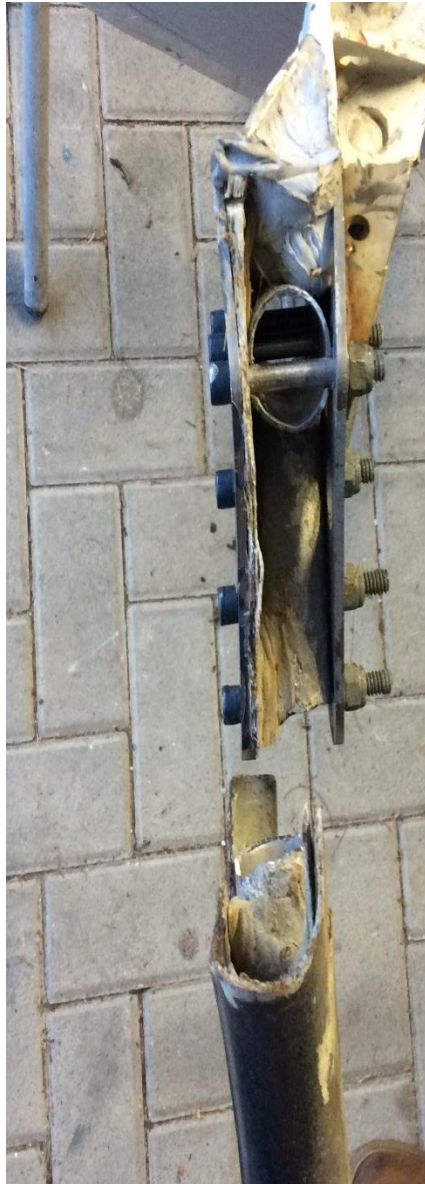
- Both ends of the aluminium rod of the fuselage structure, where the two wing struts are connected, appeared to be fractured at the same point, at a hole of one of the bolts that fix the plates to which the wing struts are fixed. The rib tube, as a result of the pressure of the bolted plates, had taken on an oval shape in both wing struts (photo 12).

The conspicuous damage to the threads of the wing strut fastening screw of the right wing (photo 12) confirmed the tearing stress suffered by this element. It is therefore believed that the fastening nuts were present on both screws at the time of the structural failure.

The installation of the metal plates for the wing strut, within which the two ends of the aluminium tubular were fixed by bolts, caused the ovalisation of the tubular itself; the deformation of the tubular thus ovalised could, in turn, lead to the weakening of the structure.

Photo 12: ovalisation of the tubular rib due to the pressure of the bolted plates.

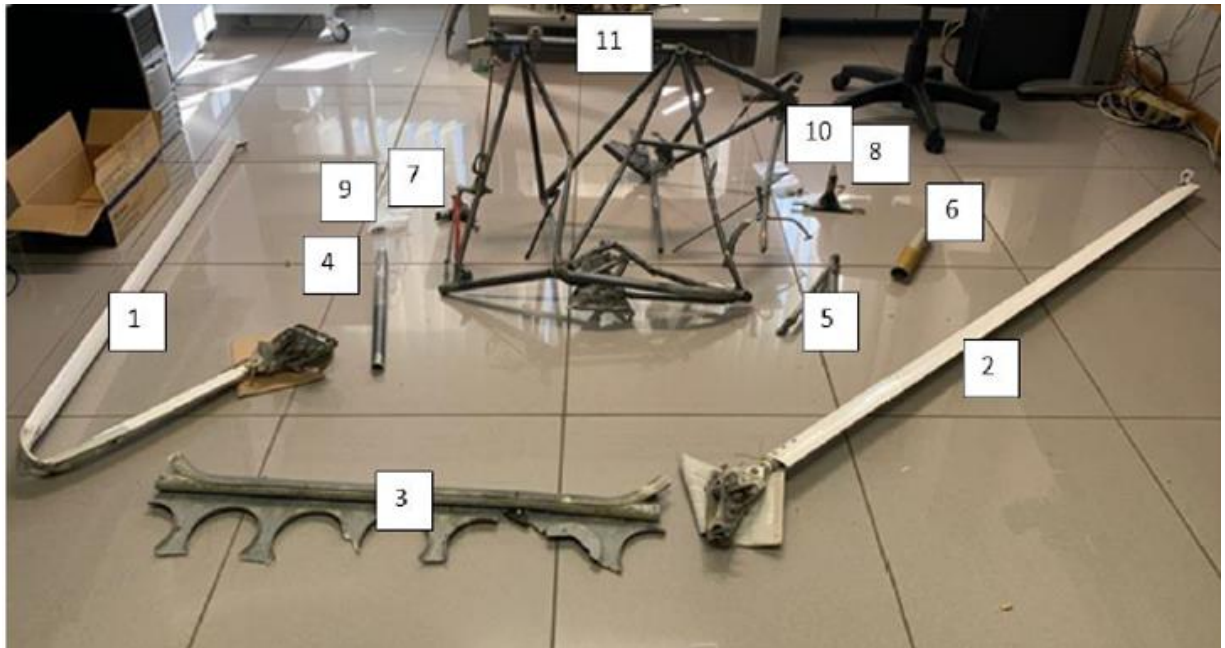
As part of the safety investigation, analyses were conducted on the fracture surfaces of certain aircraft components (photos 13, 14, 15 and 16). These analyses concerned, above all, the structural and bonding parts related to the right side of the aircraft, extending them, in some cases of interest, also to some fracture surfaces found on the left side.

Photo 13: 1. left wing strut; 2. right wing strut ; 3. internal rib wing strut connection; 4. frame rib connection tube; 5. rear right wing connection pin; 6. rear fuselage wing connection; 7. left-side fuselage spar connection mechanism; 8. right-side fuselage spar connection mechanism (*T-shape connection*); 9. wing strut fastening screw left-side wing ; 10. wing strut fastening screw right-side wing; 11. main fuselage steel frame (*cabane*).

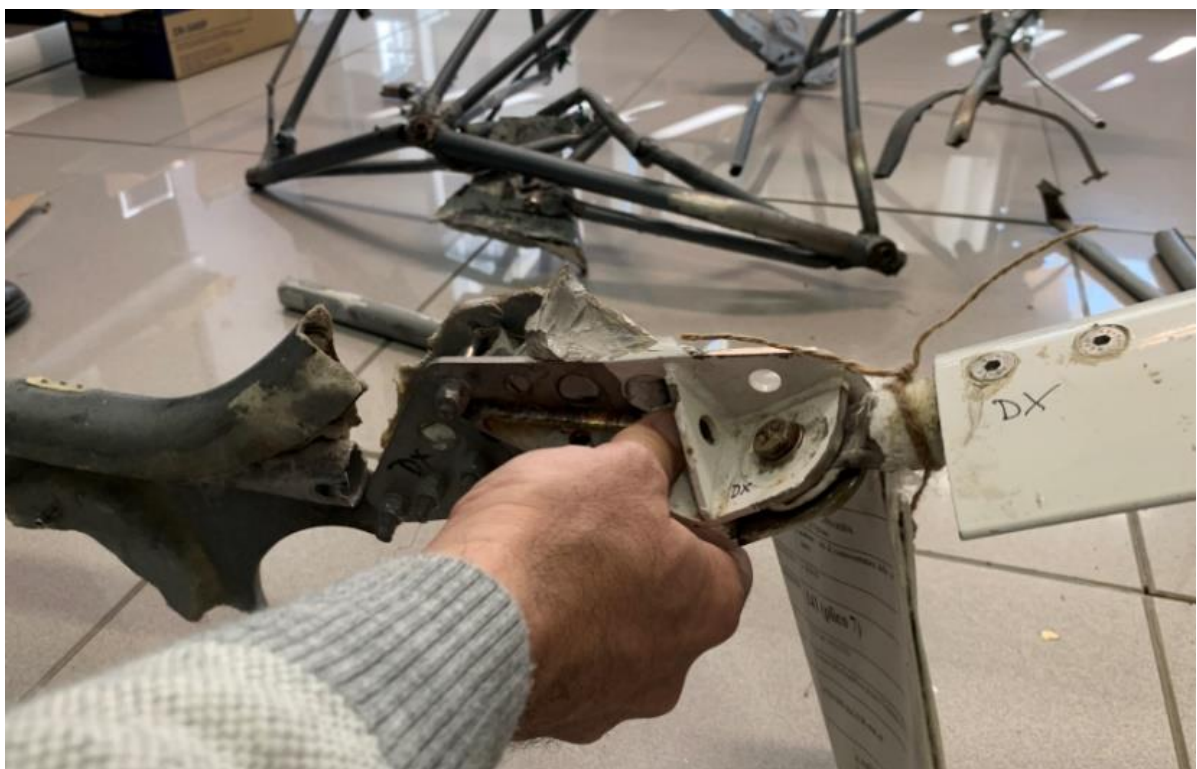
Photo 14: internal rib wing strut fixing point right side and wing strut fixing plate right side.

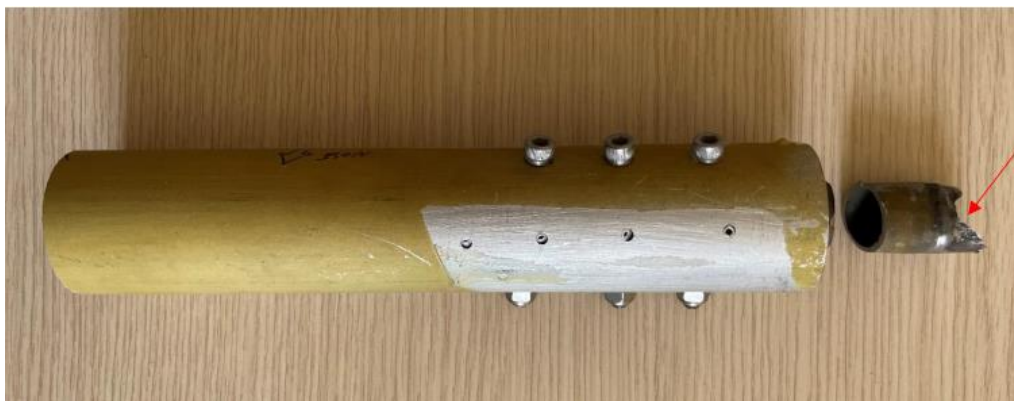
[observed fracture surface indicated with arrow in photo 17].

The presence of dimples is observed throughout the analysed surface, indicating the ductile nature of the fracture, which can be traced back to an overload fracture.

Photo 17: right wing rear connection component.

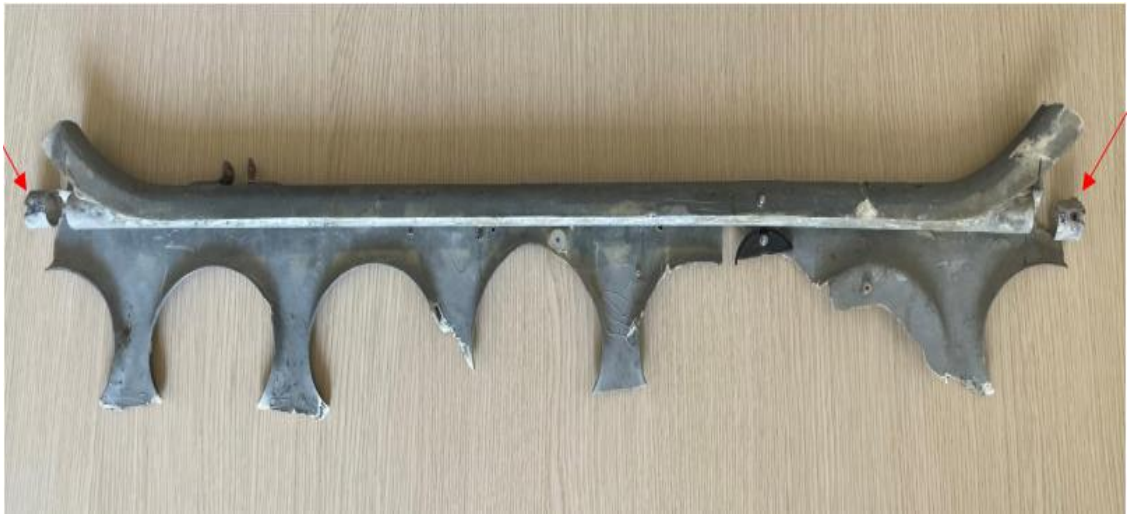
[right (RH) and left (LH) side fracture surfaces indicated with arrows in photo 18; photos 19, 20 and 21].

At the macroscopic level, a non-perfect circularity of the section was revealed at both ends, which were in fact ovalized. On the basis of the images obtained by the stereo-microscope and the pictures obtained by the scanning electron microscope, a high degree of corrosion is observed on the right and left end parts of the inner rib wing strut fixing points, in the fracture zone. For both fracture surfaces, the corrosion, in some areas, appears to be through the thickness; these areas are of greater extent on the fracture surface relative to the right-hand component (photo 22). The EDS analysis in the areas characterized by corrosion showed traces of salts (Figure 5 referring to area highlighted in photo 22). This makes it presumable that the progressive deterioration phenomenon may be associated with the presence of salt water in the vicinity of the corrosion areas. The semi-quantitative EDS analysis highlights, in addition to aluminium as the base element, the presence of magnesium and silicon, thus placing this alloy in the 6000 series (AlMgSi), consistent with the specification for a 6060 type alloy.

Photo 18: internal rib component rear connection.

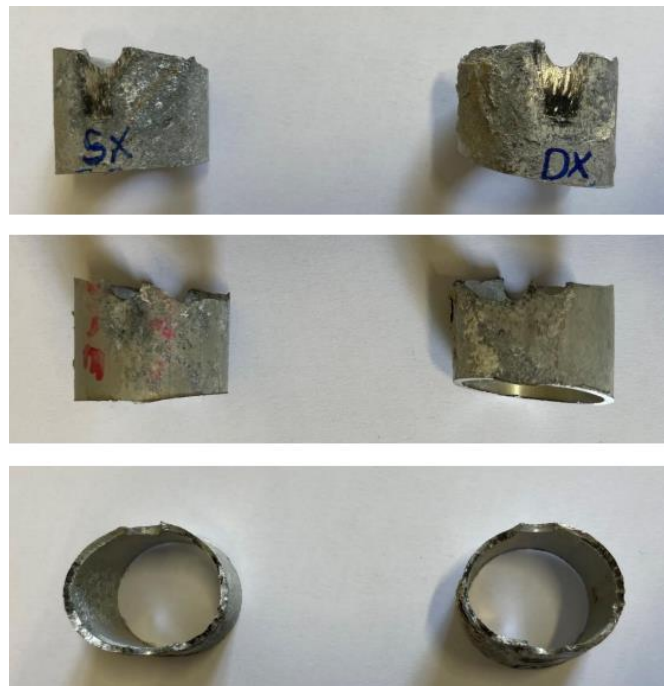
Photos 19, 20, 21: internal rib component. Sectioned fracture surfaces.

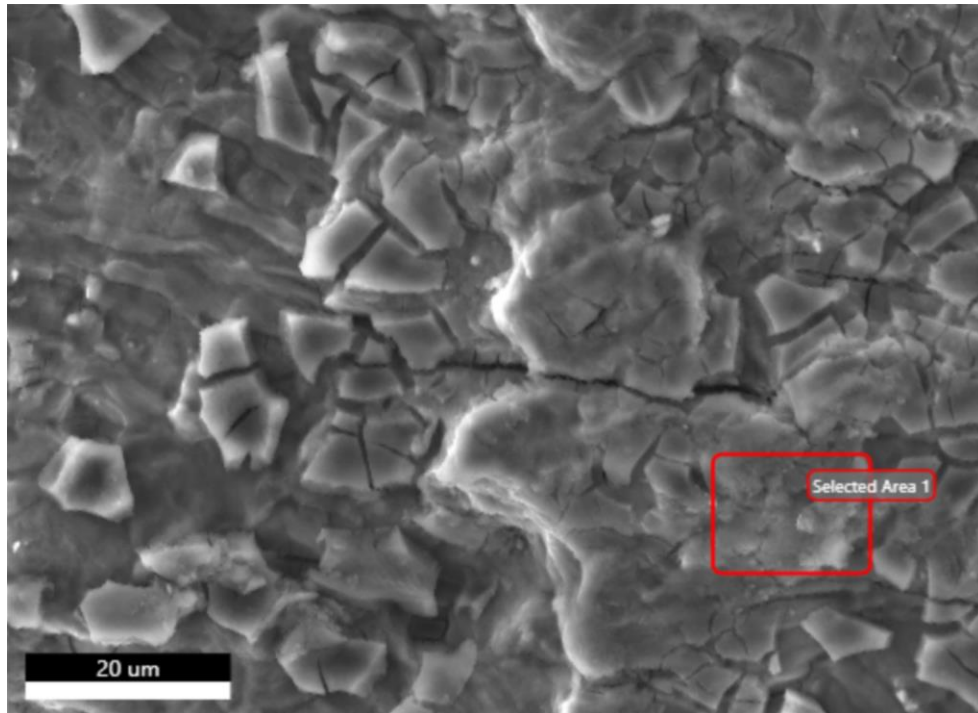
The metallurgical analysis made it possible to establish that the failure of the right wing is to be associated with the presence of extensive corrosion, in some cases through the thickness corrosion, localised on the aluminium tube constituting the lower rib. This leads to believe that the structural failure originated in the rib itself, initially due to the fracture of the aluminium tube on the right side; the latter, in fact, was more affected by environmental attack, although the left side was also conspicuously corroded. The failure of the tube on the right side realistically induced anomalous stresses to the remaining part of the structure of the right wing, until it detached. The presence of salts in the areas characterised by corrosion of the tubular failure surfaces suggests that the phenomenon of progressive deterioration can be associated with the presence and stationing of salt water in the vicinity of the places where the corrosion developed.

Photo 22: internal rib fracture surface right-hand upright.

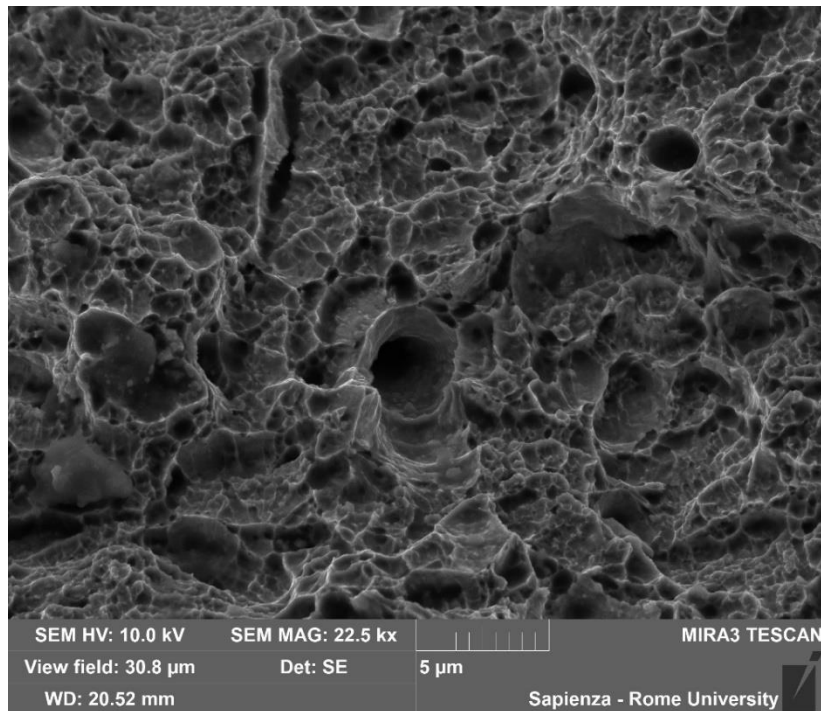
Micrographs show the presence of dimples (photo 23) on the entire surface analysed, highlighting the ductile nature of the fracture attributable to an overload fracture.

Photo 23: *T*-shape connection fracture surface, dimples.

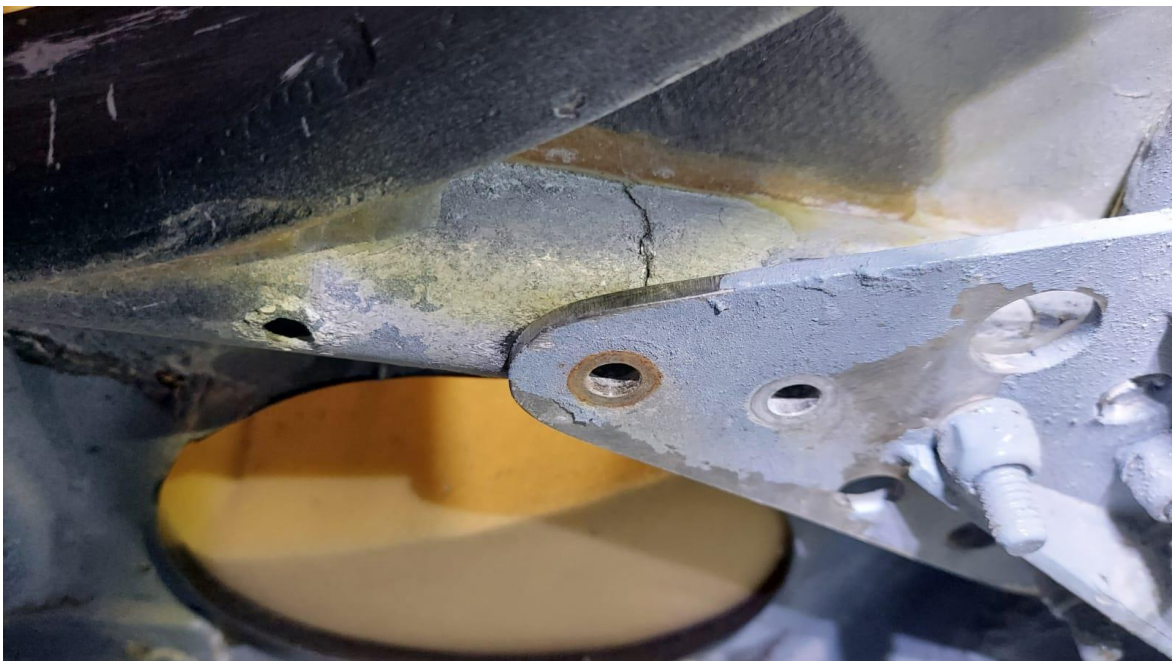
It should also be noted that on at least two Seamax M-22 in Italy, during extraordinary inspections after the accident carried out by the owners, cracks with fracture of the aluminium tubular were found at one of the holes in which the screw that locks the wing strut joint plate to the tubular itself passes.

Photo 24: fracture of the aluminium tubular of the rib at the bolt securing the wing strut fixing plates, found on an Italian Seamax M-22 aircraft after the accident at I-7608.

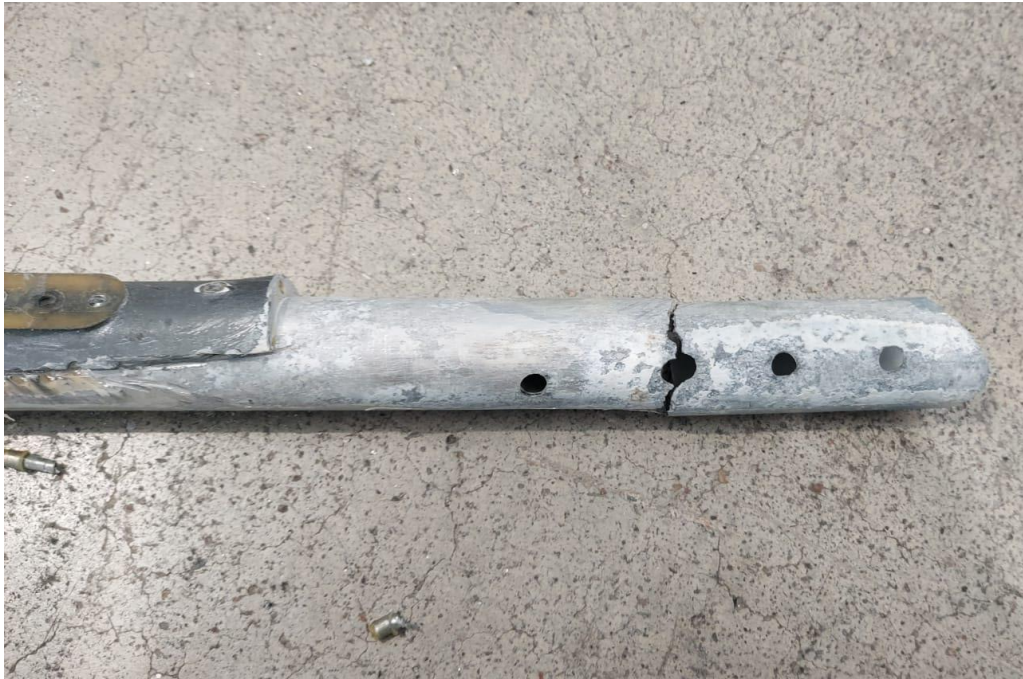
Photo 25: fracture of the aluminium tubular rib at the bolt securing the wing strut fixing plates, found on an Italian Seamax M-22 aircraft after the accident at I-7608.

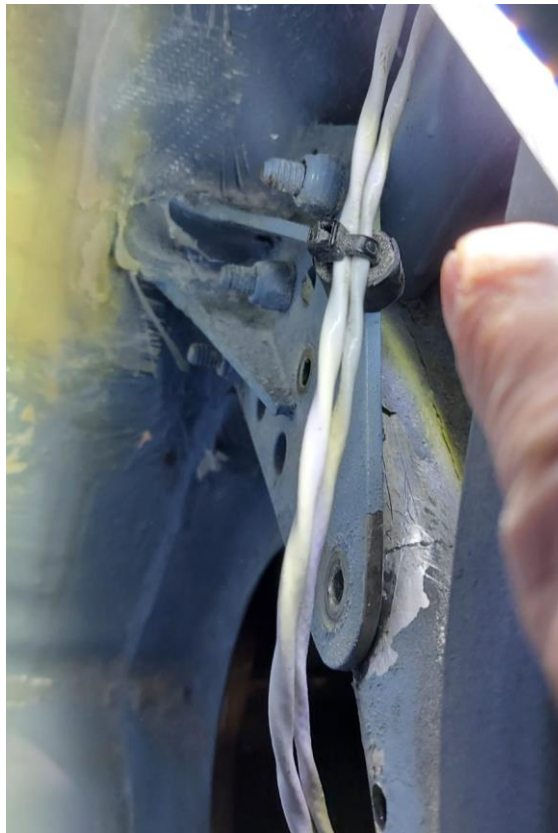
Photo 26: fracture of the aluminium tubular rib at the bolt securing the wing strut fixing plates, found on an Italian Seamax M-22 aircraft after the accident at I-7608.
