FINAL REPORT

ACCIDENT

**Boeing B777-300ER, registration marks PT-MUG,
Milan Malpensa “Silvio Berlusconi” Airport,
9th of July 2024**

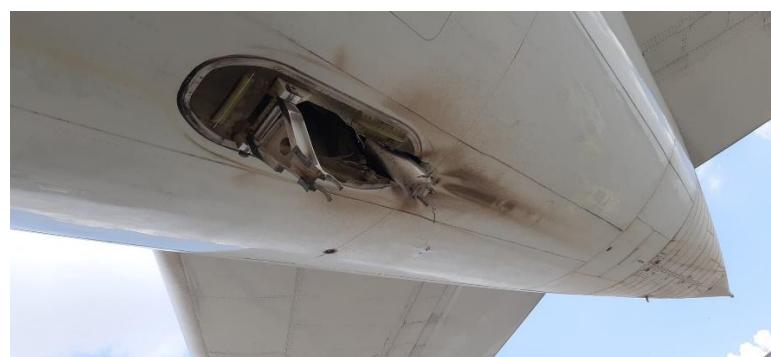
The aircraft sustained numerous damages, the most visible of which are those to the tail skid assembly (Photo 1 and Photo 2), a drain mast (Photo 3), and the tail strike sensor (tail strike warning sensor, Photo 4).

Photo 1: detail of the tail skid assembly.

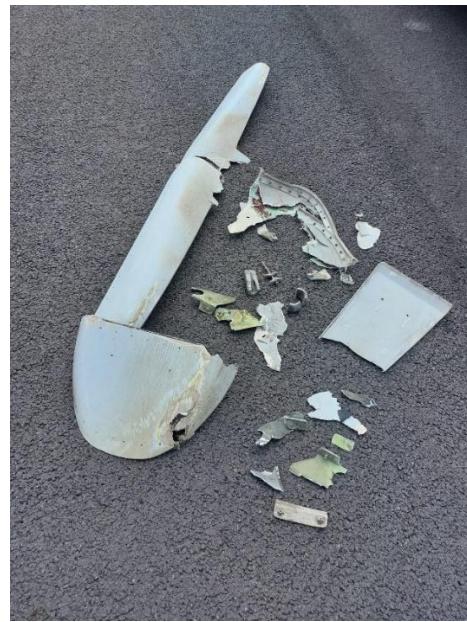
Photo 2: parts of the tail skid assembly found on the runway.

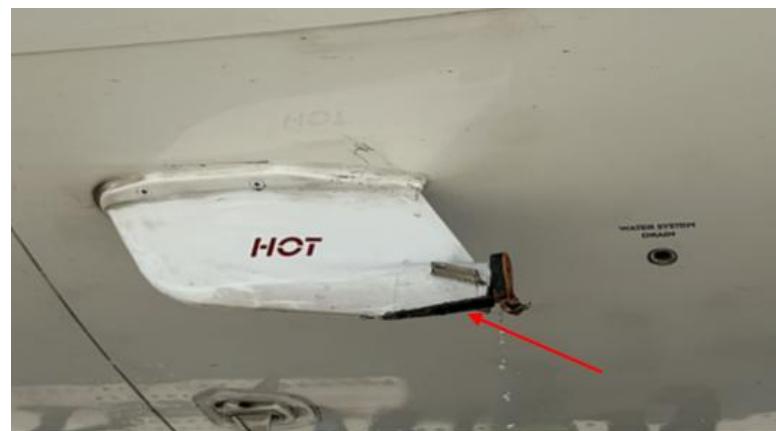
Photo 3: drain mast, indicated by the arrow, detail of the damage.

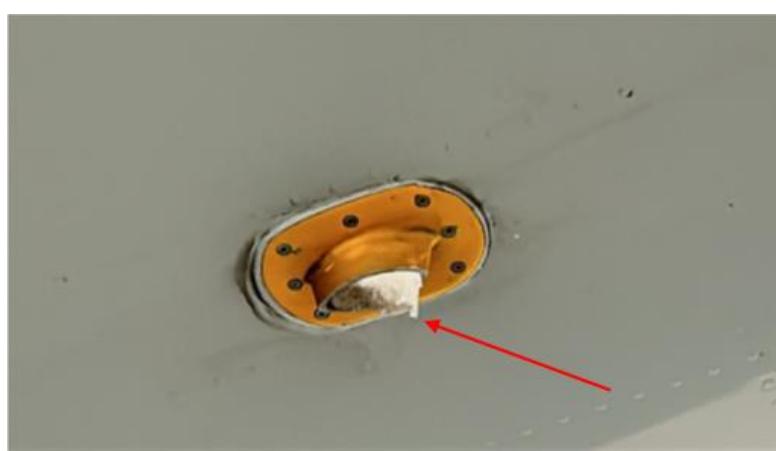
Photo 4: tail strike sensor, indicated by the arrow, detail of the damage.

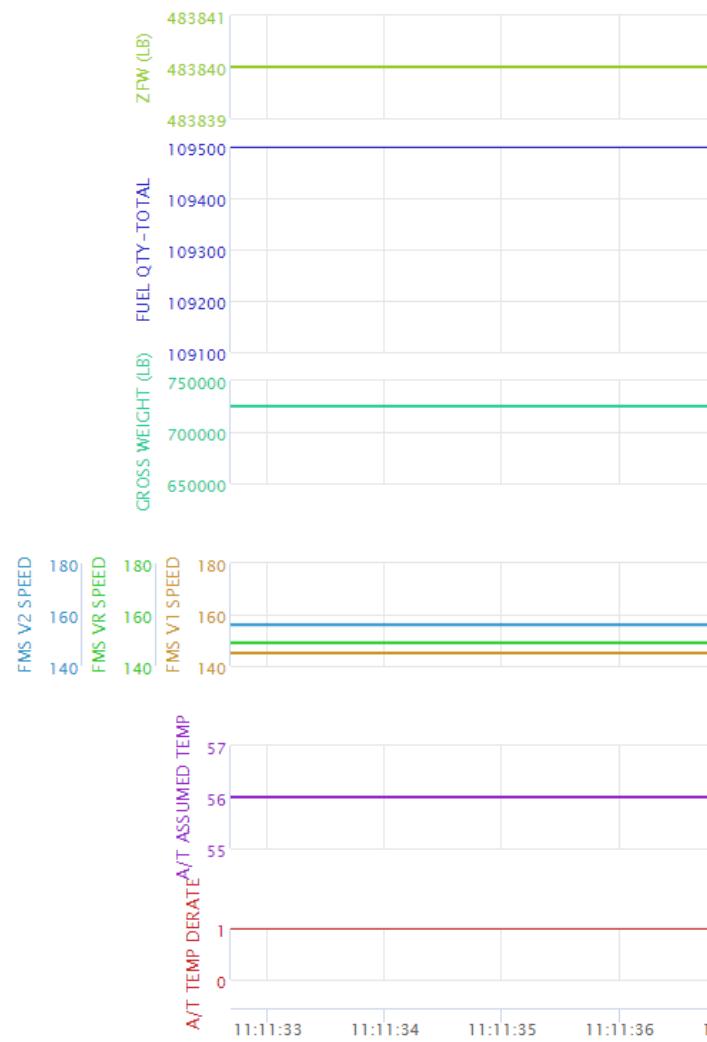
Figure 21: data entered or recorded on the FMC recorded by the FDR, including the ZFW (on the FDR in pounds) corresponding to the actual value and V1 145 kt, VR 149 kt, V2 156 kt, Assumed Temp 56°C, Flaps 5°.

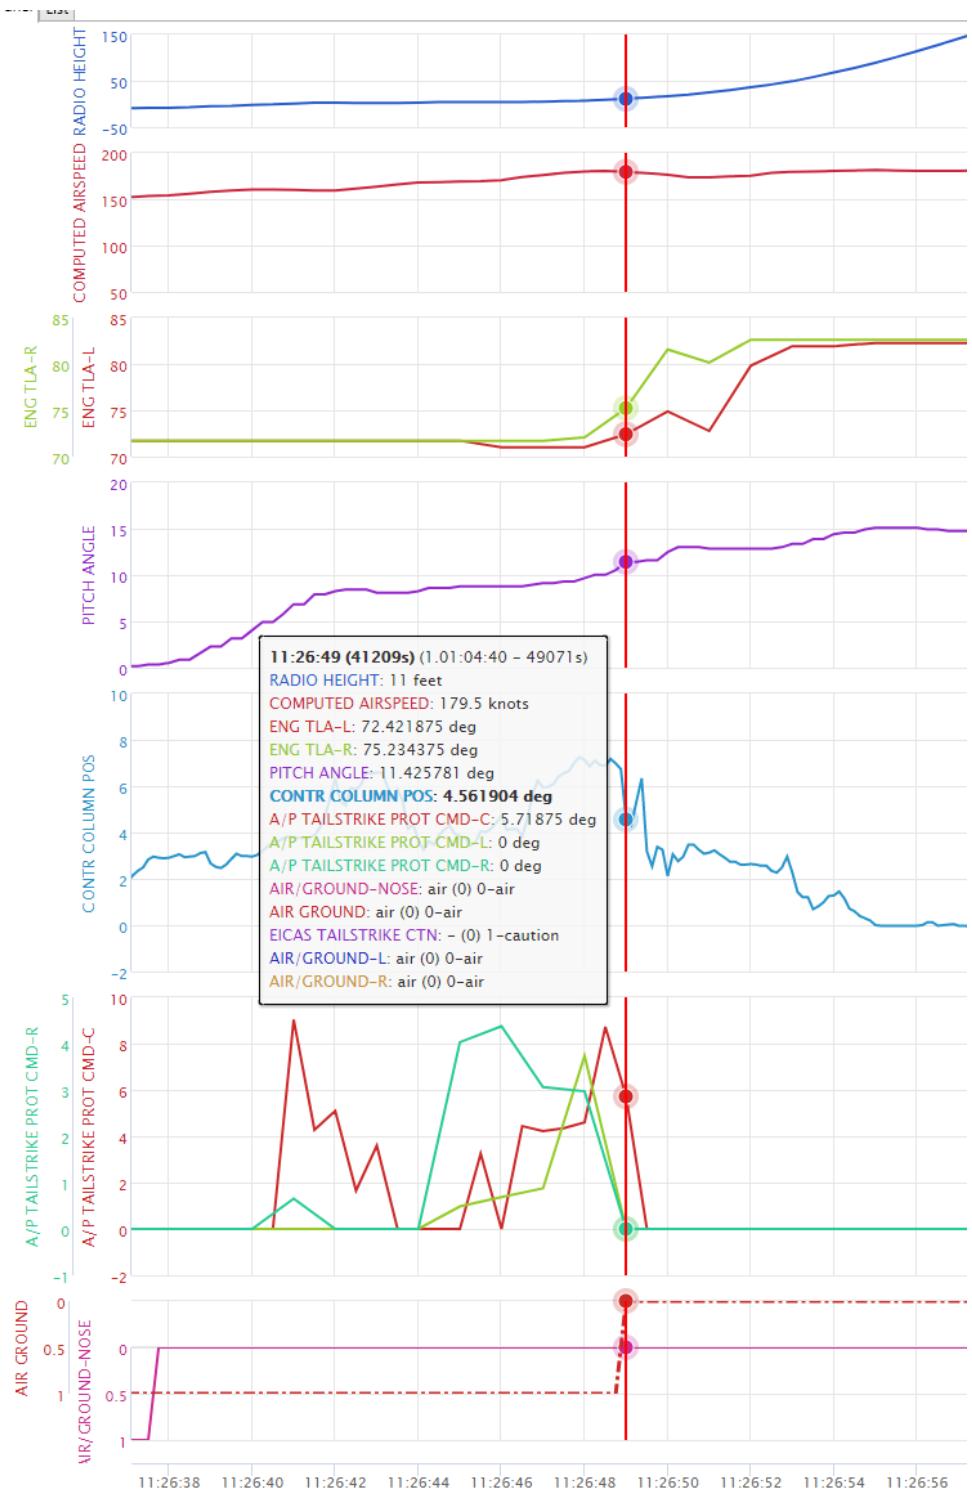
Figure 24: time 11.26'49" aircraft inflight. The pitch angle is 11.4°. Activation of the tail strike protection command channels from 11:26:40 to 11:26:49.

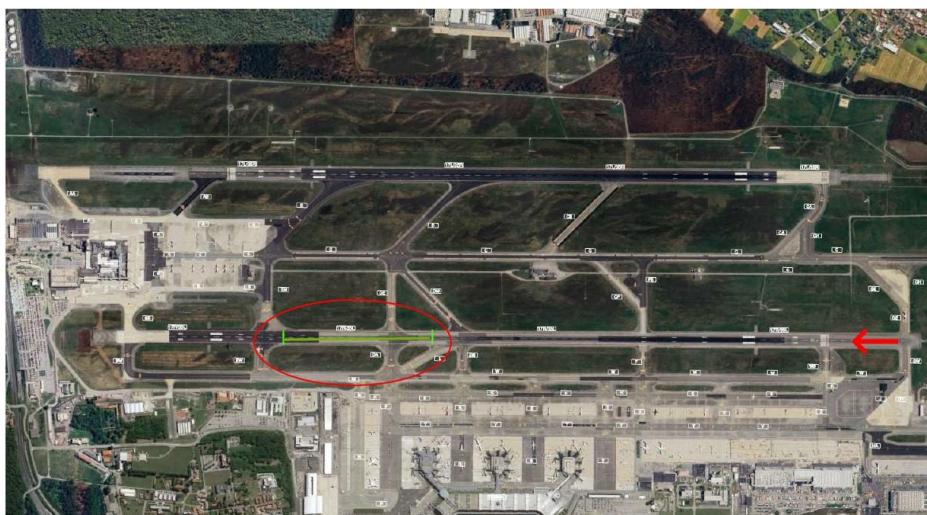
The tail strike occurred during take-off from Malpensa for RWY35L (Figure 28).

Figure 28: the red circle highlights the area of the scars on the ground. The red arrow indicates the direction of take-off.

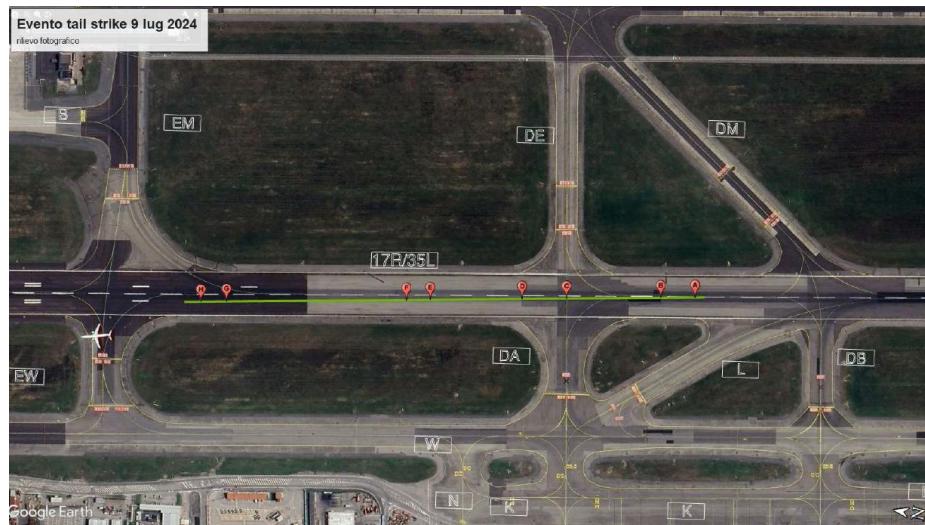
On RWY35L, a ground mark (groove with varying depths of up to 6 cm) was found, measuring 723 linear meters, originating between intersections DM and DE and 2 meters to the left of the centerline, and ending at a point just before intersection EM, 8.5 meters to the left of the centerline (Figure 29).

Figure 29: the green line indicates the ground scar between intersections DM and EM on RWY35L.

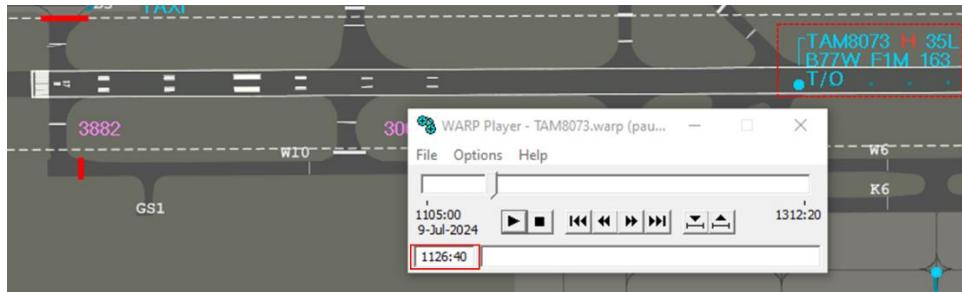
Figure 31: screen shot of the SMR referring to the time 11:26:40: start of tail strike.

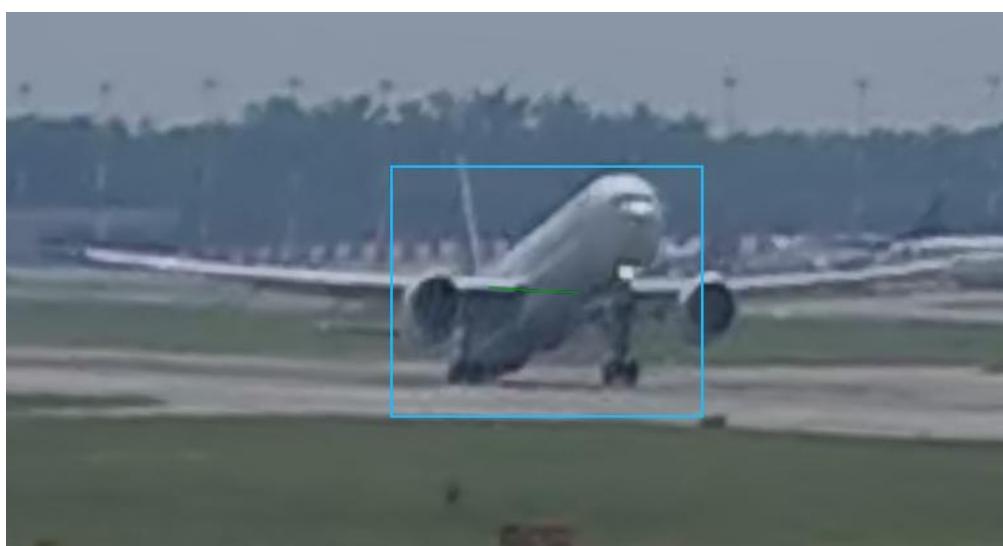
Photo 6: 11.26'42" start of contact between the tail of the aircraft and the runway.

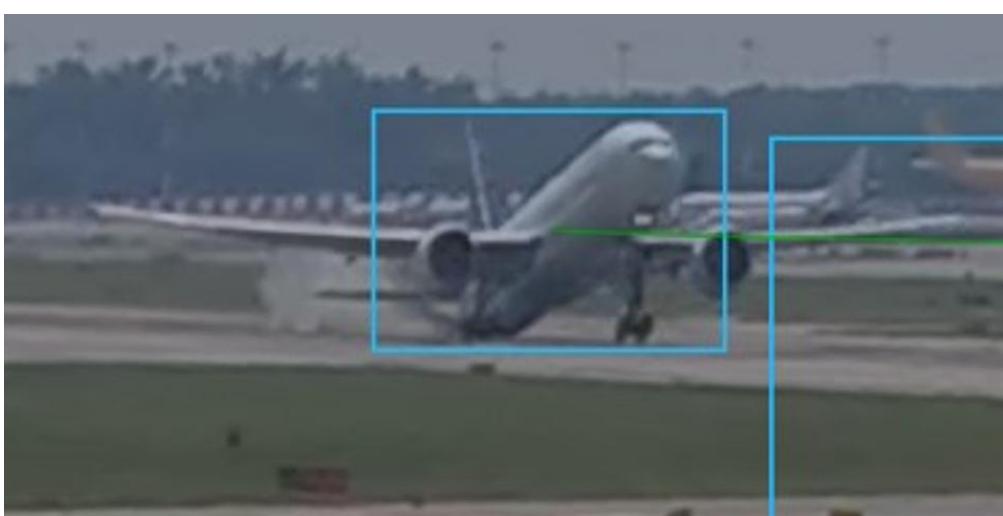
Photo 7: 11.26'43" smoke is clearly visible following the rear end skidding on the runway.

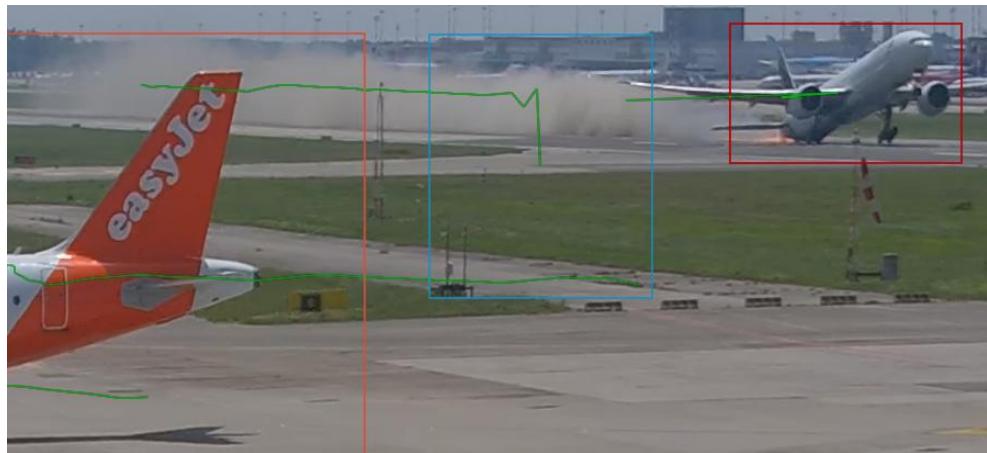
Photo 8: 11.26'49" main landing gear detached, tail skid still in contact with runway.

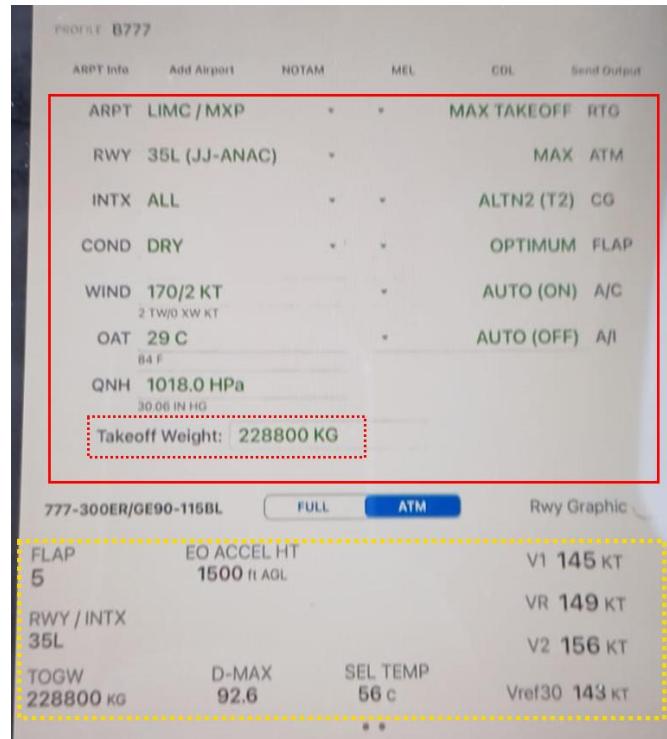
The screenshot clearly shows that the take-off weight entered was approximately 100000 kg less than the TOW reported on the final loadsheet.

Photo 10: OPT/iPad screen. The red box shows the data and selections made by the pilots. The dotted red box shows the Take-off Weight entered, equal to 228,800 kg. The yellow box shows the data resulting from the OTP calculation.

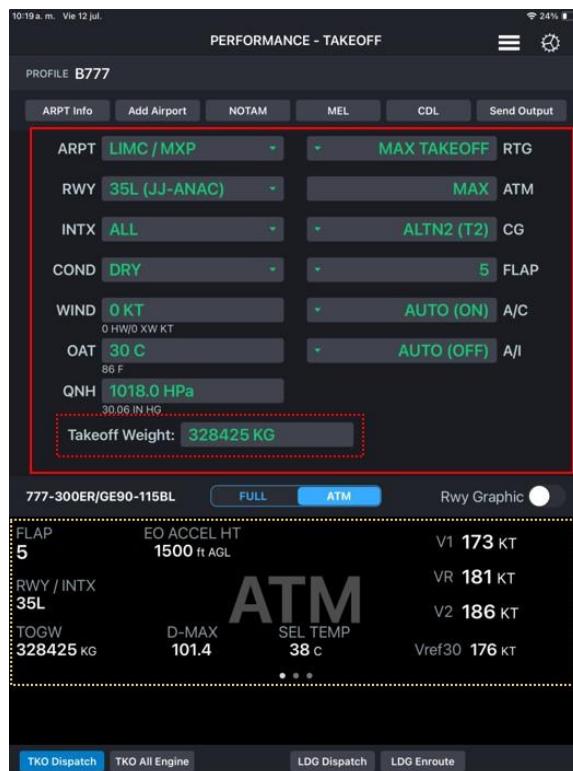
The calculations made after the event using the take-off weight from the final loadsheet resulted in the data shown in Photo 11. The difference between the calculated and entered take-off parameters and the parameters predicted for the actual TOGW is summarized in the comparative table (Table 1).

Photo 11: calculations performed after the event using the Take-off Weight from the final loadsheet (in the red dotted rectangle), entering the flap configuration at 5° for comparison with the speeds entered in the event flight.
