ANSV AGENZIA NAZIONALE PER LA SICUREZZA DEL VOLO

Study on occurrences involving passengers falling from the airstairs of the Boeing B737 aircraft

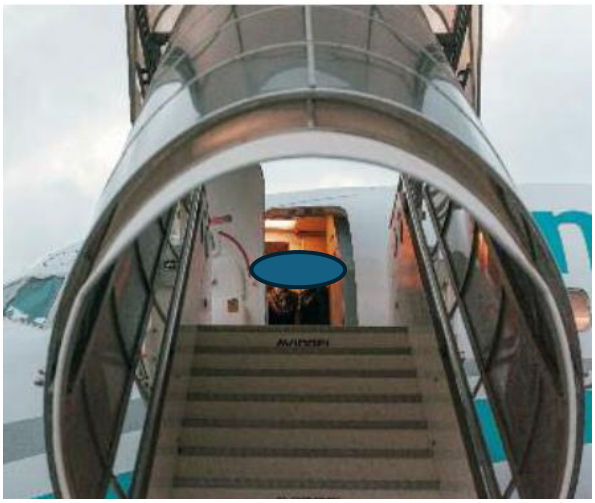
Photo 2: example of a passenger boarding staircase used by airport operators.
