Our ref. ANSV 1147/19

Subject: serious incident occurred on the 10th of August 2019, at Rome Fiumicino airport (Italy), to B787-8 registration marks LN-LND. ANSV safety recommendations.

1. Foreword.

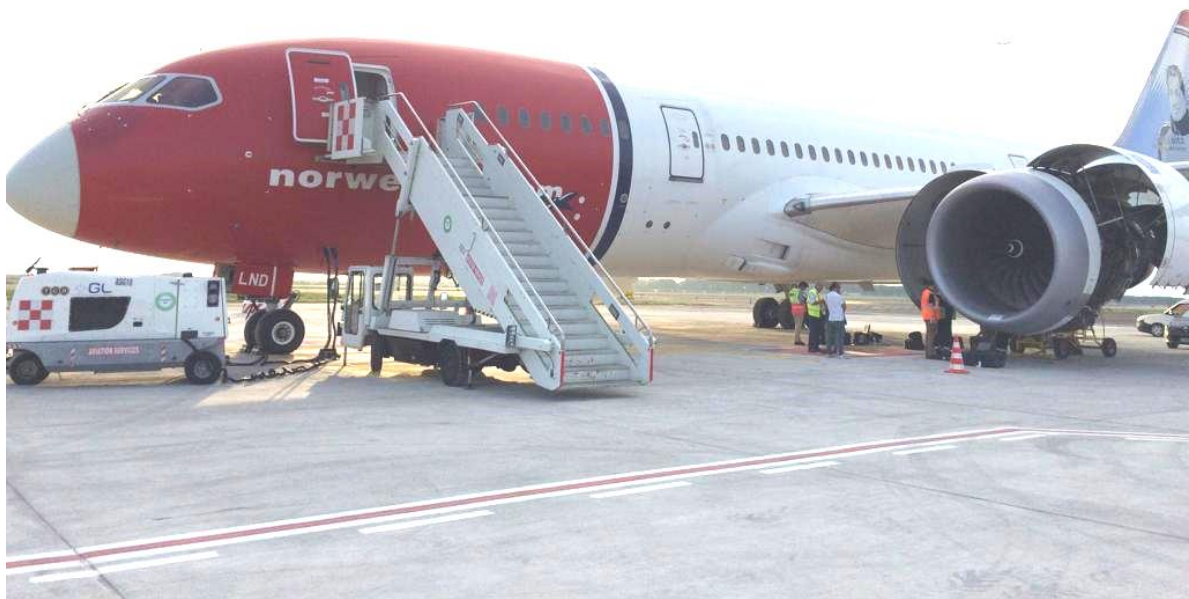
Picture 1: Fiumicino airport, B787-8 LN-LND.

On the 10th of August 2019 the B787-8 registration marks LN-LND (picture 1), flight DY7115, planned FCO-LAX, took off from runway 16R at 14.45.35 UTC.

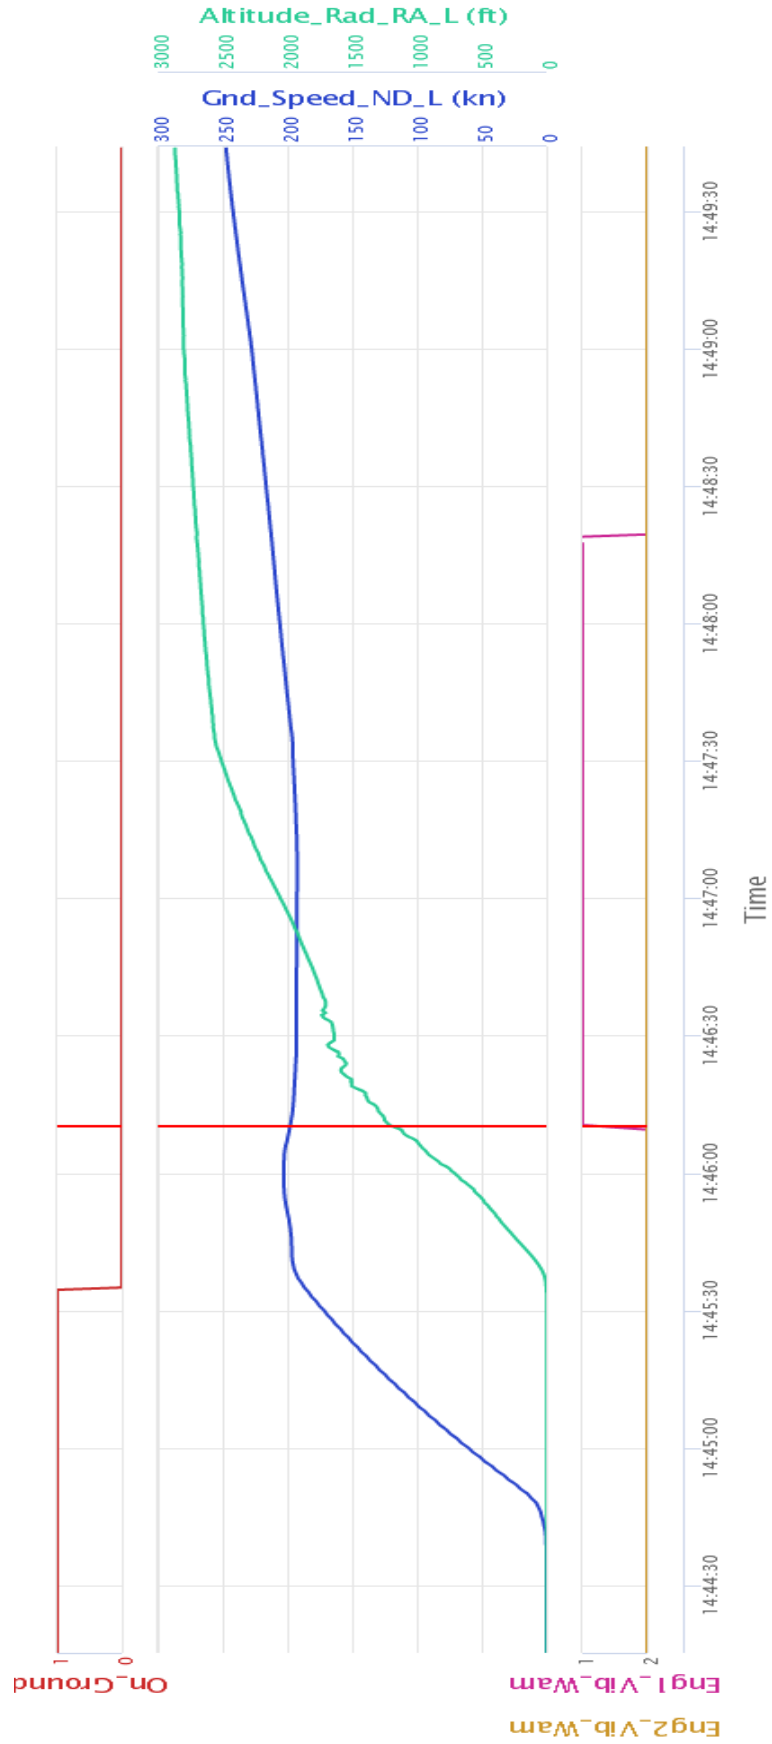
Figure 1: selection of EAFR data, red line 14.46.11 UTC.

At 14.46.11 UTC, after 36" being airborne, at a height of about 1200 ft and 200 kts groundspeed (figure 1), over the city of Fiumicino, the flight data recorder provided information the "Eng1_Vib_Warn" (left engine vibration warning) discrete parameter activated, followed shortly by several other fault messages. These are in line with the crew declaration about receiving "EEC MODE L", "LOSS OF TPR L", "ENG L EGT RED" (UTC 14.46.14), "ENG LIMIT EXCEED L" (UTC 14.46.16) and "OVERHEAT ENG L" (UTC 14.46.20) messages. The crew commanded the In-Flight Shut Down (IFSD) of the left engine and elected to turn back to departure airport (ground track in figure 2). An overweight one engine inoperative (OEI) landing took place at 15.10.10 UTC.

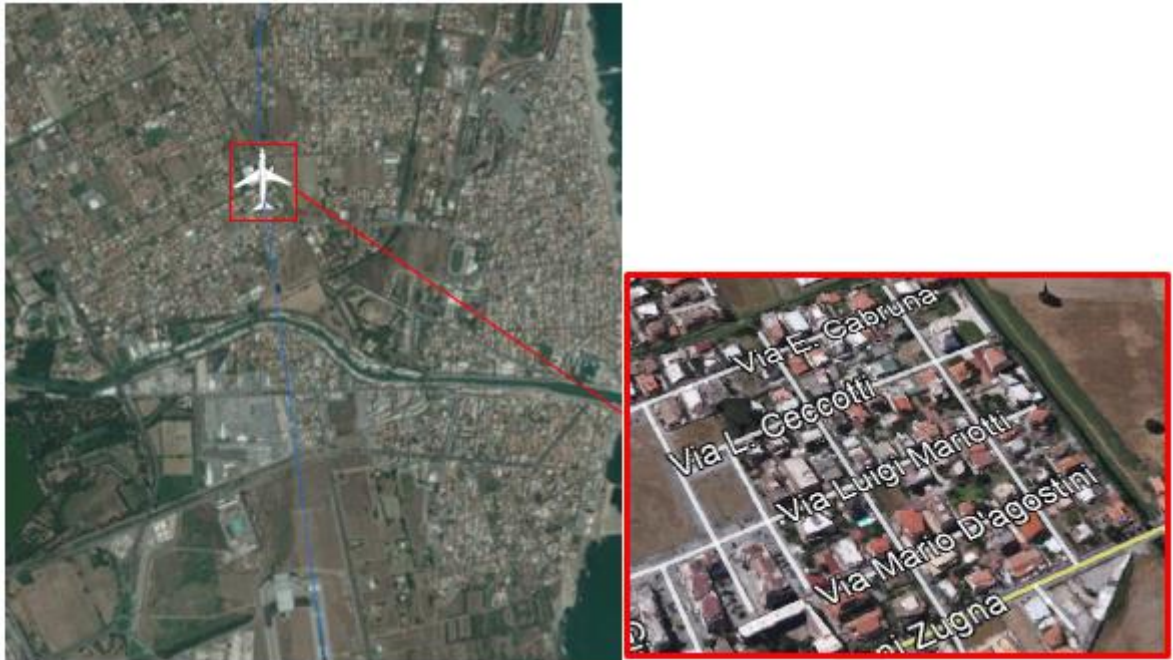
About 4 kg of debris (mainly fragments of turbine blades, picture 2) coming from the left engine were recovered from the streets of Fiumicino (the city nearby the airport, detail in the red rectangle in figure 3), along the direction of the runway, where several damages to buildings and cars were reported by the population. No debris were found within the airport area.

Figure 3: position of the aircraft at the activation of the FDR discrete parameter “Eng1_Vib_Warn”; details of the streets around that area, where debris from the left engine were collected.

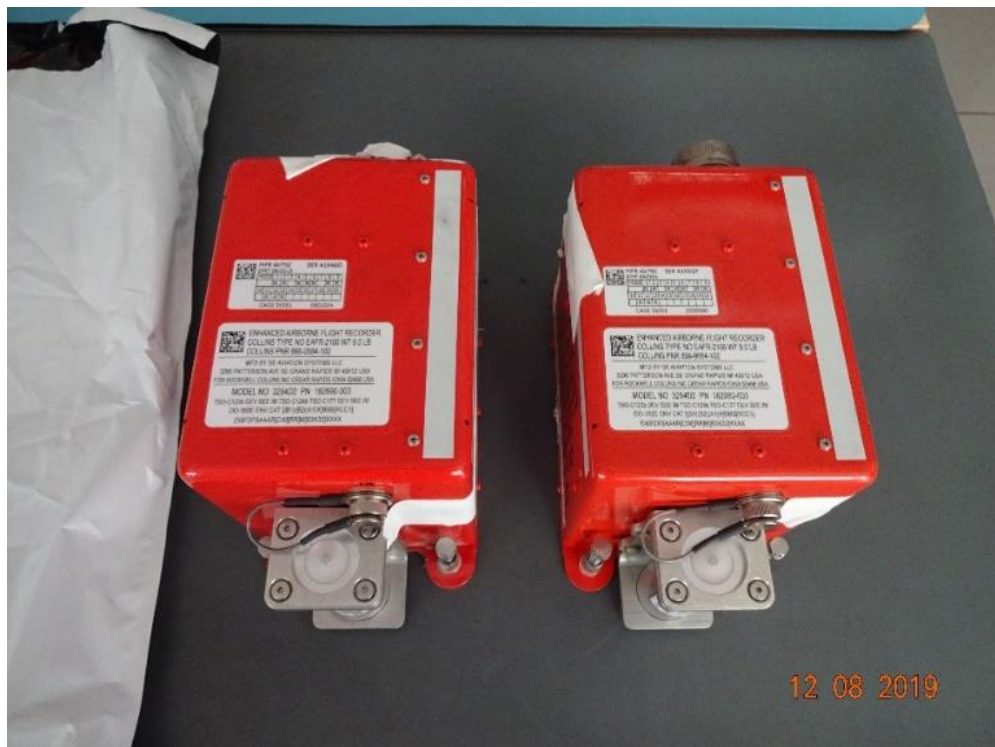
Picture 11: EAFRs from the B787-8 marks LN-LND.

Following the event, data were downloaded on site from the Engine Monitoring Unit (EMU) and from the Continuous Parameter Log (CPL). The Enhanced Airborne Flight Recorders (EAFR, picture 11) were downloaded at the ANSV laboratories.

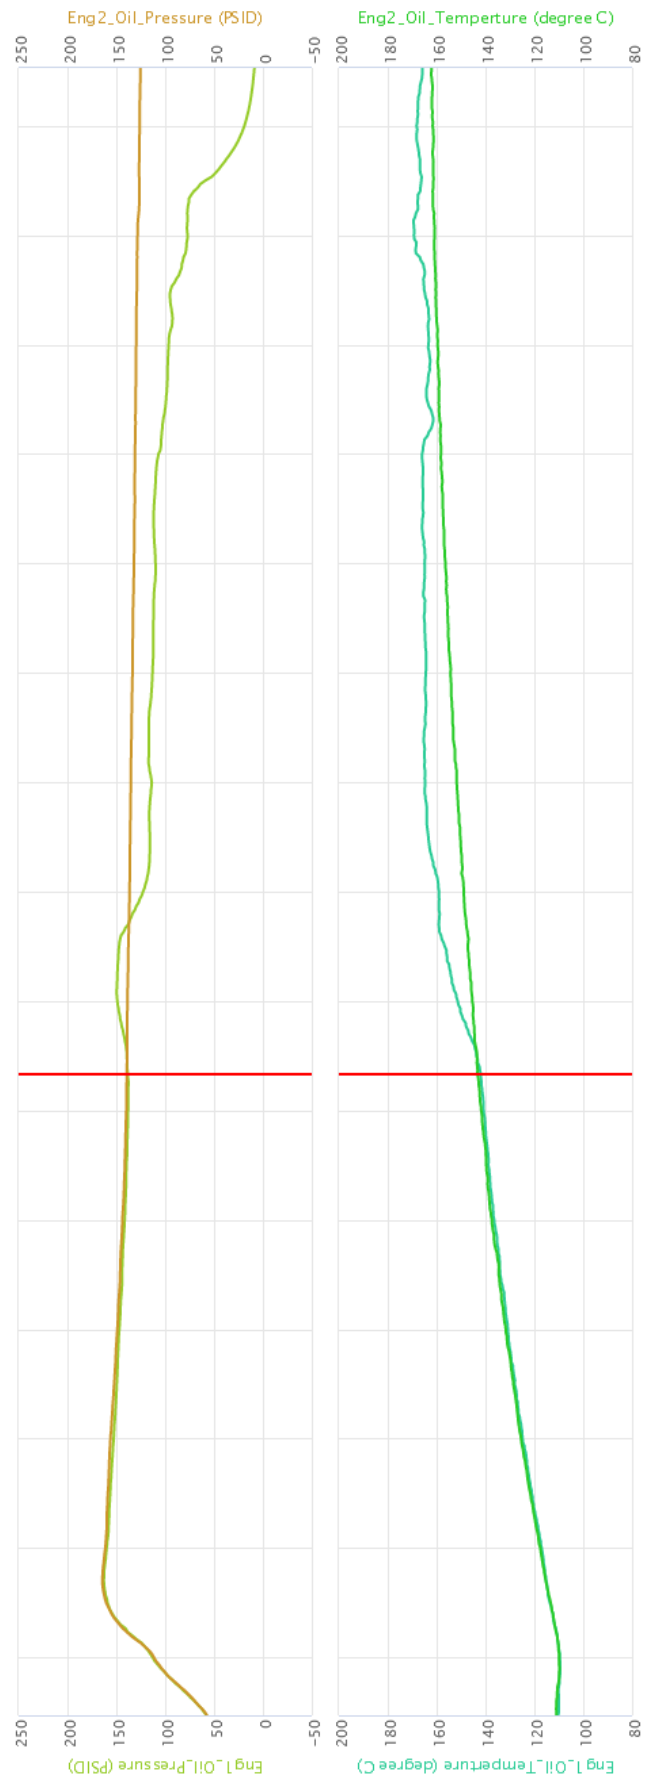
The preliminary analysis of the EAFR data shows that at 14.46.05 UTC (about 6 s before the “Eng1_Vib_Warn” discrete parameter activation) an abrupt decrease of left engine N1 (from 90% to less than 60%, figure 4). At the same time, left engine N2 and N3, oil temperature and pressure slightly increased (figure 5). From the point onward the overall vibration level of the left engine increased (figure 6/7). The left engine IFSD was commanded by the crew at 14.48.06 UTC. The engine manufacturer reviewed the EMU (5 Hz sampling rate) data, confirming the above evidence as well as highlighting, in addition, that the behavior of the engine was compatible with an Intermediate Pressure Turbine (IPT) blade damage. In more detail, the EMU data shows that the drop in N1 happened after IP tracked order vibration increased (as a result of the IPT blade release). Therefore, the most likely sequence of events is (figure 8):

Figure 5: selection of EAFR data, red line 14.46.05 UTC, comparison of ENG1 (left) and ENG2 (right).

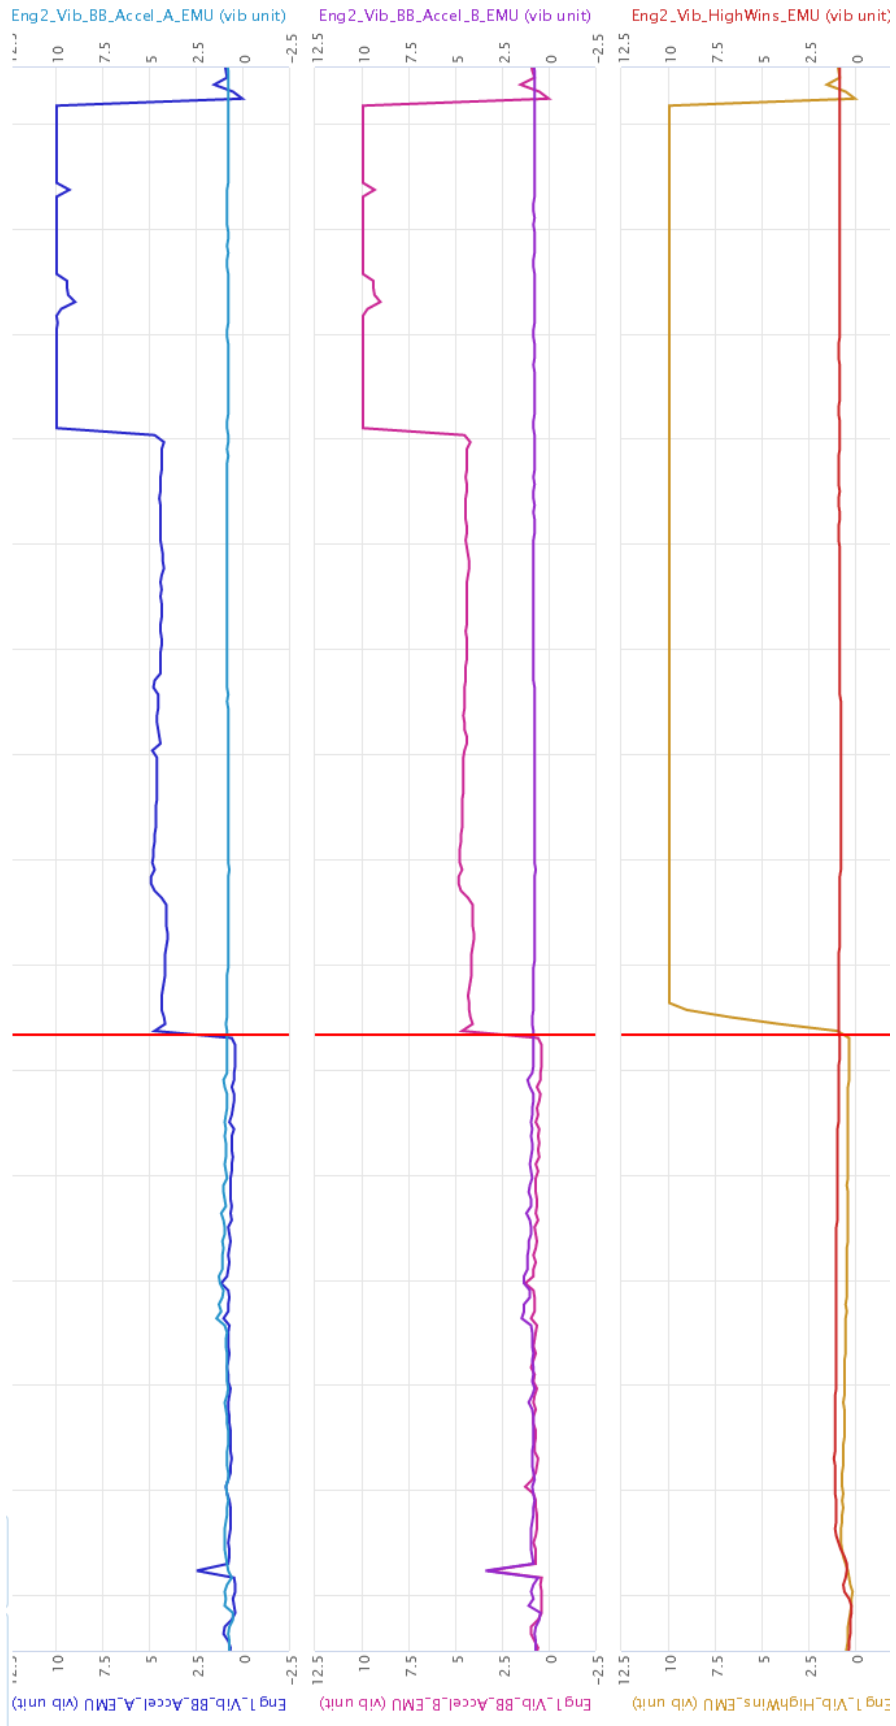
Figure 6: selection of EAFR data, red line 14.46.05 UTC, comparison of ENG1 (left) and ENG2 (right).

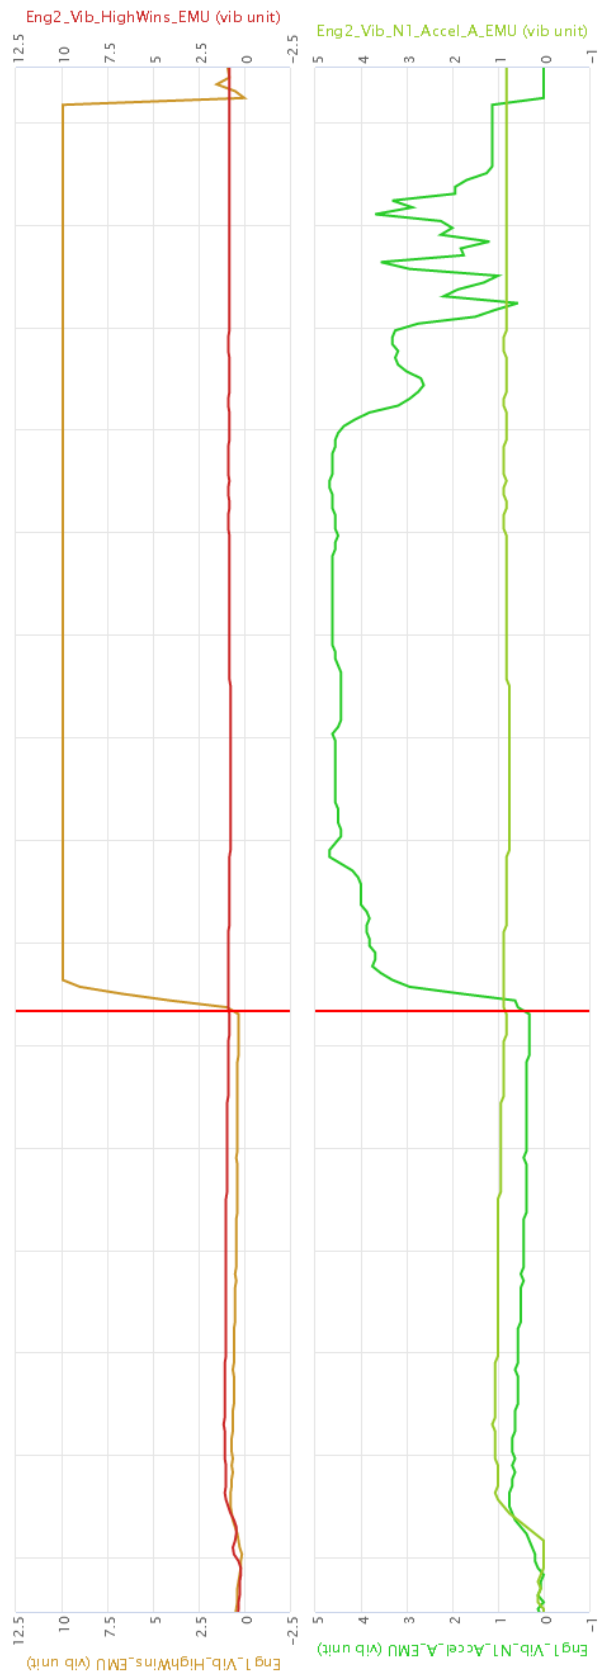
Figure 7: selection of EAFR data, red line 14.46.05 UTC, comparison of ENG1 (left) and ENG2 (right).

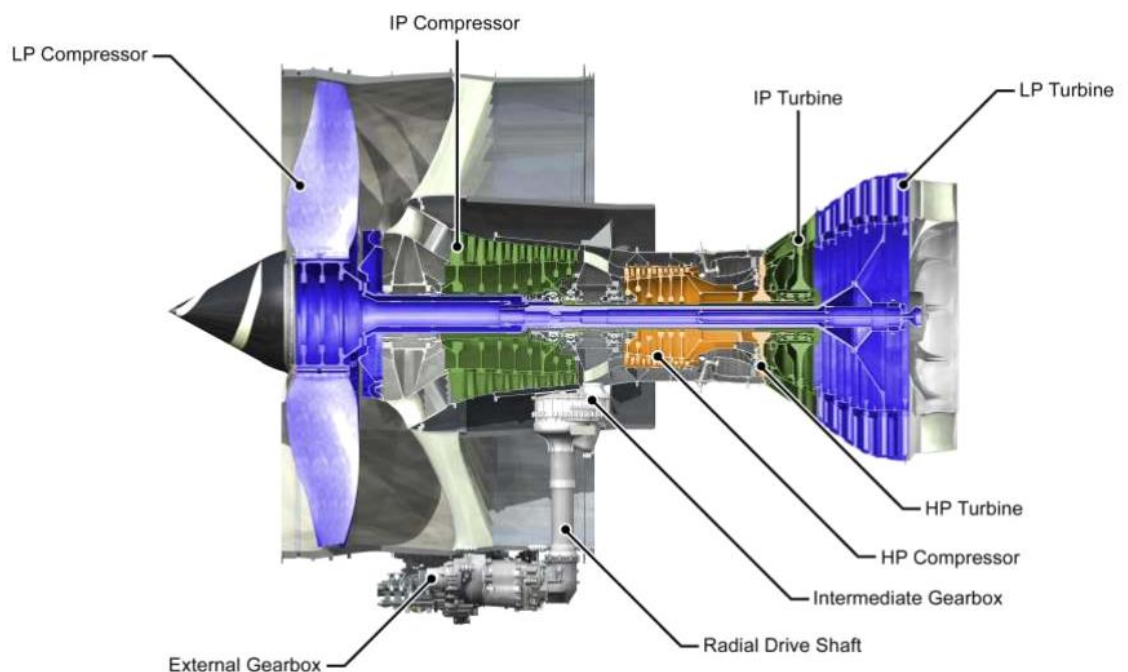
Figure 9: TREN 1000, schematic view (source Rolls-Royce).

Borescope inspection of the left engine revealed as main evidence the failure of two adjacent blades (picture 12 left) in the IPT stage (figure 9) and consequent damages in the following stages, confirming the preliminary data analysis. The fracture surface of one of the two IPT blades fractured appears to be a progressive failure (picture 12 right). The trailing blade, also fractured, appears to be an overload failure.
