DICHIARAZIONE INTERMEDIA

INCIDENTE
occorso all'aeromobile
Fokker F27 MK050 marche SE-LEZ,
aeroporto di Catania Fontanarossa,
30 aprile 2016

Technical Event Investigation Report

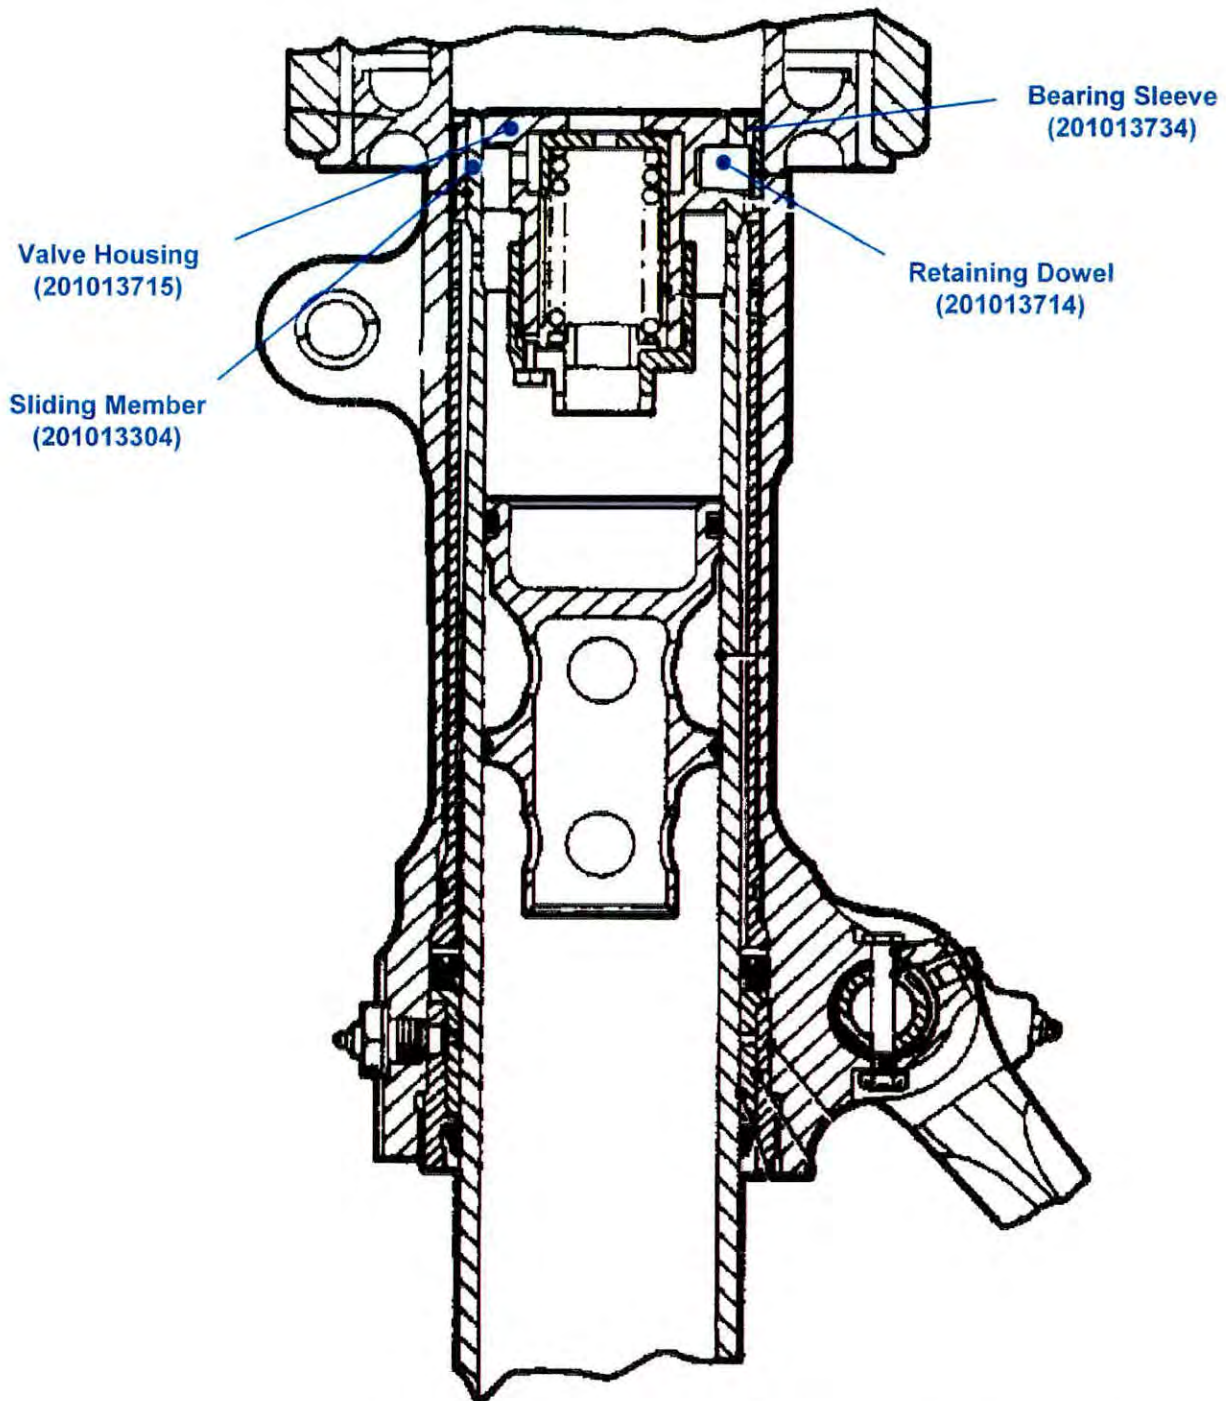
FIGURE 8: DIAGRAM SHOWING MEASURED COMPONENTS LISTED IN TABLE 1

The numbered references of the each retaining dowel and each dowel hole in the Valve Housing, Bearing Sleeve and Sliding Member refer to the same numbered positions mentioned in Appendix C. All measurements taken were in line with the Fits and Clearances section In-Service Wear Limits detailed in Ref [2].

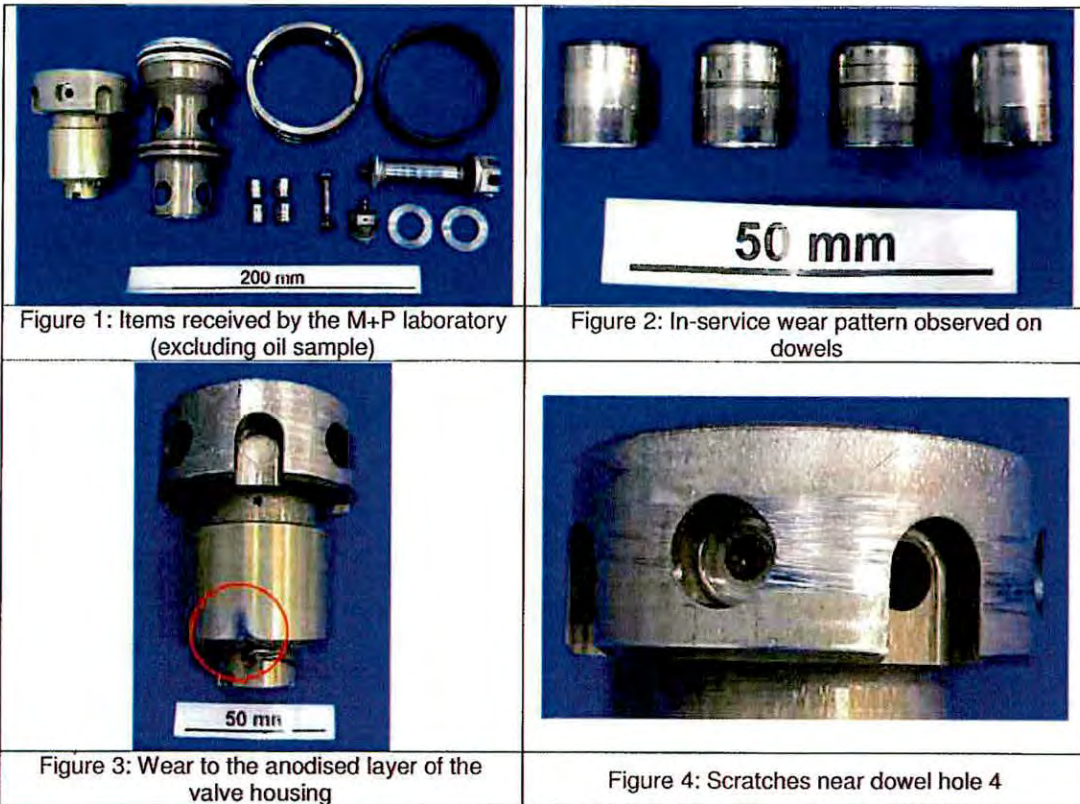
All components received for examination, excluding the oil sample and metallic debris, are shown in Figure 1. The 4 dowels supplied were in a good condition, other than the usual wear patterns created from in-service use (Figure 2). Analysis of the valve housing revealed some wear to the anodised layer on the OD (Figure 3). A number of scratches were seen near to what was labelled as dowel hole 4 (Figure 4). Circular scratches were found in the orifice slot between dowel holes 1 & 4 (Figure 5). All four orifice slots had a very similar damage pattern on the inner wall of the slot. The typical damage found, two scratches, is shown in Figure 6. Examination of the bearing sleeve showed an uneven wear pattern to the inner diameter. In the location near to dowel hole 4 (Figure 7) the wear was found to be more noticeable than near to dowel hole 2 (Figure 8). Significant play was noted between the apex bolt and nut. Disassembly of the two parts found their threaded regions to be in good condition (Figure 9). The chromium plating on the apex bolt was worn circumferentially in the location of the greasing hole. The piston was also received by the laboratory. This was in a good condition, apart from some wear marks on the inner diameter of the head (Figure 10).
