SAFETY RECOMMENDATION

Subject: serious incident occurred on September 9th 2010 to Antonov An-124-100 registration marks RA-82079 (equipped with Ivchenko Progress D18T engine series), Turin-Caselle airport (Italy).

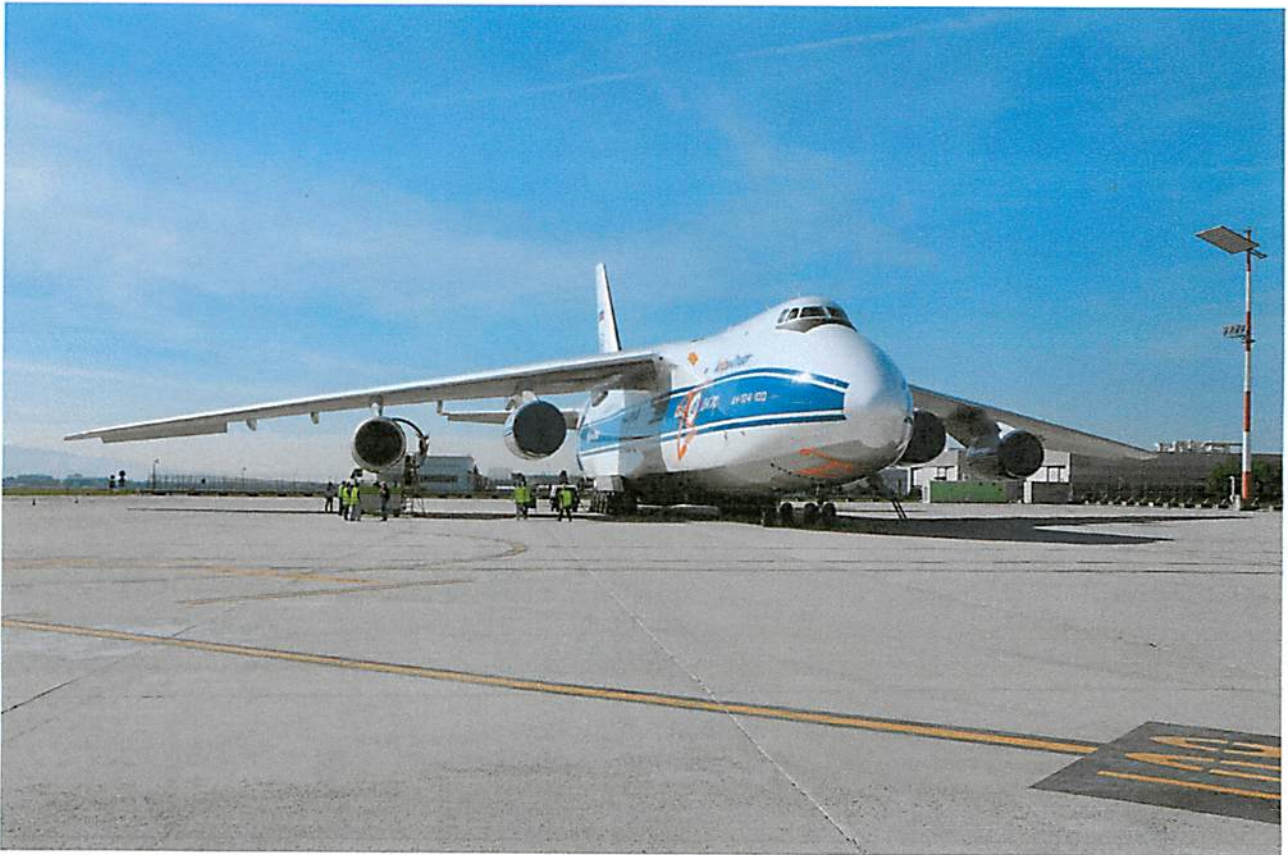
Picture 1: Antonov An-124-100 registration marks RA-82079.

On September 9th 2010, on Turin-Caselle airport (Torino, Italy), the Antonov An-124-100 (picture 1) registration marks RA-82079 was taking-off from runway 36. During the take-off run, at about 50 kts (confirmed by Flight Data Recorder analysis performed within ANSV laboratory), the crew experienced the engine #4 (outer right) failure with following uncommanded shut down and rejected the take-off. During the application of the thrust reverse, crew experienced an uncommanded shut down of the engine #1 (outer left) too.

The aircraft stopped safely on the runway and the emergency services on the airport approached the aircraft after witnesses saw flames and smoke from the exhaust of the engines affected by shutting down. No aircraft or airport damages and no injuries were reported.
