Subject: safety recommendations on the accident occurred on June 8th 2013, at Rome Fiumicino airport (Italy), to A320-200 registration marks HA-LWM.

1. Synopsis

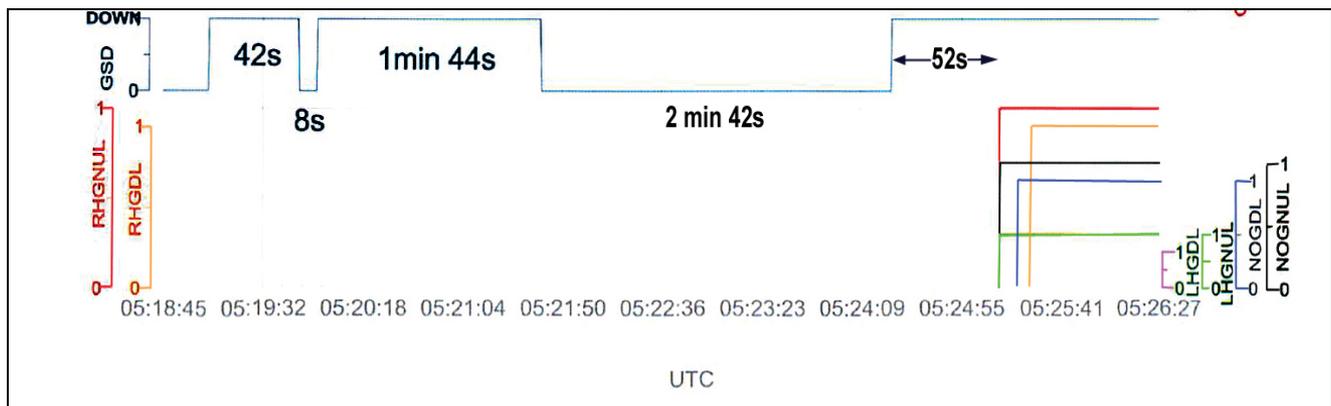
- recycle of the landing gear by moving the lever in the “UP” position for 8”, followed by repositioning it in the “DOWN” position during 1’44”;
- L/G lever moved again in the “UP” for 2’42”;
- L/G lever repositioned “DOWN”;
- 52” later, activation of gravity extension.

This sequence of actions seems in disagreement with the OEB 209/1 dated Feb 2011 and following modifications (OEB 44.00 dated 25 Nov 11 and OEB 44.01A issued on 30 May 2012) that recommends the flight crew, if ECAM triggers the “L/G GEAR NOT DOWNLOCKED” warning, to wait for 2 minutes after the recycling of the landing gear, before extending the landing gear by gravity.

In order to avoid excessive workload in stressful condition like an emergency landing due to L/G not locked, it would be advisable to require that the content of the OEB 209/1 (and its following modifications) and associated point in EASA AD 2011-0069R1 to be included in the related abnormal and emergency checklists.

In order to avoid any possible flightcrew misinterpretation about the effective meaning of the 2 minutes waiting time after recycling required to activate the L/G gravity extension, it would be advisable to review the activation procedure; in particular it is recommended to specify that the freefall mechanism must be activated after a minimum time of 2 minutes with the lever kept in the lower position, and no other shorter intermediate recycles are allowed.
