FINAL REPORT

**ACCIDENT
Occurred to the helicopter
AS350 B3 registration marks I-AMVV,
at Monte Miravidi, La Thuile (AO),
January 7th 2020**

The accident occurred on January 7th 2020, at 10:53 UTC (11:53 local time), at Monte (Mount) Miravidi, La Thuile (AO), and involved the helicopter AS350 B3, registration marks I-AMVV.

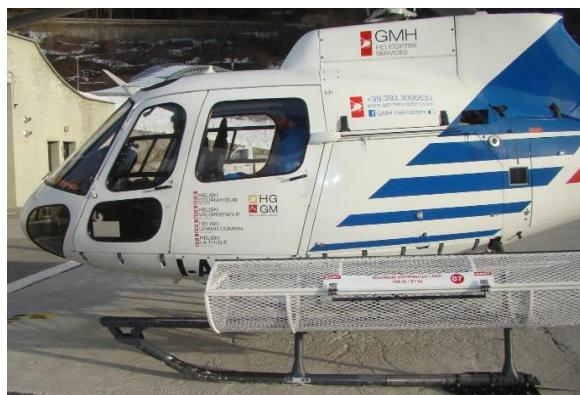
Photo 2: installation of the utility basket (source GMH).

The helicopter installs a DART D350-607-041A metal material transport container on the left skid, produced by DART Aerospace, capable of transporting material up to a weight of 200lbs/91kg.

- The utility basket installed on board is certified for use on the AS350 B3 helicopter and was correctly operated and maintained.
- There is no damage on the basket due to accidental hooking of the ski instructor/task specialist, there is a protruding hook on the basket which is part of the locking mechanism.

- No damages are present on the two protrusions of the basket closing system, as result of the engagement of the task specialist on the ground.

Motivation: the protrusions on the closing system of the utility basket D350-607-041A, manufactured by DART Aerospace, while not a cause in the I-AMVV accident, still pose a hazard to operators during operations conducted on the ground around the utility basket.

Text: ANSV recommends to request the manufacturer DART Aerospace to evaluate the possibility of modifying the closing mechanisms of its baskets, in order to remove protrusions potentially dangerous during ground operations around helicopters equipped with such products.

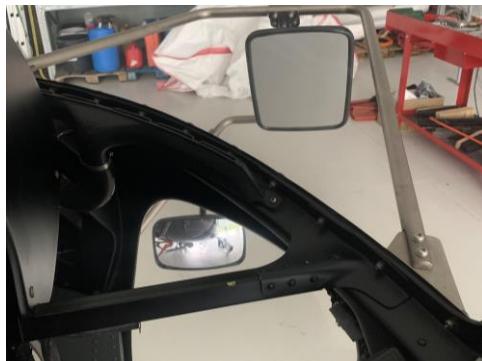
Photo 3: right and lower visibility via lateral and cargo mirrors.

The I-AMVV helicopter is equipped with cargo mirrors positioned on the right side, which provide a wide rear view to the pilot both on the low right side of the helicopter and on the space below the central fuselage, usually used in central hook operations.

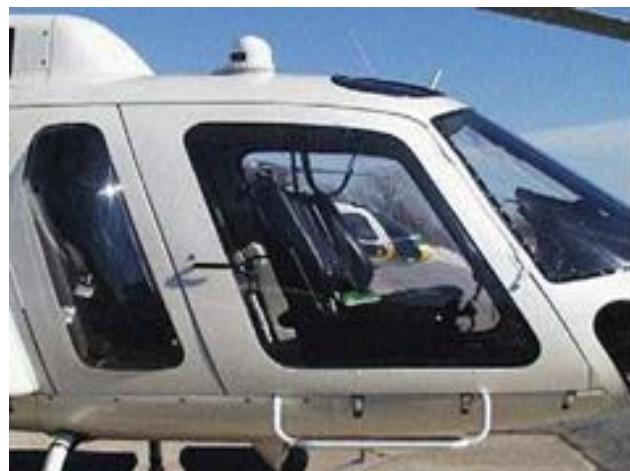
Photo 7: high visibility doors installation (source Airbus Helicopters).

For the left side, the visibility available to the pilot is instead provided by the windows on the front and rear door on the left side. Such visibility available does not allow the pilot to see the lower left side of the helicopter, on which the basket is installed.

The view of this area of the helicopter is possible partially from the left front seat, almost completely from the left rear seat. The manufacturer Airbus Helicopters supplies as optional equipment also high visibility doors, both front and rear, which allow a better visibility of the left side by the pilot, usually used for central hook operations. Such installation does not allow to have sliding rear doors on board.

Text: ANSV recommends to request the manufacturer Airbus Helicopters to evaluate the possibility of implementing retro-vision systems that would provide the pilot with the fullest and widest possible view of the left side of the AS350 helicopter, currently only partially available.

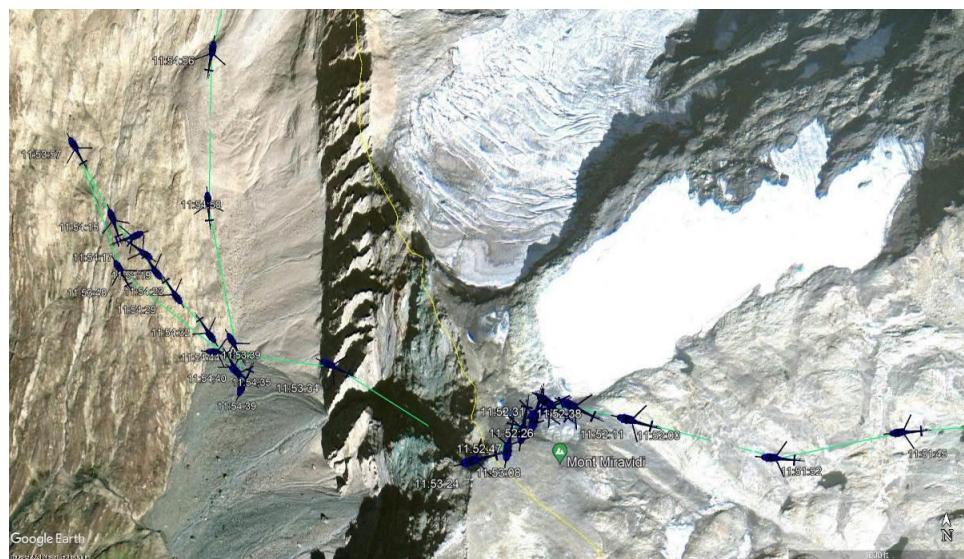
Photo 10: I-AMVV ground path related to the release of the second group of skiers, take-off and release of GMH task specialist on event site (Google Earth Pro)

The heights associated with the positions recorded in flight are not representative in some sections of the two selected routes, in the following image the helicopter positions are projected on the ground and the view is vertical.

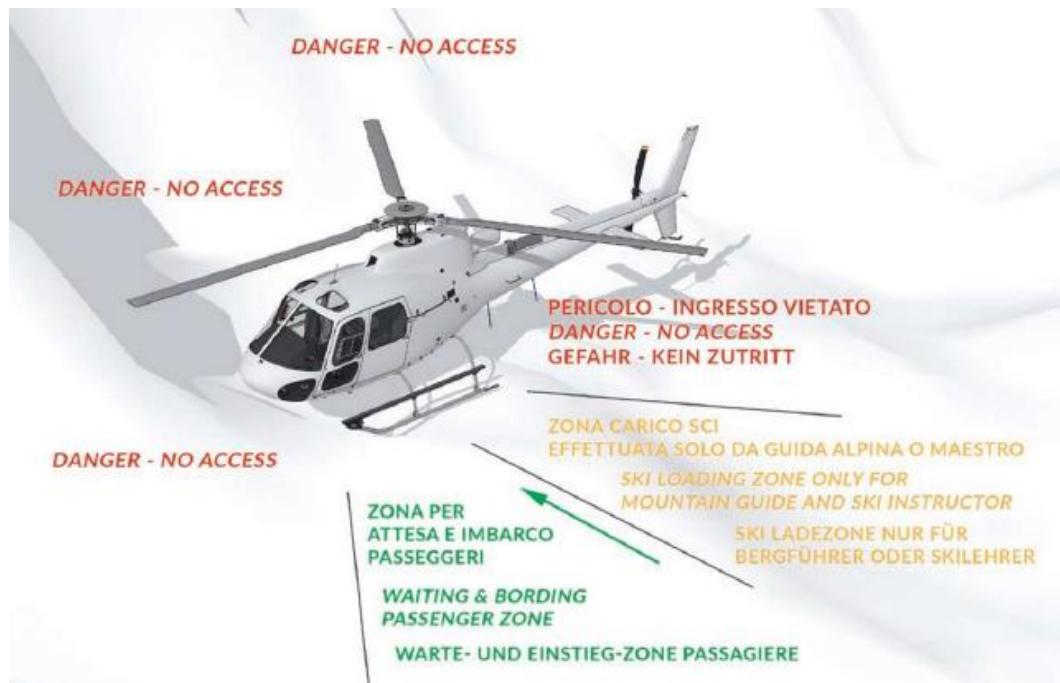
Figure 2: excerpt from the GMH *Guida di riferimento per attività di Heliski*.

The *Guida di riferimento per attività di Heliski* above further details the activities that alpine guides/ski instructors who, as task specialists, accompany customers on heliski flights are required to carry out. They are considered as ground assistants and, as such, must be trained by the operator at the beginning of the eliski season. It is made clear that once disembarkation has taken place, passengers should remain stationary and in a stooped position near the equipment disembarked. The following image, taken from the same *Guide*, clearly identifies this area and the dangerous/banned areas.

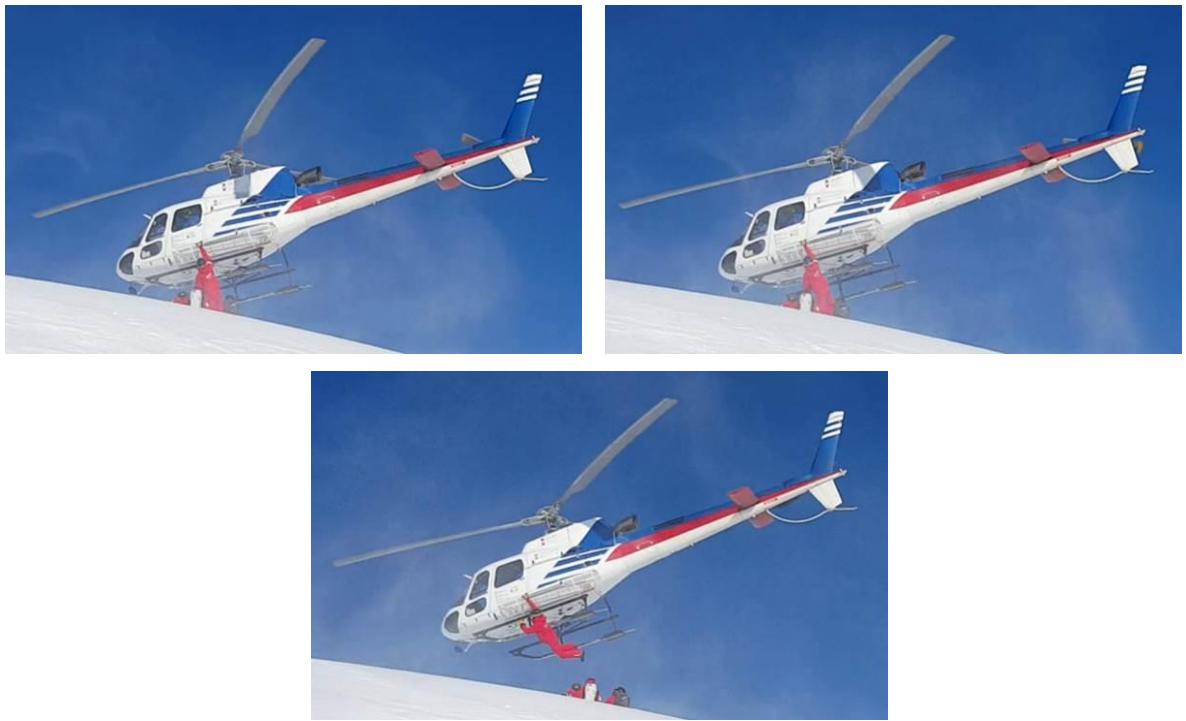
The images apparently show a continuous eye contact between the embarked task specialist and the ski instructor/task specialist on the ground during door closing operations and in the initial phase of takeoff.
