FINAL REPORT

ACCIDENT
occurred to the aircraft
Seamax M-22 identification marks I-7608,
in Buccella (Vigevano, Pavia),
14th February 2021

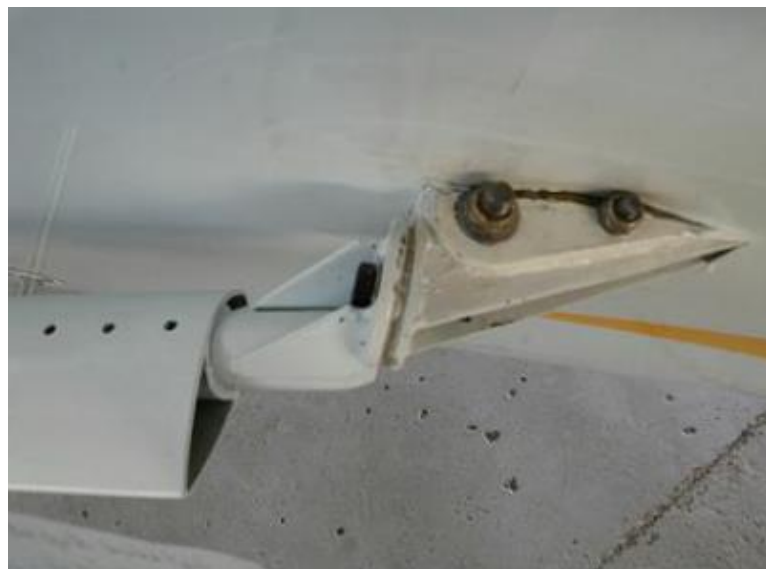
The wing strut is tied at the top to the steel fixing point on the lower part of the wing by means of a bolt (photo 2). The rod, thanks to a plastic *bushing* placed between the two metal parts, is able to rotate to allow the folding of the wing.

Photo 2: upper fixing point of the wing strut to the lower part of the wing (right wing).

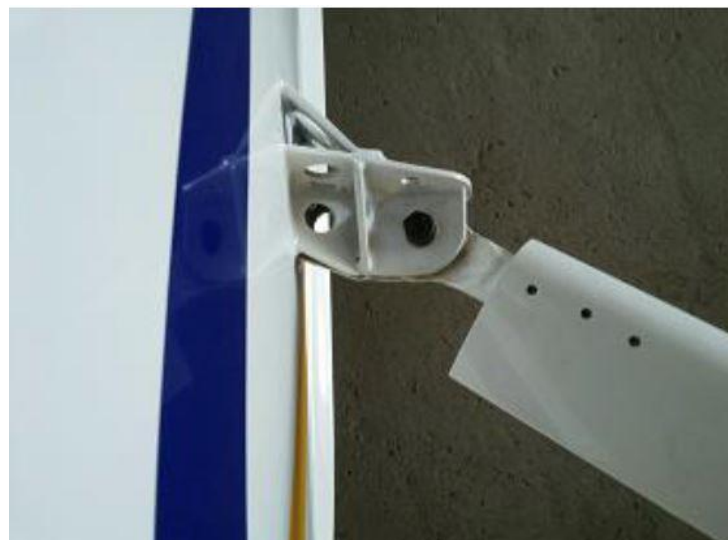
The wing strut is fixed at the bottom (photo 3) to a system of metal plates fixed on two aluminium tubulars: one running transversally behind the seats of the people on board and one running vertically on the side of the fuselage (figures 3 and 4, photos 4 and 5). On the lower fixing point, the rod is also able to rotate to allow the folding of the wing.

Photo 3: lower fixing point of the wing strut to the fuselage (right wing).

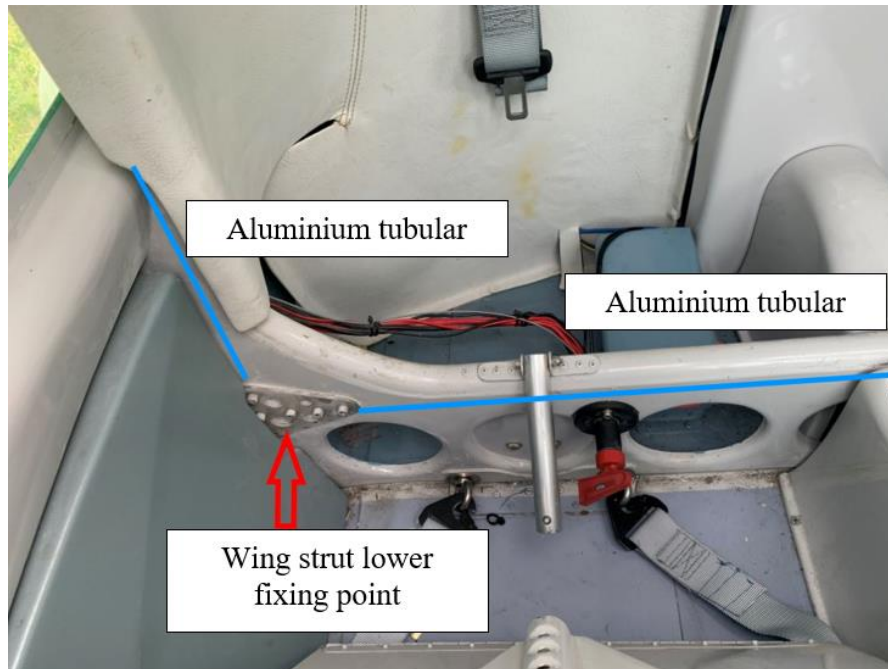
Photo 4: front view of the metal plates connecting the wing strut to the aircraft structure. In blue are highlighted the positions of the aluminium tubulars that constitute the structure (right wing strut fixing point). Photo taken during the ANSV inspection of an aircraft like the one that crashed, on the "Leonardo da Vinci" airfield in Vigevano.

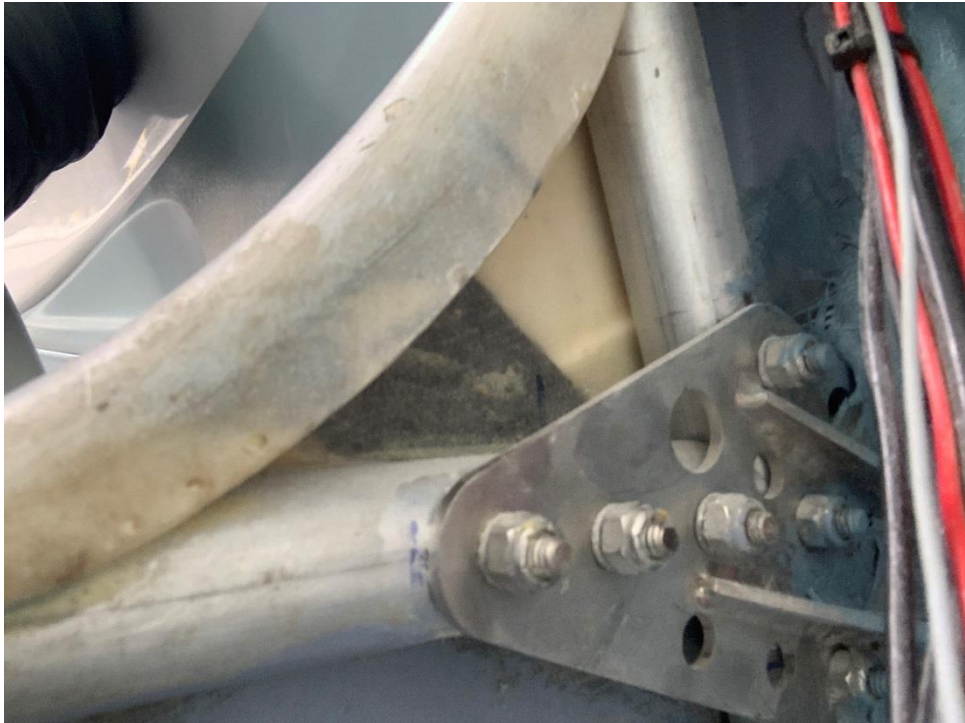
Photo 5: rear view of the metal plate constraining the wing strut and the structure's aluminium tubulars (right wing strut fixing point). Photo taken during the ANSV inspection of an aircraft of the same type the one that crashed, on the "Leonardo da Vinci" airfield in Vigevano.

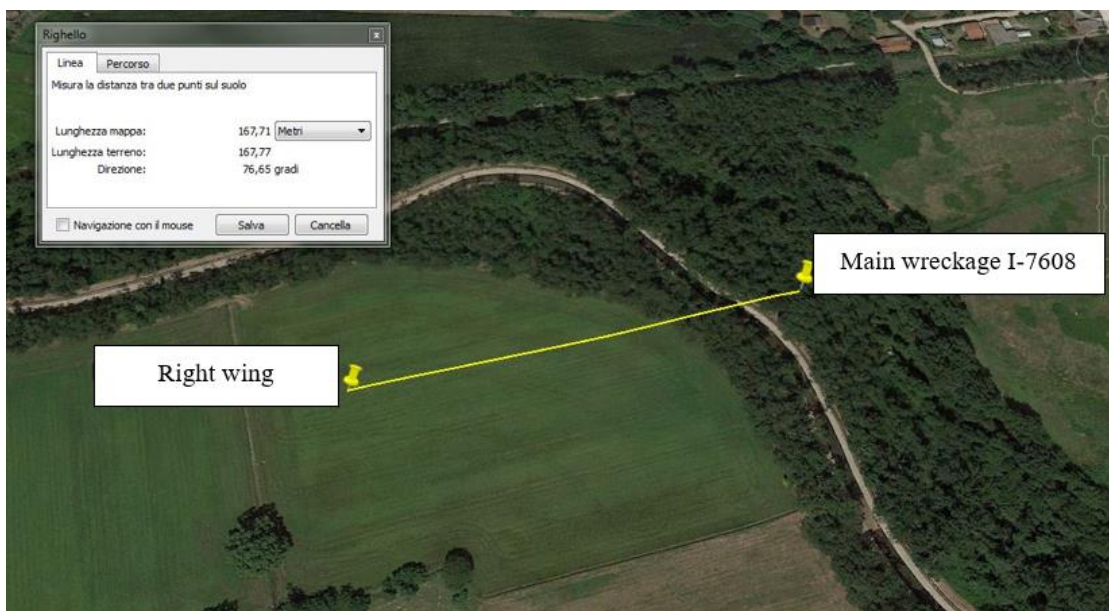
The right wing (photos 7, 8, 9 and 10) was found at coordinates 45°20'44.7"N 008°51' 22.5"E, approximately 170 m from the main wreckage, in a large rice field. The wing in question was complete, from the root to the tip. A strong smell of fuel was present on site. The leading edge showed no dents or impact marks. The *T-shape connection* was fractured approximately 10 cm from the beginning of the spar. The aileron was tied to the wing at the connection points; it still showed perfect functionality from the *link*, which had separated from the rest of the control line. The flap was tied to the wing at the left hinge only (inner, adjacent to the wing root) and had a tear at the right hinge (outer, further away from the wing root).

Photo 7: Representation of the positions of the main wreckage and the right wing (on Google Earth support).

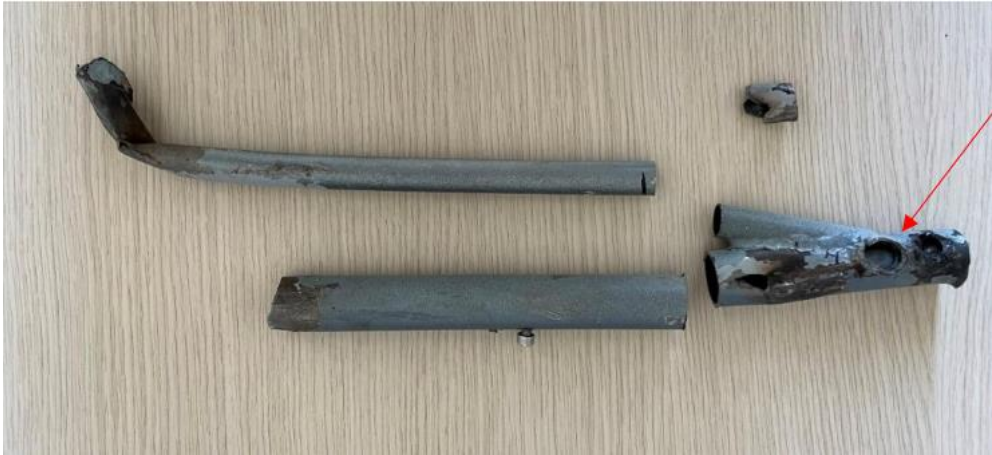
Photo 15: right rear *cabane* component.

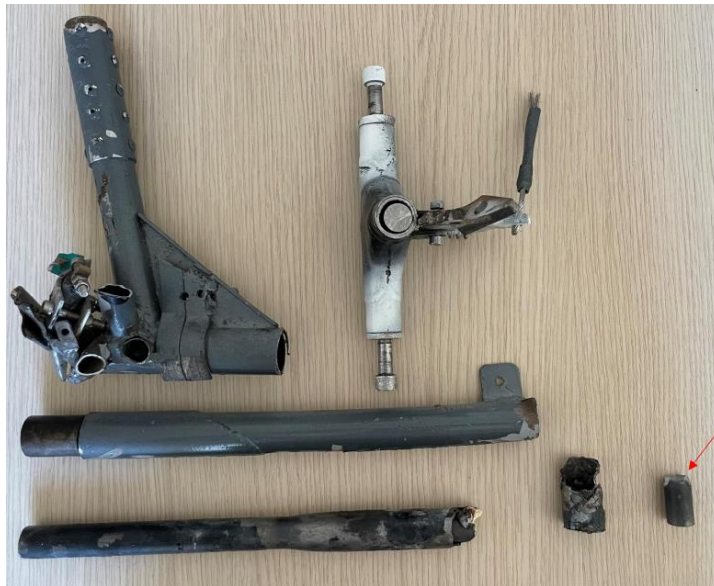
Photo 16: *T-shape connection* component right side.

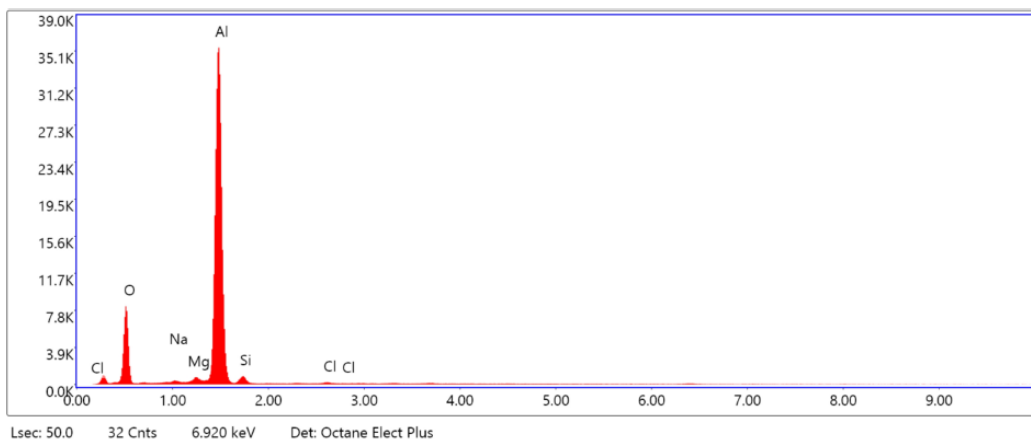
At the macroscopic level, a non-perfect circularity of the section was revealed at both ends, which were in fact ovalized. On the basis of the images obtained by the stereo-microscope and the pictures obtained by the scanning electron microscope, a high degree of corrosion is observed on the right and left end parts of the inner rib wing strut fixing points, in the fracture zone. For both fracture surfaces, the corrosion, in some areas, appears to be through the thickness; these areas are of greater extent on the fracture surface relative to the right-hand component (photo 22). The EDS analysis in the areas characterized by corrosion showed traces of salts (Figure 5 referring to area highlighted in photo 22). This makes it presumable that the progressive deterioration phenomenon may be associated with the presence of salt water in the vicinity of the corrosion areas. The semi-quantitative EDS analysis highlights, in addition to aluminium as the base element, the presence of magnesium and silicon, thus placing this alloy in the 6000 series (AlMgSi), consistent with the specification for a 6060 type alloy.

Element	Weight %	Atomic %	Net Int.	Error %	Kratio	Z	A	F
O K	14.45	22.18	858.00	4.11	0.0845	0.7668	0.7622	1.0000
NaK	0.07	0.07	3.92	67.63	0.0005	0.7000	0.9596	1.0223
MgK	0.98	0.99	73.77	4.87	0.0073	0.7144	1.0007	1.0435
AlK	82.26	74.87	5626.59	1.65	0.5781	0.6908	1.0168	1.0004
SiK	1.83	1.60	98.95	6.71	0.0105	0.7093	0.8084	1.0005
ClK	0.41	0.28	15.62	17.03	0.0026	0.6718	0.9405	1.0032

Figure 5: EDS analysis referring to the area highlighted in the red square.

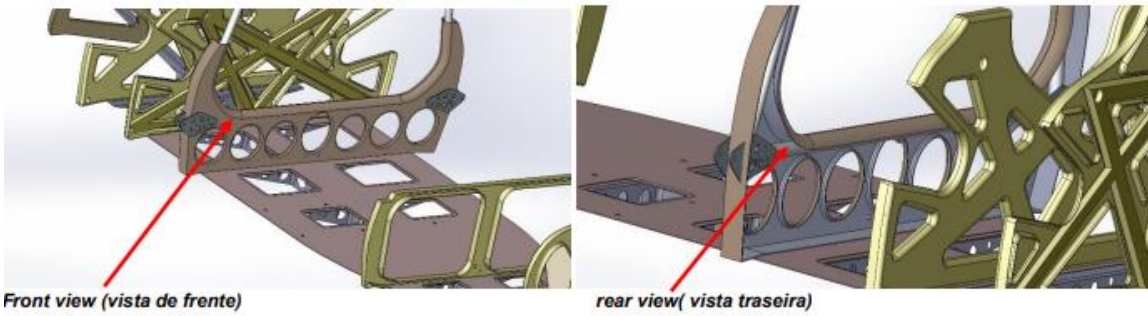
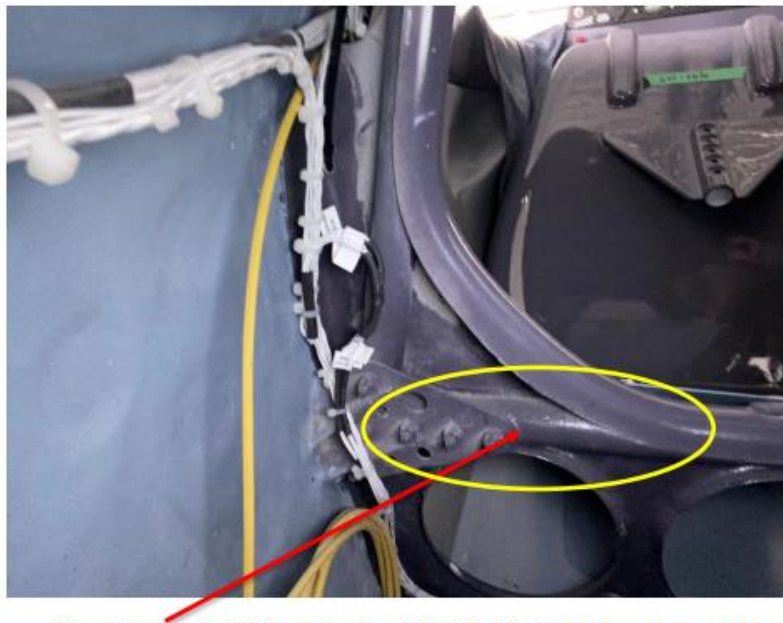
This tube is hard to inspect once is glued inside station 3, from behind, as show on fig 1. On figures, the skin of the fuselage is removed to easy visualization.

View of the tube installed on the aircraft (Vista to tubo instalado na aeronave)

Esse check deve ser realizado nas primeiras 300 horas de operação da aeronave. Após esse tempo, deve ser inspecionado a cada 100 horas.
